DATE: May 14, 1982  
REVISION DATE: August 26, 1983  
BULLETIN NO.: I/O:41  
PRODUCT: 26-4104 Model II Hires Graphics Board  
SUBASSEMBLY: N/A

PURPOSE: To correct small hash marks in the first eight inches of the left side of the video display.

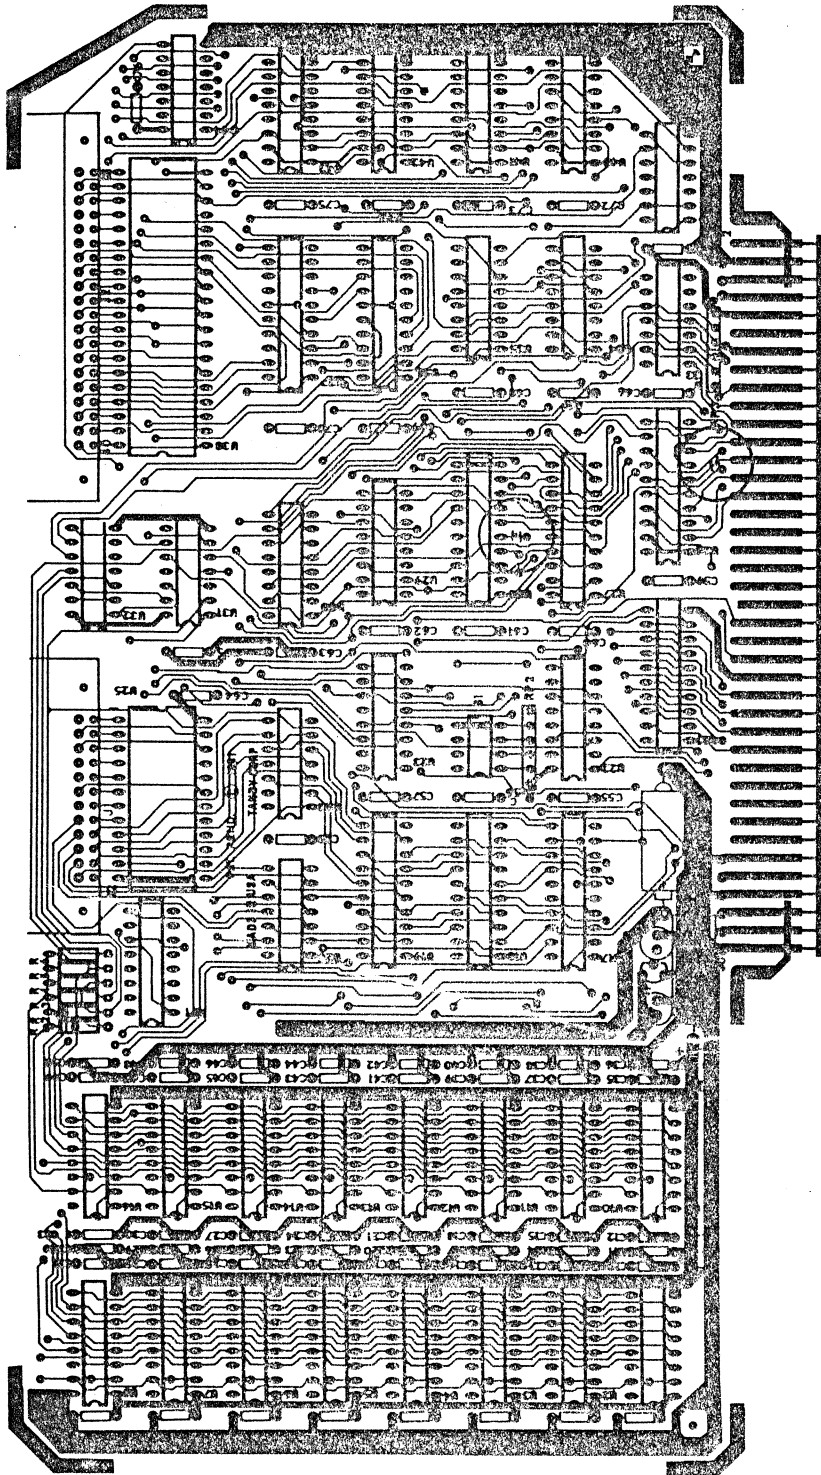
Figure 1

DISCUSSION/PROCEDURE: This problem will occur when updating the video memory on revision A boards. To modify install the following cuts and jumpers:

Cuts: U26 pin 6 (pin 26 on the edge card connector)  
(See figure 1) U28 pin 5 (cut at the first feed through)

Jumpers	U38 pin 39	to	U32 pin 4
	U38 pin 40	to	U32 pin 5
	U32 pin 6	to	U26 pin 6
	U26 pin 14	to	U28 pin 5
