Subject: Reversal of Model 12 serial channels

SUBJECT: DC Wiring Harness on the Cooling Kit Upgrade

FILE: Model 16B+

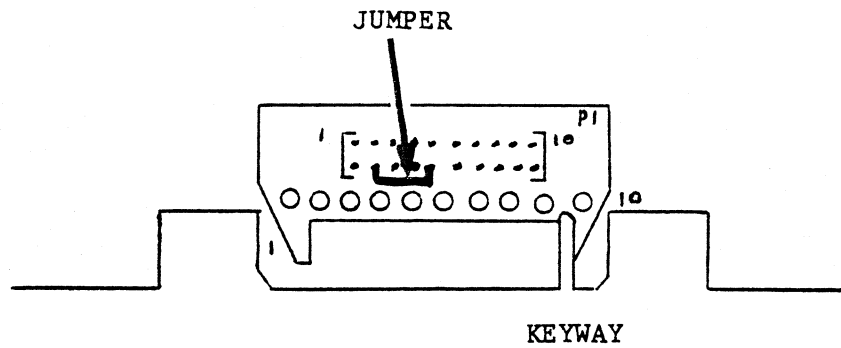
Figure 1

DISCUSSION: The Model 16 can use either an unmodified or modified Motorola video board, although it comes with an unmodified board. The Model 12 must use a video board that has been modified with a cut and jumper. This modification allows the video signal from the video/keyboard interface board to be routed through the video driver board on its way to the brightness control. This modification must be done to any Motorola board that is used in a Model 12.

PROCEDURE: The modification consists of a jumper that connects pin 2 of P1 to pin 5 placed in the holes closer to the edge connector as shown in figure 1. Then a cut must be made between the 2 holes in the trace that is connected to pin 2 which will disconnect pin 2 from the rest of the PC board as shown in figure 2.

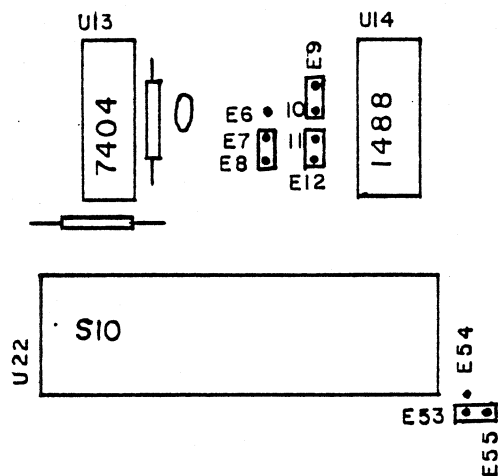
Jumpers for the Main logic board for use with another computer (Direct Wire) & the ALTEST DB25 connector
Figure 2:

The reason for the two different modifications is that the transmit clock on channel A can cause noise problems when it is connected to the RS232 cable. When a modem is used with the computer this signal can be eliminated which reduces the noise problems. This signal is needed only when a loopback connector is used or two computers are wired directly together without modems.

If it is going to be used with a modem the main logic board should be modified as shown in figure 3 by removing E10-E9. If it is going to be wired directly to another computer it should be left as in figure 2. Also, it is recommended that the customer use a 12 conductor cable on their serial channel instead of a 25 conductor cable.

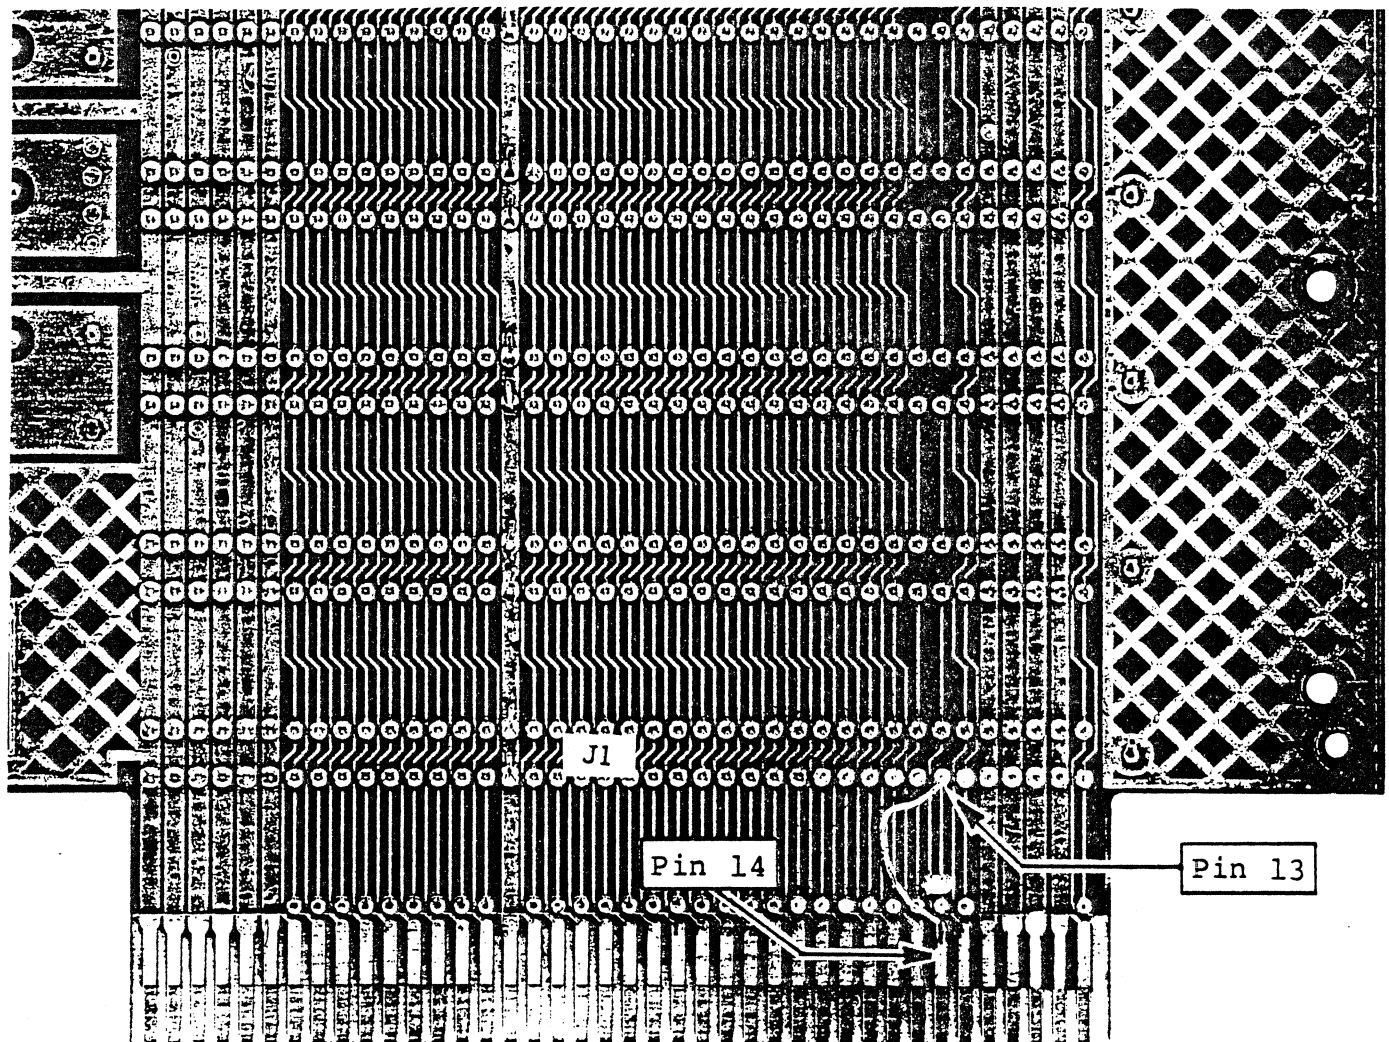
Figure 1

DISCUSSION: An error in the artwork of the mother board (revision PP4), will cause the 1st slot of the mother board to not function properly when a board using Z-80 family interrupts is installed.

PROCEDURE: Just above the point where the mother board plugs into the main logic board cut the two traces going to pins 13 and 14 of the plug (figure 1). Then run a jumper from pin 14 of the plug that goes into the mother board to pin 13 of the first socket in the mother board (J1).

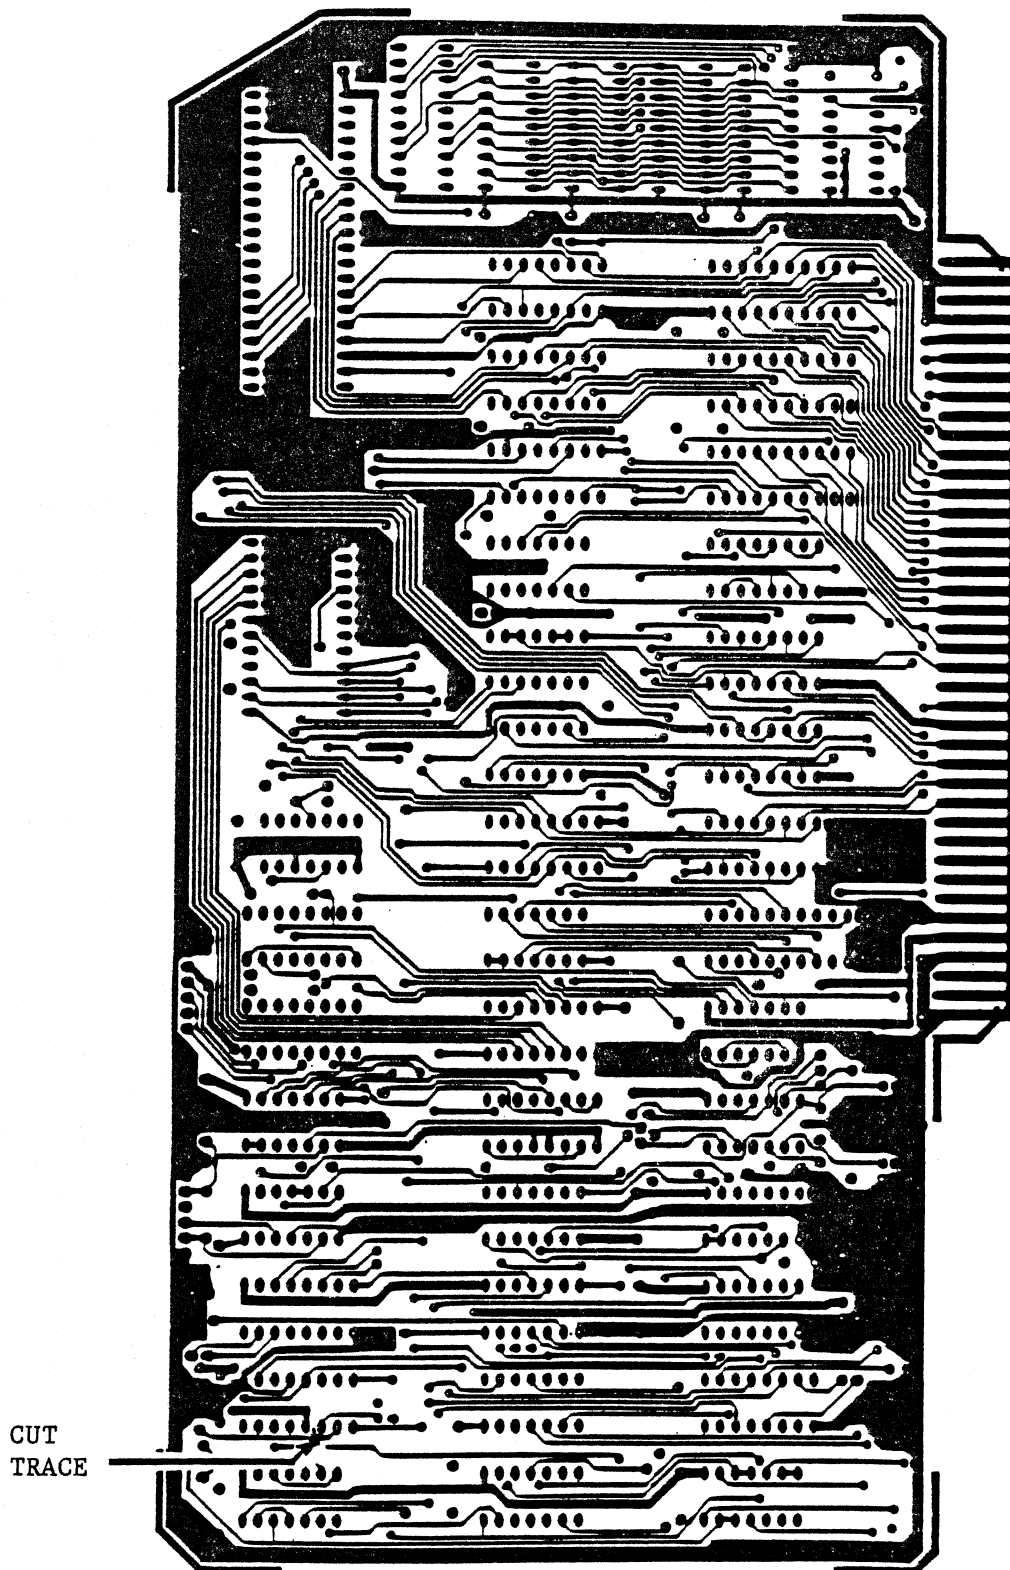
Figure 1 Video PCB (component side)

High memory addresses are shared by the Video and the 64K RAM. When the computer needs to use the video, it will activate the video RAM select logic allowing access to it. Occasionally when doing very fast RAM switching such as diagnostics, due to the access time specification of the RAM, the data transfer may not be reliable causing video failures. To correct this change the video select timing from 10ns to 100ns.

Refer to Figure 1 and cut the trace on the component side at U32 pin 7. Add a jumper wire from U32 pin 7 to U32 pin 12.

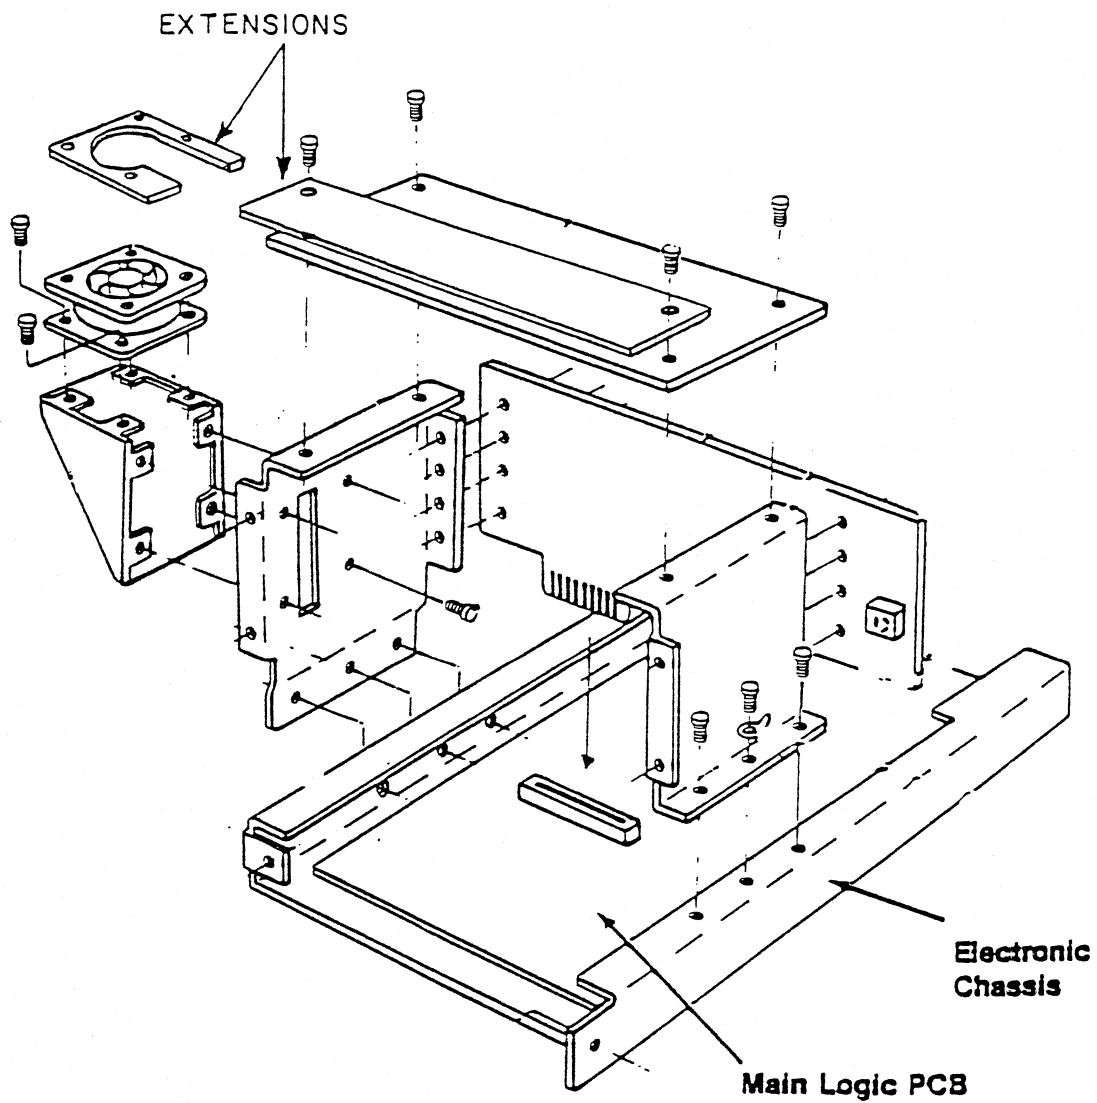
Figure 1

Due to continuous breaking of the guides and the unsecure fit of the circuit boards, the metal card guides in the card cage need to be replaced with plastic guides.

2. Remove the 6 screws that hold the card cage to the chassis.
Disconnecting the motherboard power plug and the fan wires will allow the card cage assembly to be pulled up and removed.
3. Remove the top plate, fan flume, and motherboard.
4. Replace the left and right side plates with the corresponding part numbers listed above.
5. Reassemble the card cage and the computer and check for proper operation.

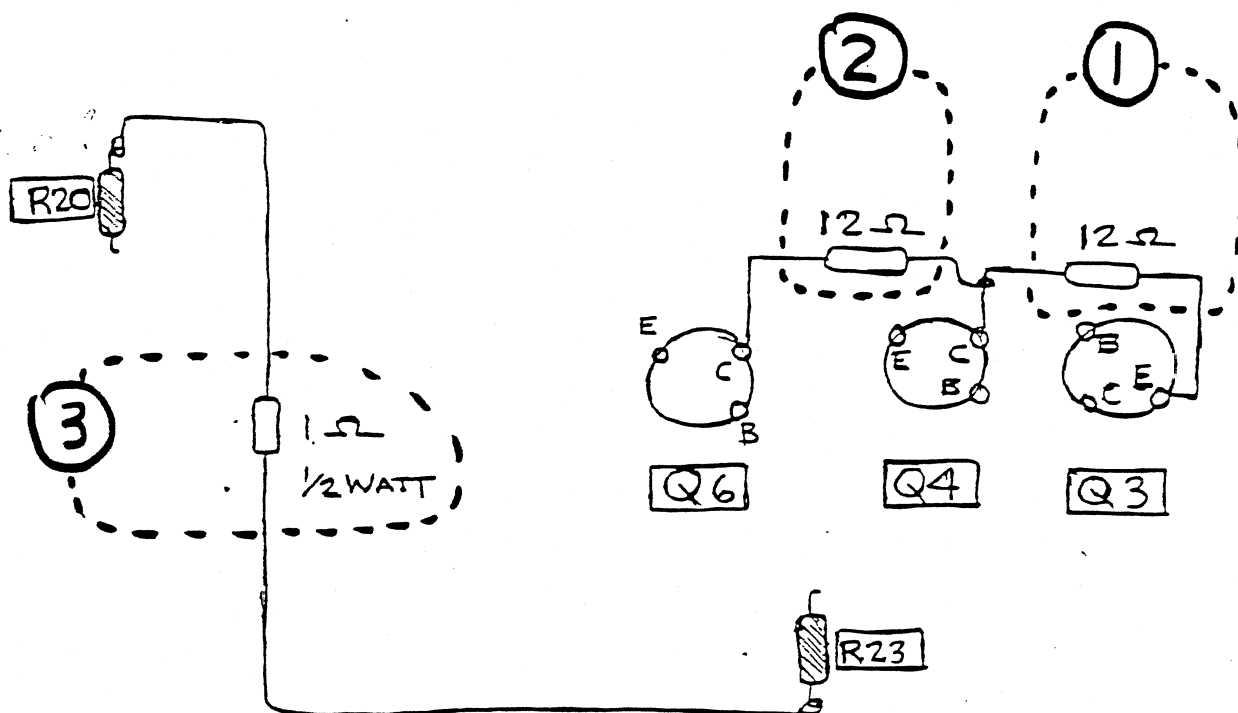
24 FIX (TO CHANGE FROM .47 TO .33)

Improper values in any of these locations causes the supply not to be able to come up under certain conditions - notably, high current drain, low line (or in some cases even high line) and cold power supply.

Note: Some units may have an "improper" modification. The improper power supply modification consists of two 12 ohm 1/4 watt 5% resistors connected to Q3, Q4, Q6, and a 1 ohm 2 watt 5% resistor attached between R20 and R23. If this is the case, remove the improper modification and follow this procedure.

ASTECC "IMPROPER" POWER SUPPLY FIX.

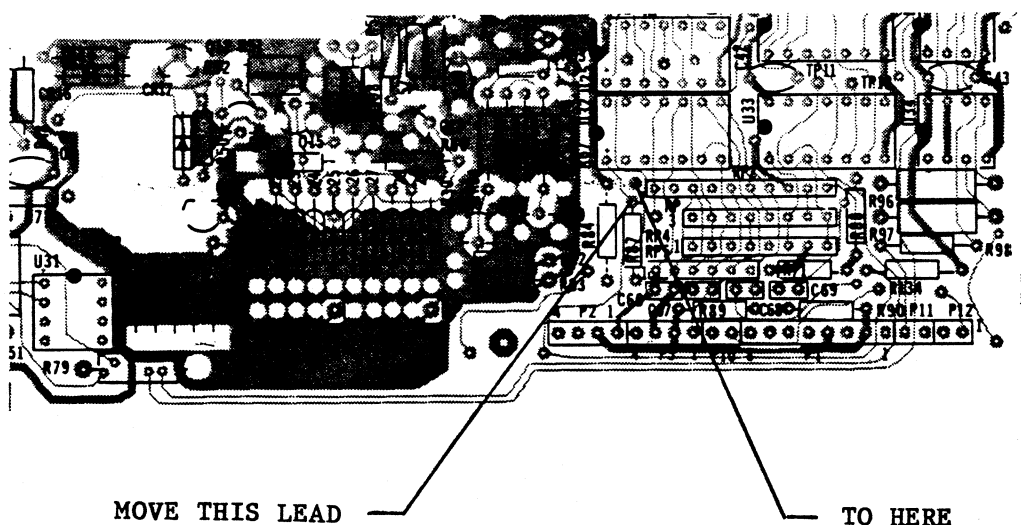
DISCUSSION: Some Tandon Belt Drive Logic Boards (Rev. Y) have come from the vendor with R87, a 150 ohm pullup resistor, installed incorrectly. These boards may be identified by the existence of a small white sticker (bearing a bar code, three numbers, and the letter "Y") attached to the board right next to the "REV" marking. The defective boards will not see the index pulses at all and will not recognize an inserted diskette, i.e. will remain at the "Insert Diskette" prompt even after a diskette is inserted and the drive door is closed.

PROCEDURE: Locate R87 on the Drive Logic Board. Note that one lead is connected to a feedthrough which has a trace running to U32, pin 1. Unsolder this lead of R87 and resolder it to the feedthrough right above it. The correct feedthrough is a +5V trace.
