# TANDY 6000 AND TANDY 6000 UPGRADE CHECKLIST

DATE: January 16, 1985  
REVISION DATE: February 13, 1985  
BULLETIN NO.: 6000:1  
PRODUCT: 26-6021/2 (Tandy 6000)  
26-6014 (8 MHz CPU upgrade kit)  
SUBASSEMBLY: 8 MHz 68000 CPU board

PURPOSE: To correct data setup time to memory board during a write cycle.

DATE: January 21, 1985  
REVISION DATE: January 21, 1985  
BULLETIN NO.: 6000:02  
PRODUCT: 26-6021/2 Tandy 6000  
SUBASSEMBLY: 8 MHz 68000 CPU PCB, Rev. A.

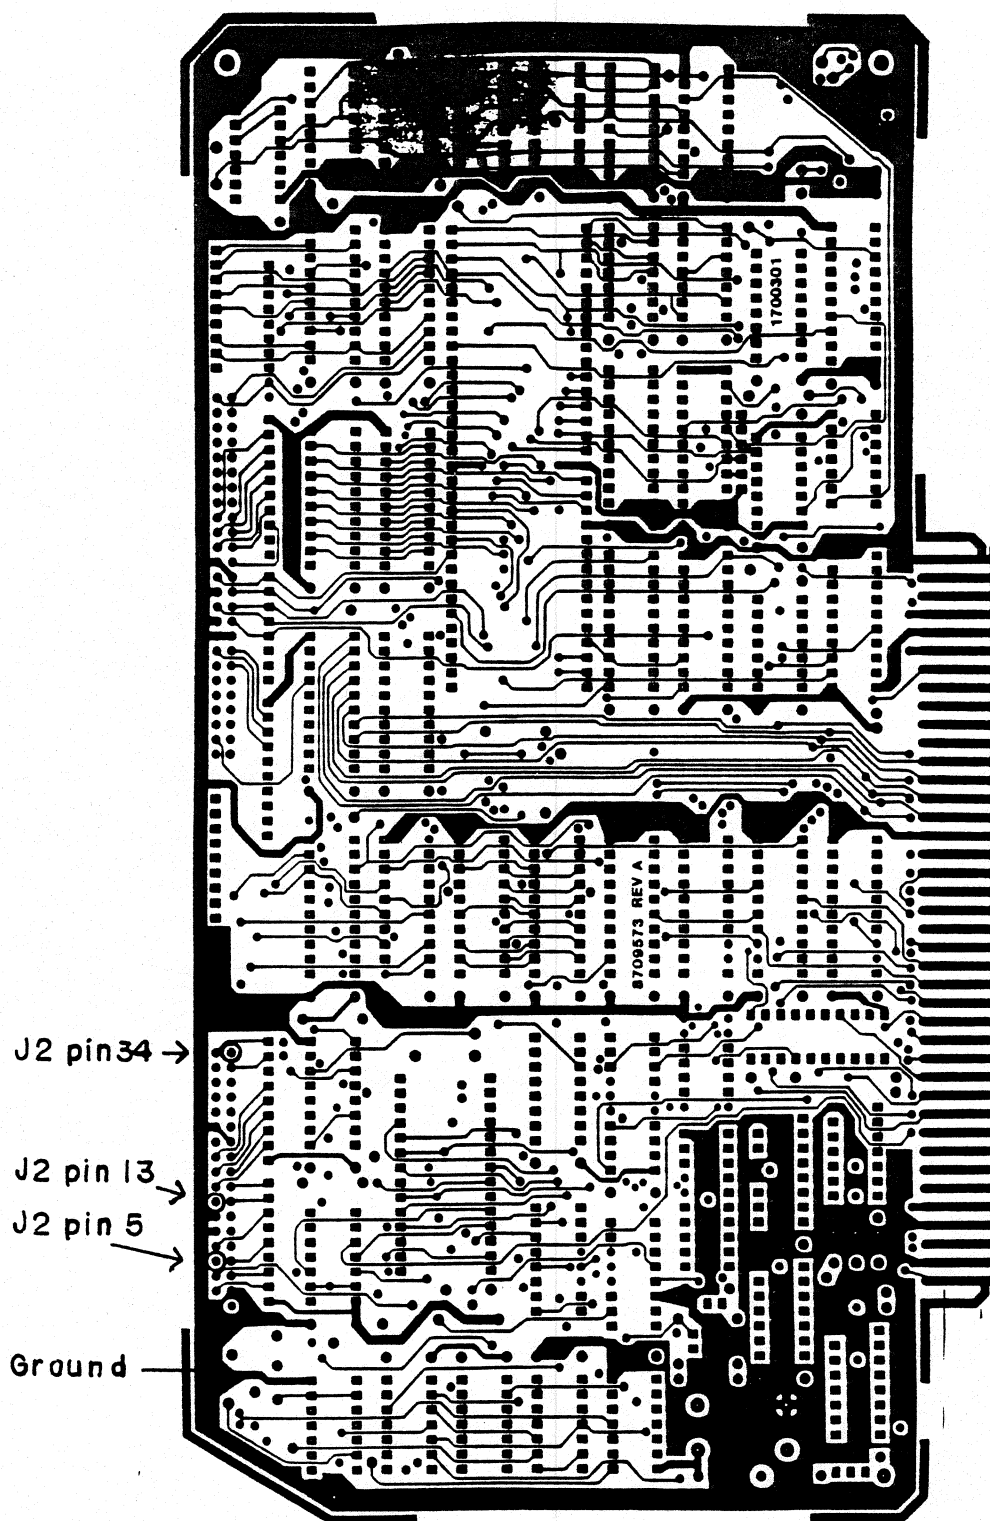
SOLDER SIDE (LAYER 4)**Radio Shack®**

Due to an error in the artwork on early revision (Revision A) boards, a modification to insure good ground connections between the 68000 CPU board and associated memory boards is required.

Using wire wrap wire, install the following jumpers on the solder side of the 68000 CPU board:

- (1) Jumper J2, pin 5 to ground.
- (2) Jumper J2, pin 13 to ground.
- (3) Jumper J2, pin 34 to ground.

Ground may be found at the feed-throughs on the ground plane near J2 on the solder side on the board.

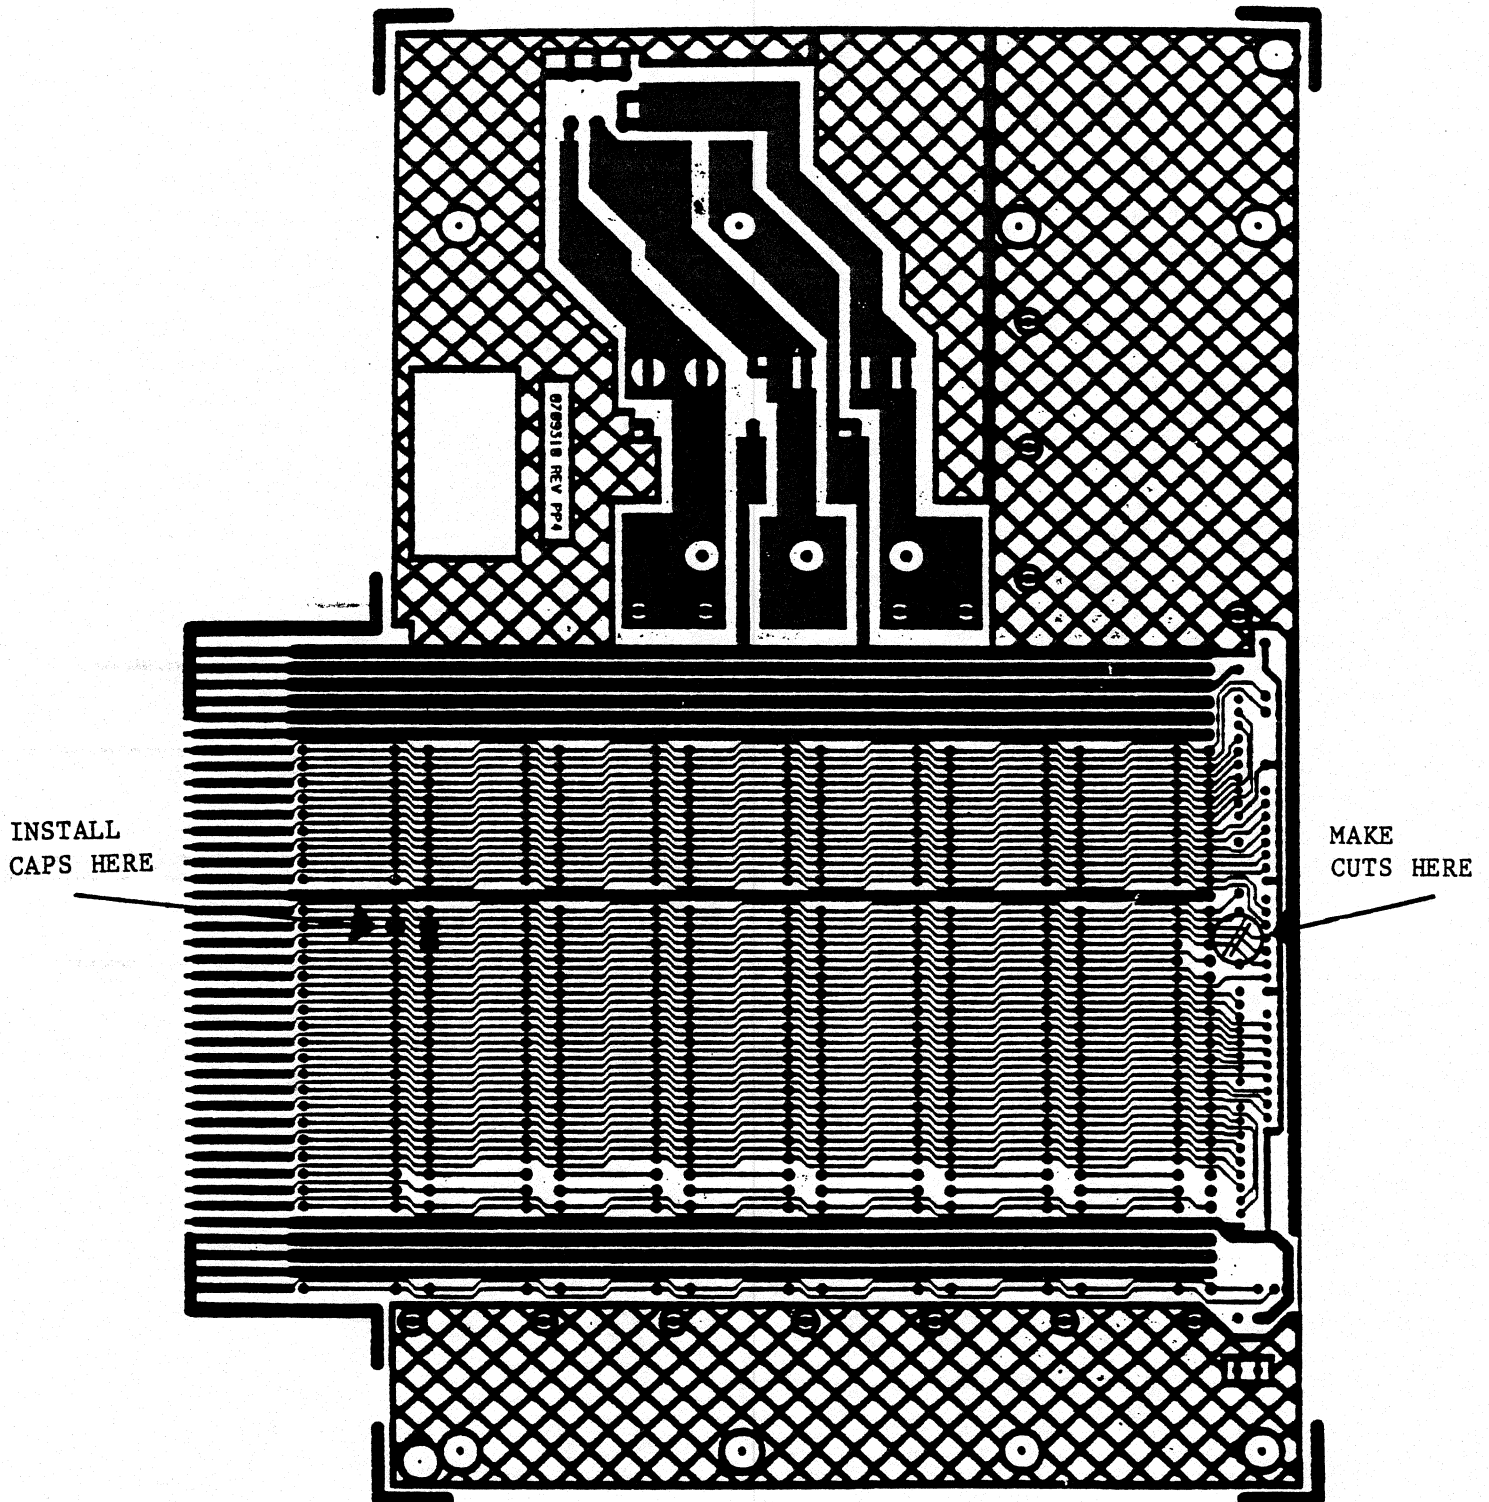
Figure 1

Circuit Trace, Mother Board 8897701, Solder Side

If 330 pf caps are found installed on the mother board, they may be considered satisfactory; however, should they need replacement, 220 pf caps should be used.

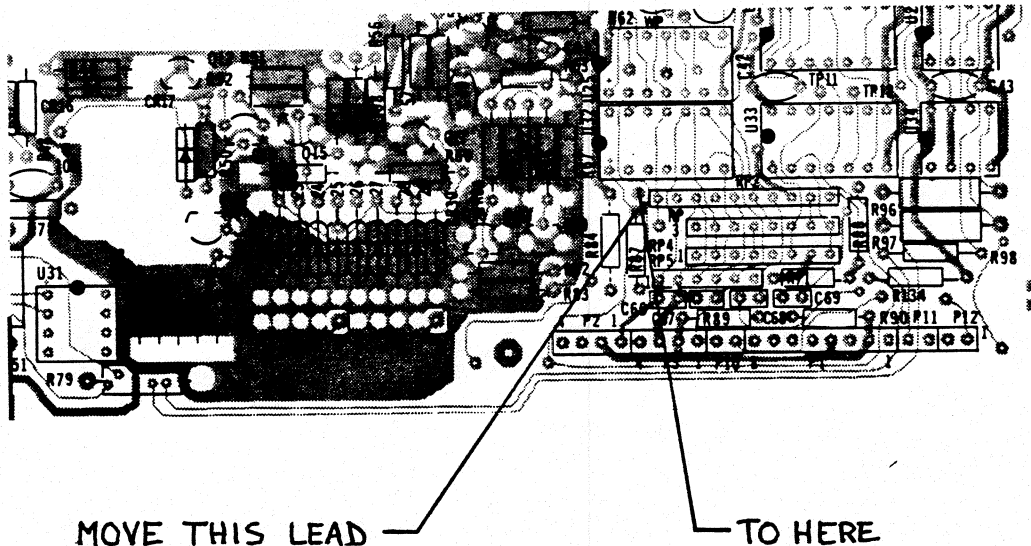
**DISCUSSION:** Some Tandon Belt Drive Logic Boards (Rev. Y) have come from the vendor with R87, a 150 ohm pullup resistor, installed incorrectly. These boards may be identified by the existence of a small white sticker (bearing a bar code, three numbers, and the letter "Y") attached to the board right next to the "REV" marking. The defective boards will not see the index pulses at all and will not recognize an inserted diskette, i.e. will remain at the "Insert Diskette" prompt even after a diskette is inserted and the drive door is closed.

**PROCEDURE:** Locate R87 on the Drive Logic Board. Note that one lead is connected to a feedthrough which has a trace running to U32, pin 1. Unsolder this lead of R87 and resolder it to the feedthrough right above it. The correct feedthrough is a +5V trace.

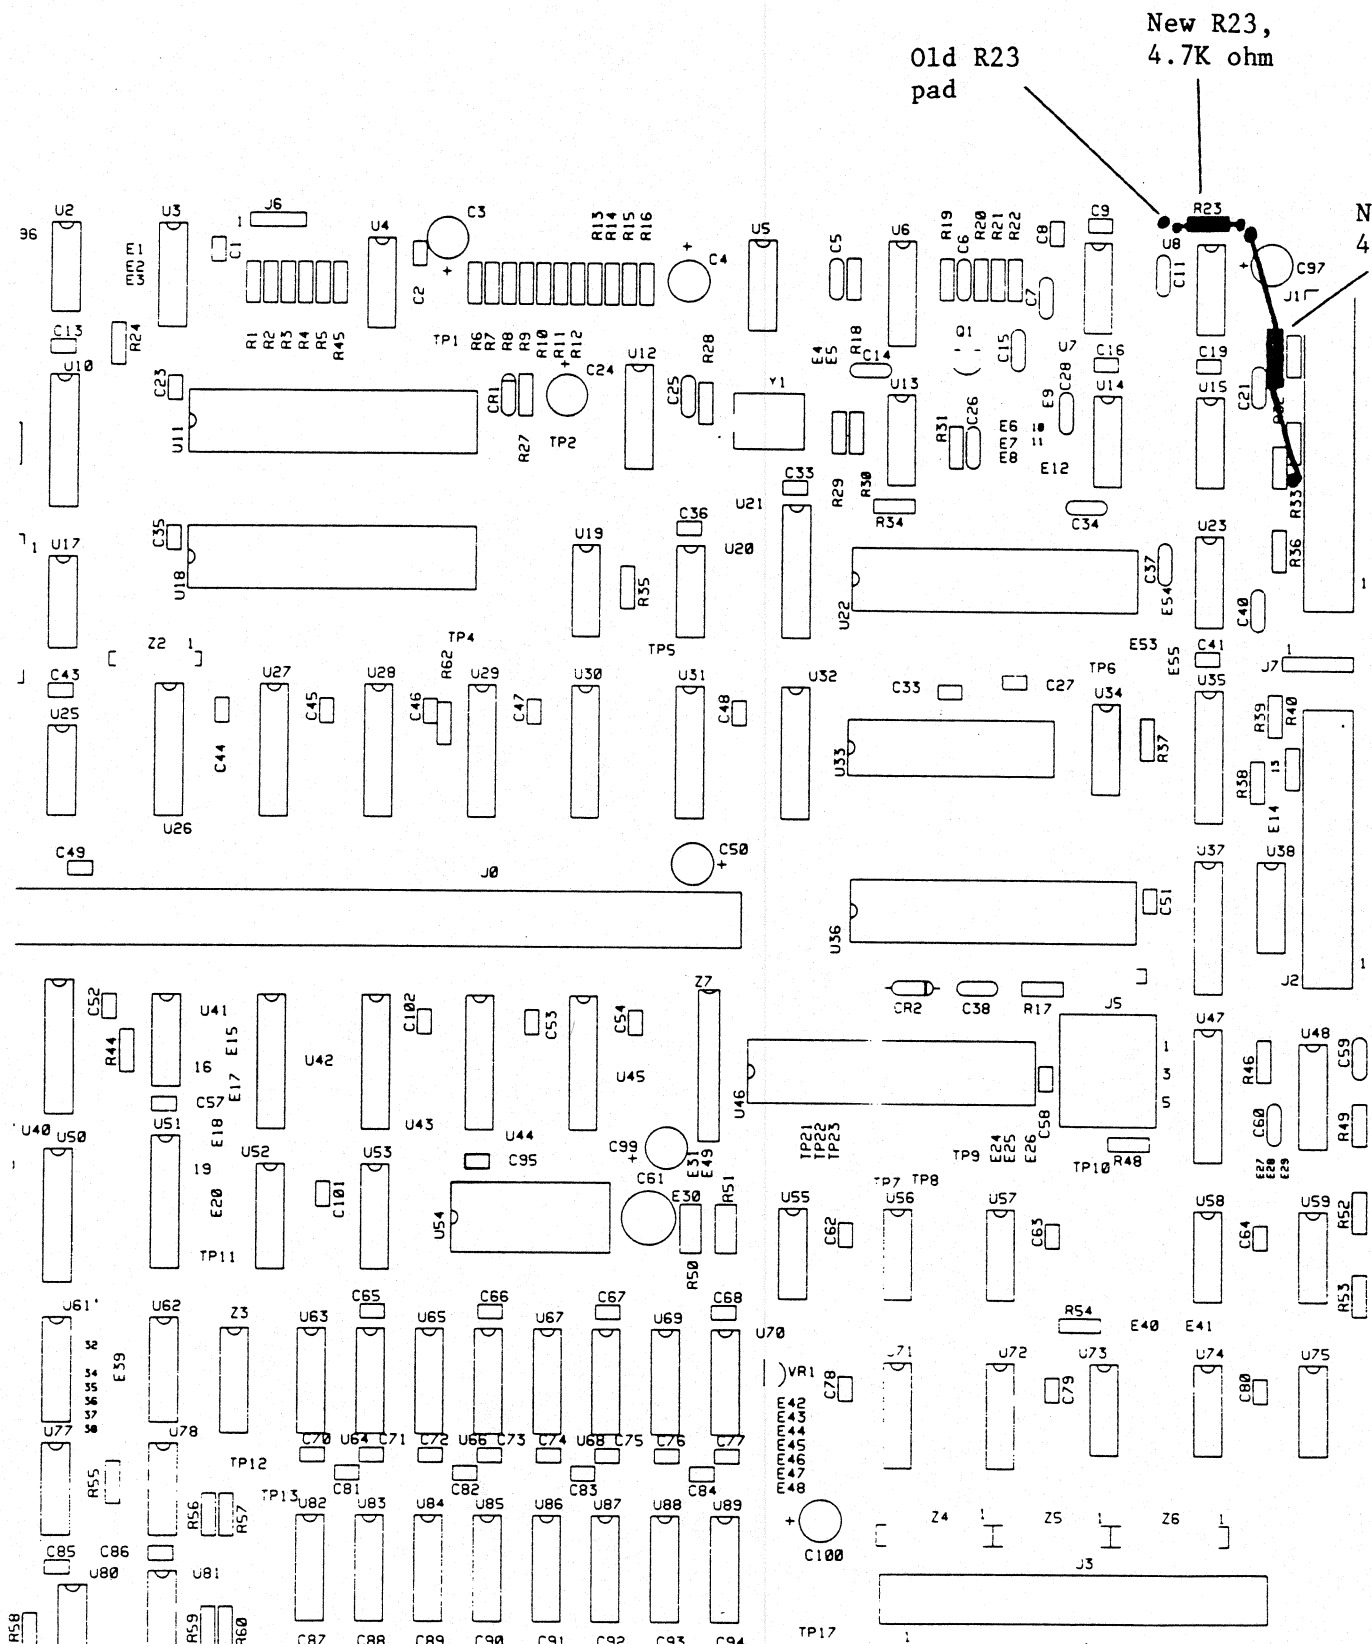
Old R23  
pad

New R33,  
4.7K ohm
