Technical Bulletins Sorted By Bulletin Number
Generated 12/31/92

DATE: May 1, 1980
REVISION DATE: November 24, 1982
BULLETIN NO.: I/O:03
PRODUCT: 26-1157 WP50 Daisy Wheel Printer
SUBASSEMBLY: N/A

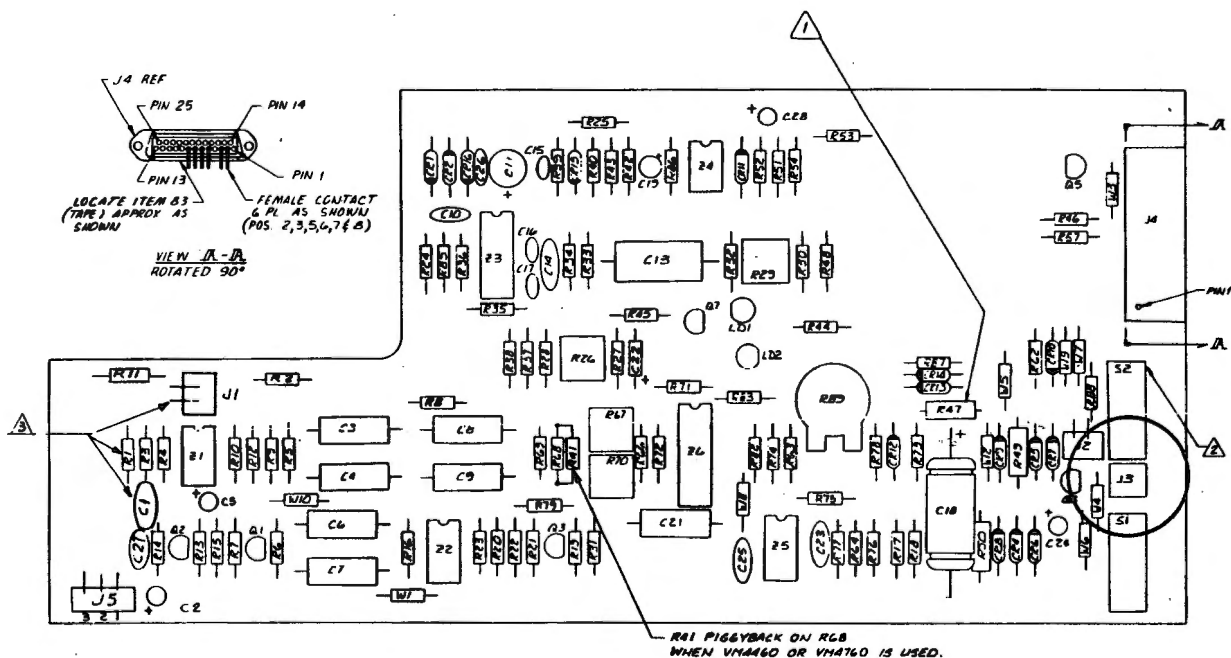
DISCUSSION: The circuit board trace just below the power connector (J3) is breaking due to stress applied by the connector. The problem is caused by insufficient trace area to securely anchor the connector or poor soldering.

PROCEDURE: Check the circuit board trace just below the power connector (J3) for hairline breaks or poor soldering. If necessary, remove the solder mask from the trace with an X-acto knife, and solder a short jumper wire across the power connector lead and the circuit board land.

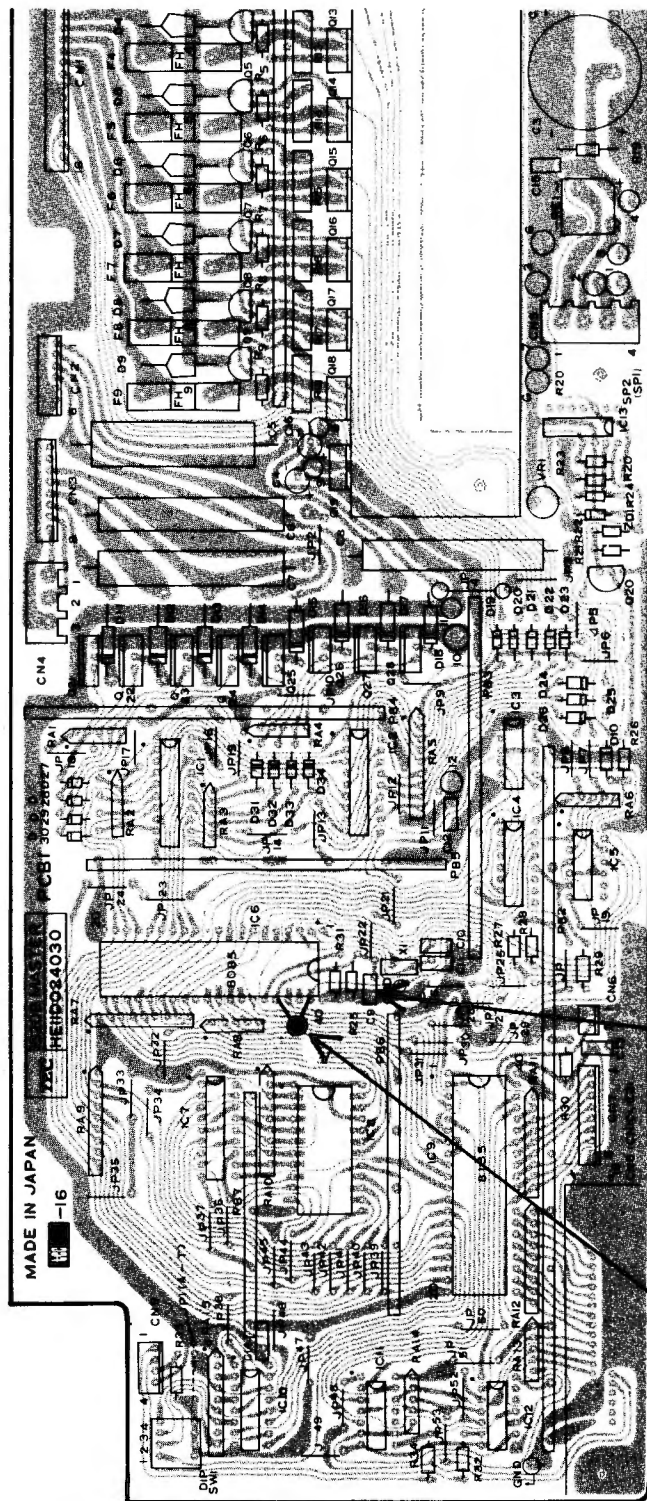
DISCUSSION: C9 was installed incorrectly at the time of manufacture. C9 is the capacitor tied to ground in the reset circuit. Hitting reset on the printer can cause the Line Printer V to glitch itself, thus it never returns from reset. Most Line Printer V's will not have this problem due to the tolerance of IC6. This modification should be installed in all Line Printer V's before date code 8A1. Do not do this modification to printers with date codes after 8A1, because they already have this modification installed.

PROCEDURE: Remove C9 from the logic board in the printer. Install a .1 uf capacitor between pins 36 and 39 of IC6.

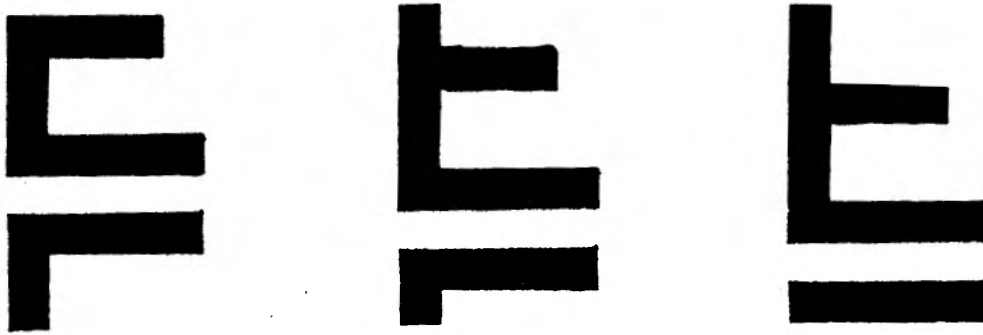
Figure 1

Instead of printing out the letter "E", the printer prints out one of the following, or a combination of any of the three.

From these examples you can see that the printer did try to print out the letter "E", but because of the improper timing between the platen and the rotation detector, they were not printed properly.

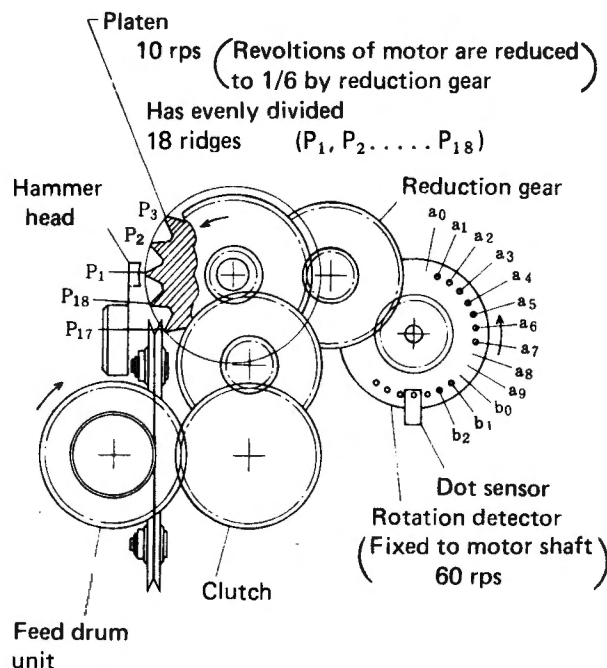
DISCUSSION/PROCEDURE: If the print head fails to move all the way to the right when printing, turn off the printer when the head stops moving. Pull the feed drum unit to the right, disengaging the coupling, and rotate it a maximum of four teeth towards the back of the printer. Release the feed drum unit. Pull the clutch assembly to the right, disengaging the coupling, and move the print head all the way to the right by rotating the clutch assembly. Turn on the printer and check for proper operation. If the printer still fails to move all the way to the right, repeat the above procedure.

If the print head fails to move all the way home after printing, turn off the printer when the head stops moving. Pull the feed drum unit to the right, disengaging the coupling, and rotate it a maximum of four teeth towards the front of the printer. Release the feed drum unit. Pull the clutch assembly to the right, disengaging the coupling, and move the print head to the home position by rotating the clutch assembly. Turn on the printer and check for proper operation. If the printer still fails to move all the way home, repeat the above procedure.

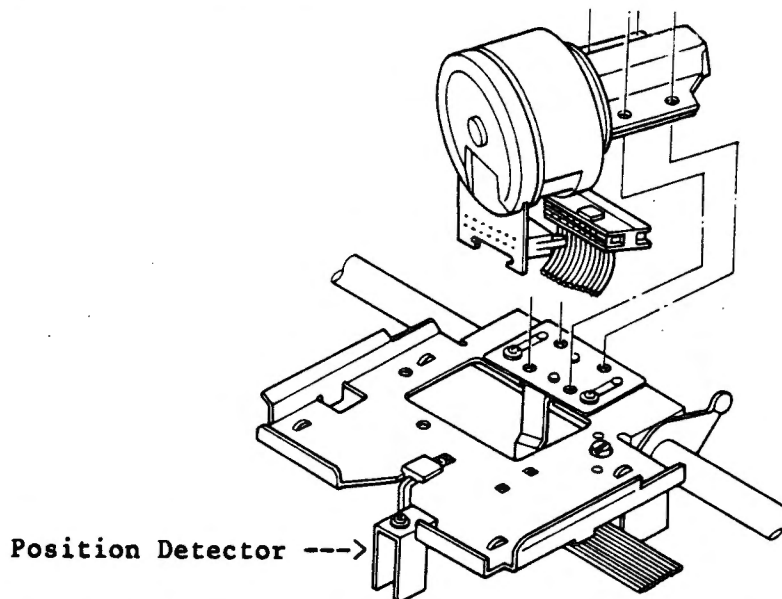
DISCUSSION/PROCEDURE: When the printer is powered up with the position detector bent, the carriage goes to the right and then to the left, but stops before reaching the home sensor and the Alert light comes on. During shipping the print head is pushed into one or both of the position detector switches on either side of the carriage assembly. This causes the position detector to become bent. With the detector bent the switch will either not be activated at all or will be activated too late. This will cause the printer to think the switch is faulty or the carriage is stuck. To correct this problem the two tabs should be parallel and straight up and down. Before shipping any Line Printer VIII be sure the carriage is secured and the position detector is not pressing against either of the switches. The only time that the printer normally uses these switches is on power up. If one of the switches is hit during printing the printer will go into check (ALERT).

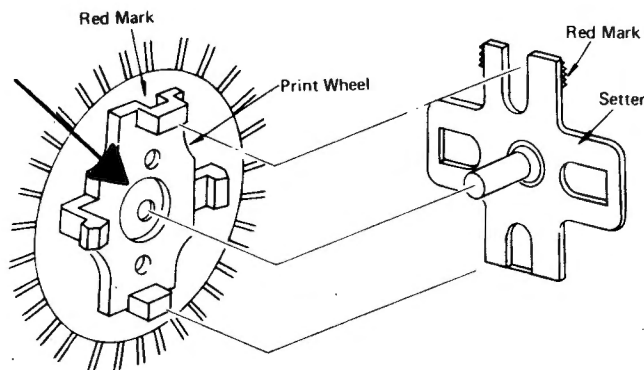
DISCUSSION: A defective Daisy Wheel II print wheel may cause the characters to be unevenly spaced or cause some characters to be close together while others are far apart. On the back of the print wheel there is a an "X" shaped plastic bracket (pointed to by the arrow in the illustration) which mates with the "setter" on the carriage assembly. If this is loose it will allow the the petals on the print wheel to slip a small amount in either direction. This will cause uneven character spacing. This occurs the most in print wheels that have been in use for some time. New print wheels have also been found to be defective. Before assuming that there is a mechanical or electrical problem be sure to check for a defective print wheel.
