TECHNICAL BULLETIN INDEX
Sorted by Bulletin Number
06/25/86

DATE: January 10, 1983
REVISION DATE: January 10, 1983
BULLETIN NO.: 12/16B:1
PRODUCT: 26-4004/5 (Model 12)
SUBASSEMBLY: Motorola Video Board

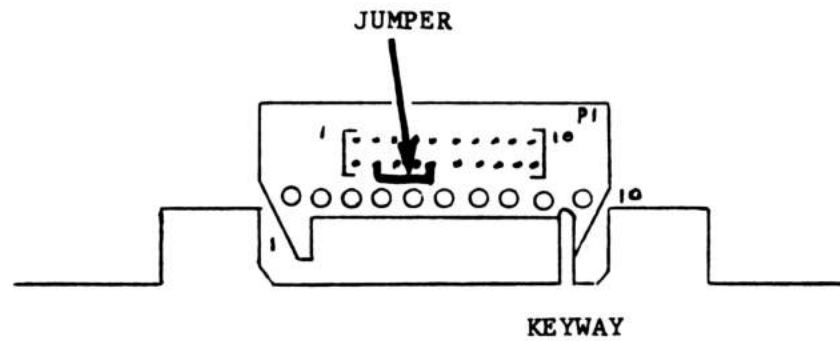
Figure 1

DISCUSSION: The Model 16 can use either an unmodified or modified Motorola video board, although it comes with an unmodified board. The Model 12 must use a video board that has been modified with a cut and jumper. This modification allows the video signal from the video/keyboard interface board to be routed through the video driver board on its way to the brightness control. This modification must be done to any Motorola board that is used in a Model 12.

PROCEDURE: The modification consists of a jumper that connects pin 2 of P1 to pin 5 placed in the holes closer to the edge connector as shown in figure 1. Then a cut must be made between the 2 holes in the trace that is connected to pin 2 which will disconnect pin 2 from the rest of the PC board as shown in figure 2.

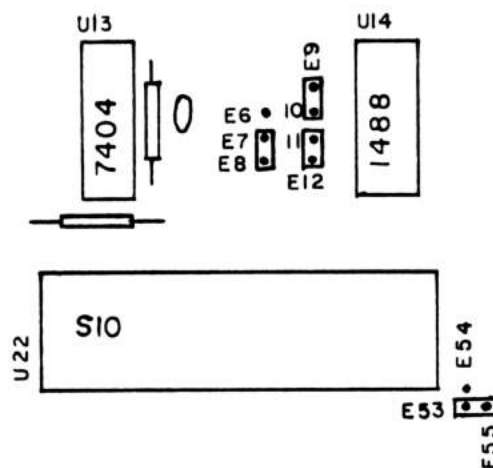
Figure 2:

Jumpers for the Main logic board for use with another computer (Direct Wire) & the ALTEST DB25 connector

Remove jumpers E10-E11 and E53-E54 and install jumpers E53-E55, E9-E10, and E11-E12 as shown on page 4 in figure 2. You will need an additional jumper, National Parts part number AJ-6769 jumper plug. If these are not in stock wire wrap can be used instead.

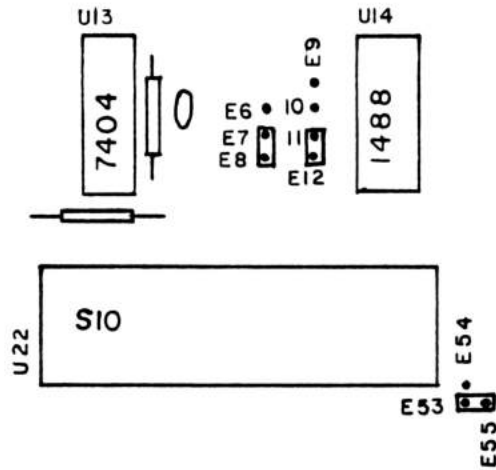
Jumpers for the Main logic board for use with a modem
Figure 3:

The reason for the two different modifications is that the transmit clock on channel A can cause noise problems when it is connected to the RS232 cable. When a modem is used with the computer this signal can be eliminated which reduces the noise problems. This signal is needed only when a loopback connector is used or two computers are wired directly together without modems.

If it is going to be used with a modem the main logic board should be modified as shown in figure 3 by removing E10-E9. If it is going to be wired directly to another computer it should be left as in figure 2. Also, it is recommended that the customer use a 12 conductor cable on their serial channel instead of a 25 conductor cable.

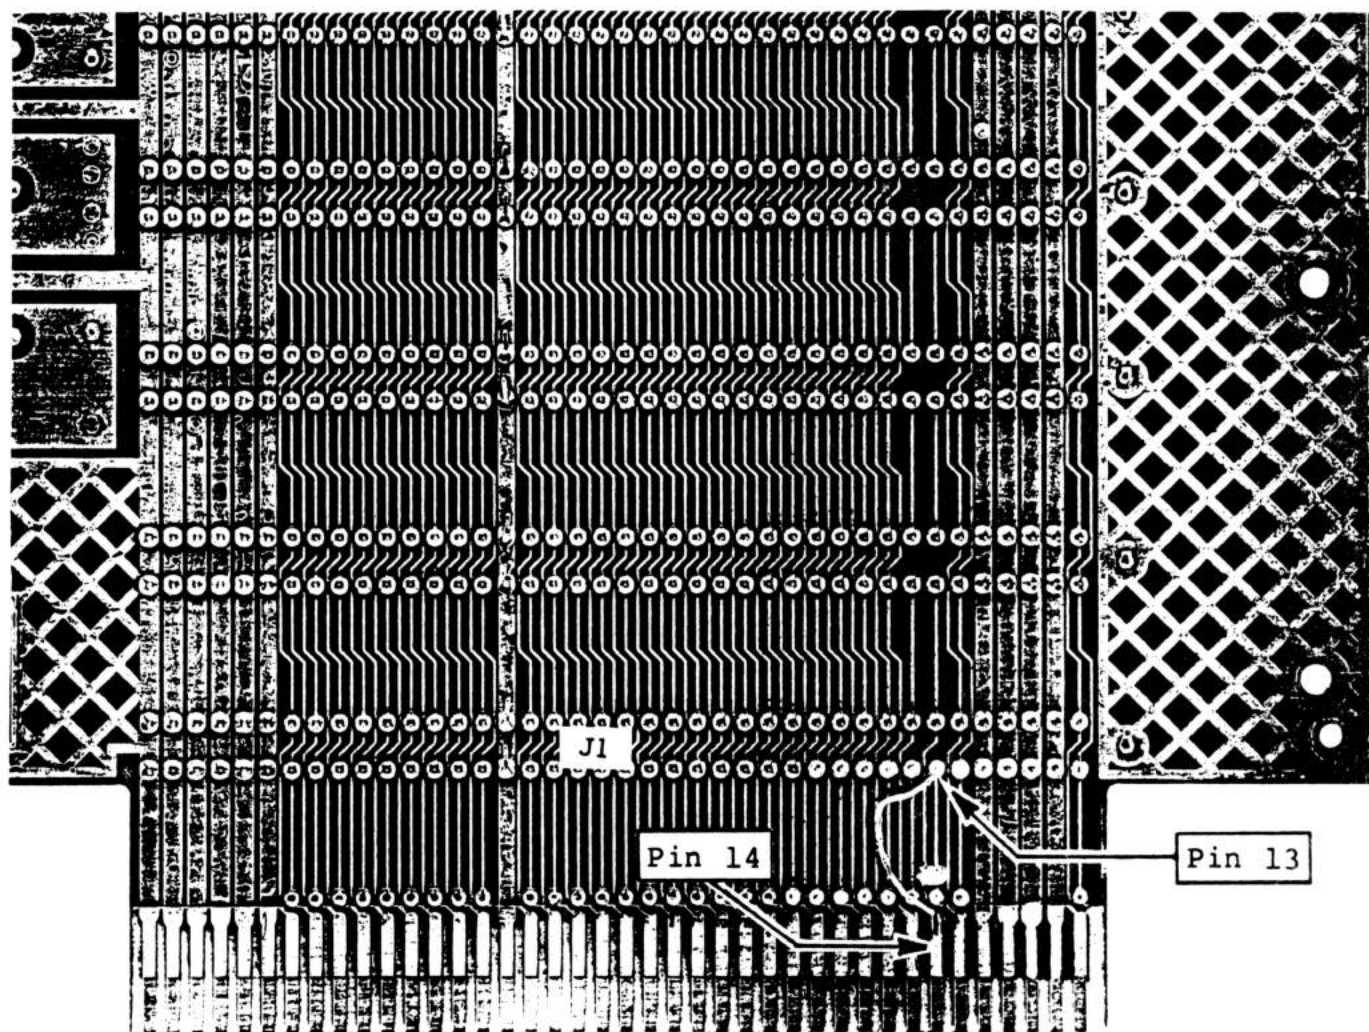
Figure 1

DISCUSSION: An error in the artwork of the mother board (revision PP4), will cause the 1st slot of the mother board to not function properly when a board using Z-80 family interrupts is installed.

PROCEDURE: Just above the point where the mother board plugs into the main logic board cut the two traces going to pins 13 and 14 of the plug (figure 1). Then run a jumper from pin 14 of the plug that goes into the mother board to pin 13 of the first socket in the mother board (J1).

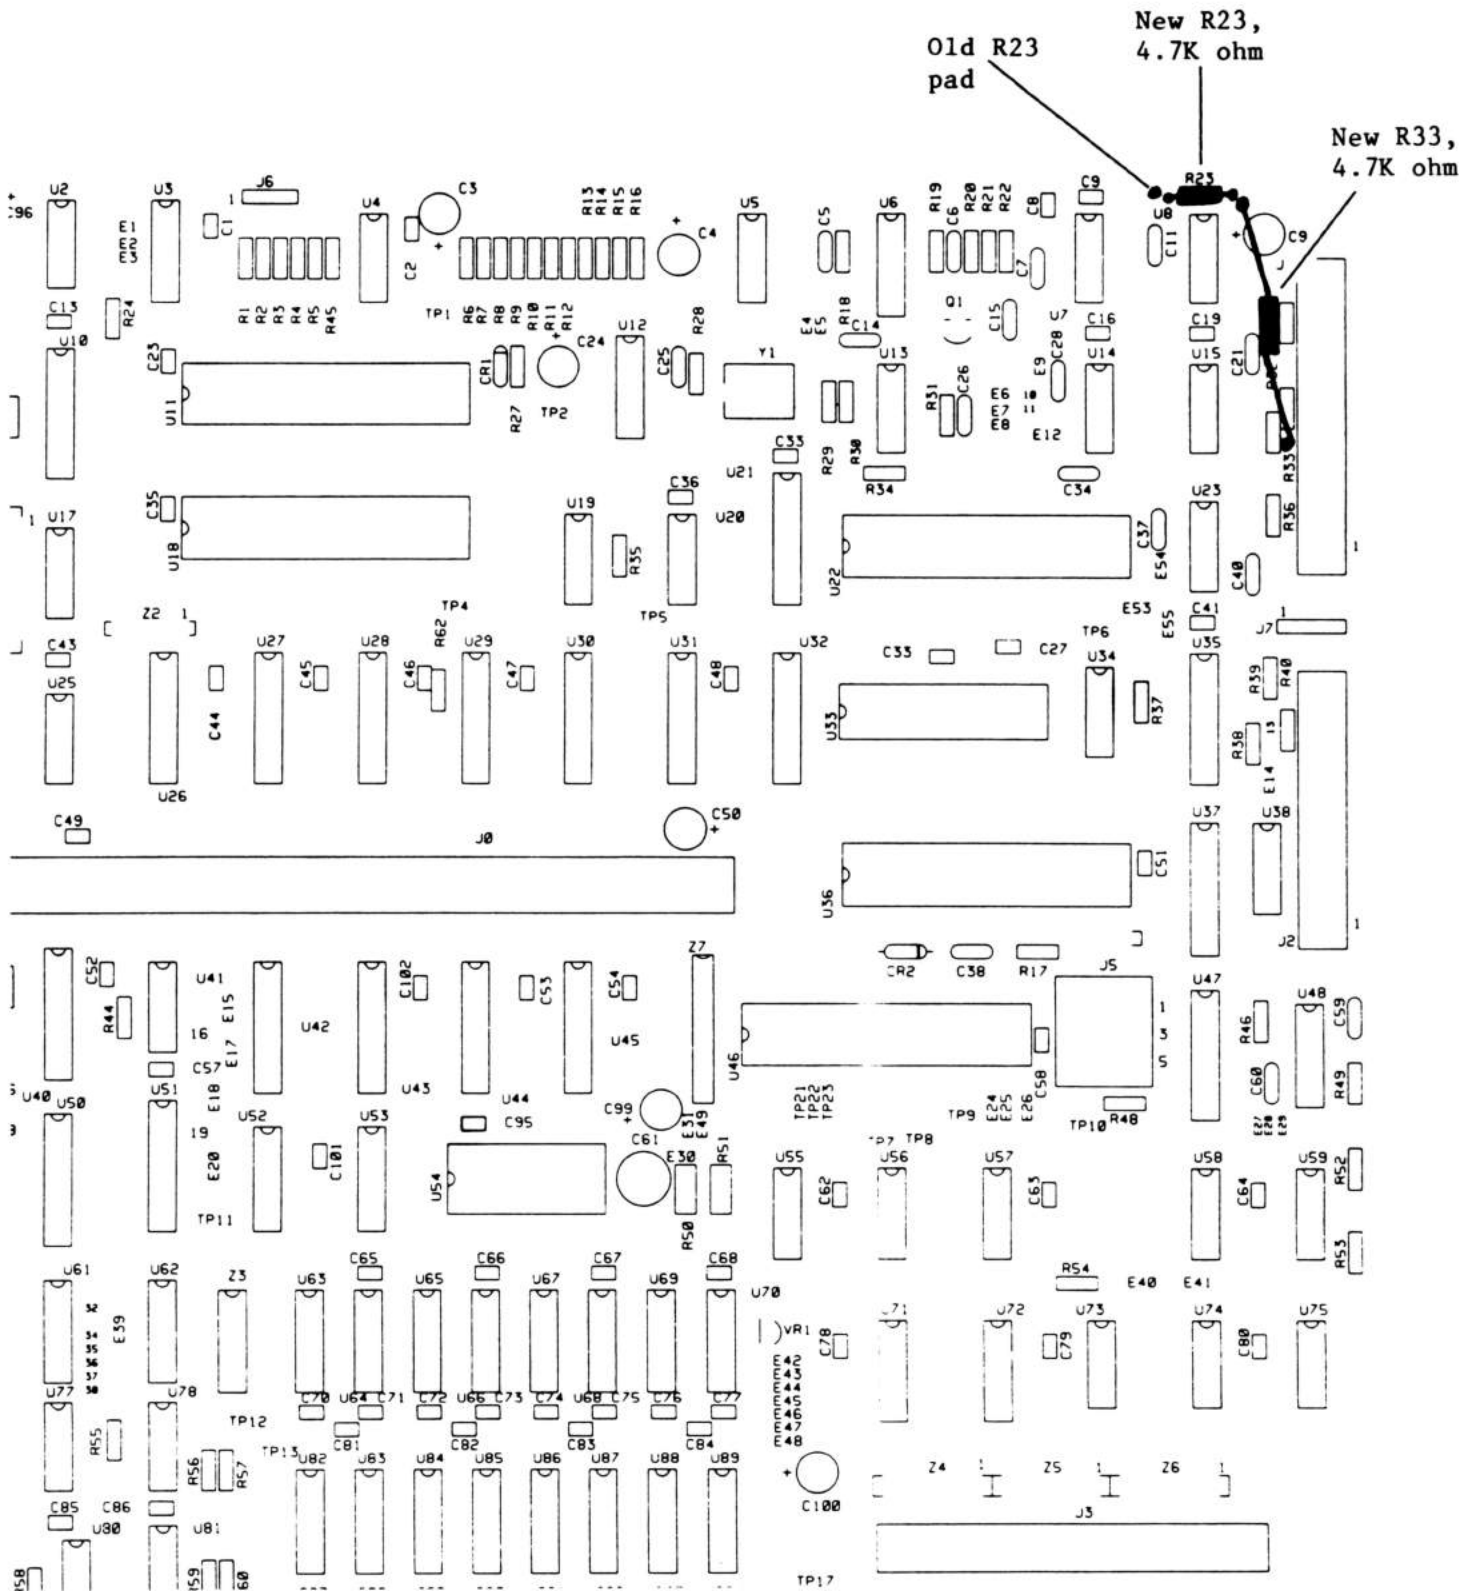
PURPOSE: Modification to make carrier detect signal normally true and guarantee fail-safe signal level for SIO control signals. This modification may also correct problems with systems which will not initialize port B terminals in Xenix operation.

Remove resistor R23. On the component side of the board, install a 4.7K ohm resistor with one lead attached to the old R23 solder connection closest to C97, and the other lead attached to the +12V line at the feedthrough adjacent to the remaining R23 solder connection. The +12V line in question also connects directly to U7, pin 14 (refer to figure 1).

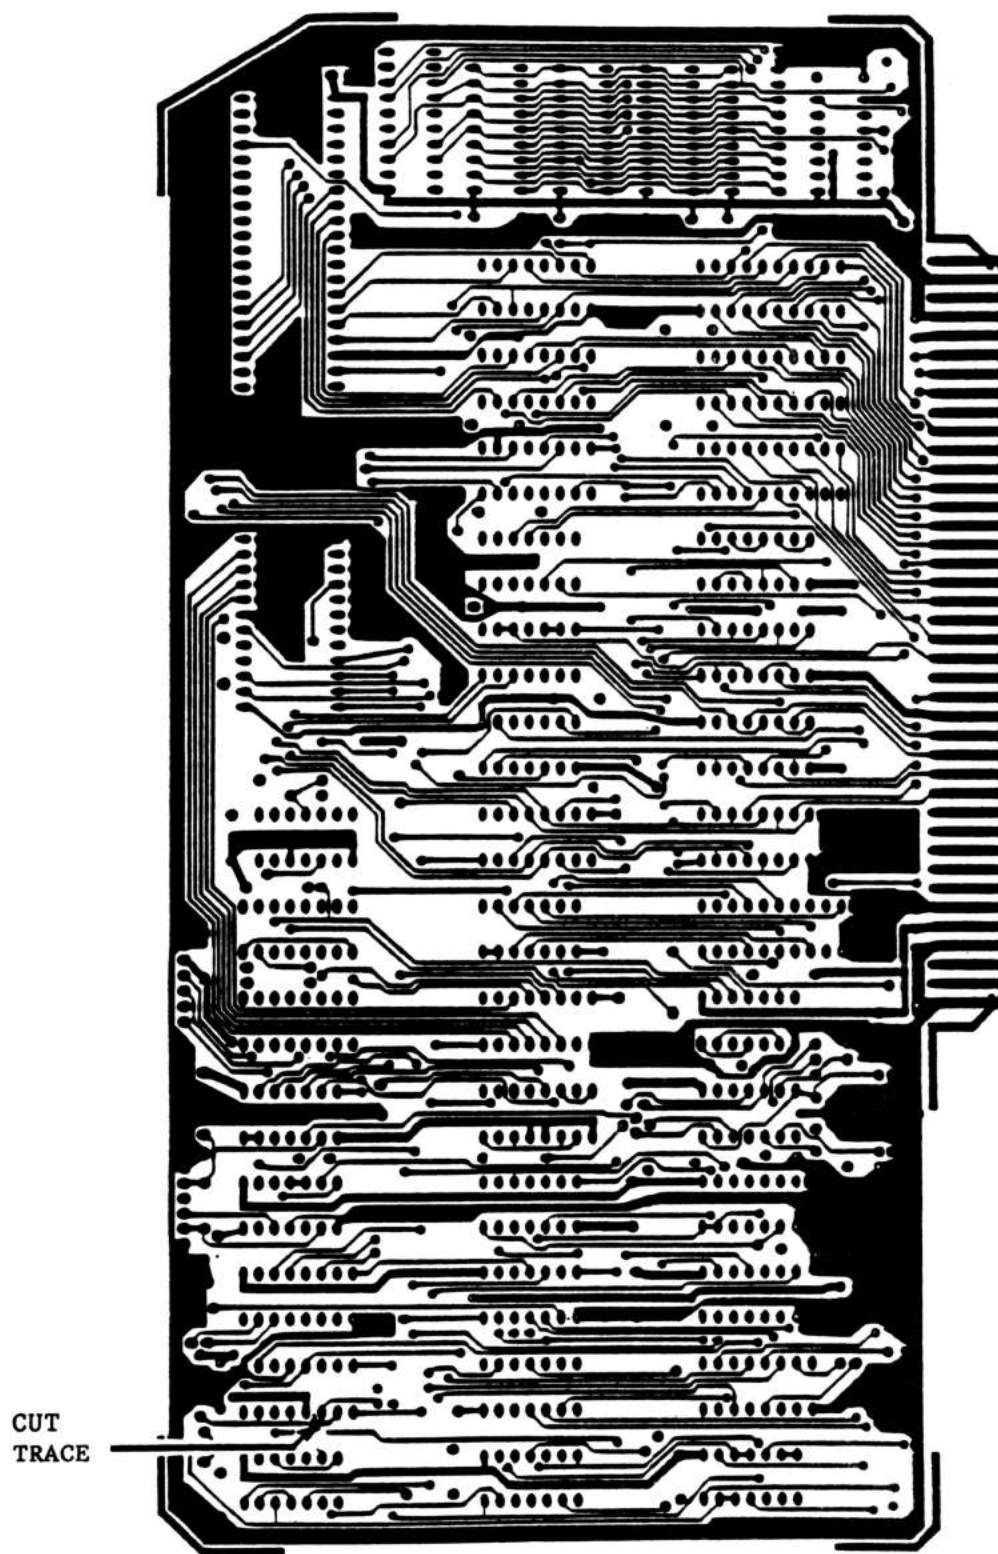
Figure 1 Video PCB (component side)

High memory addresses are shared by the Video and the 64K RAM. When the computer needs to use the video, it will activate the video RAM select logic allowing access to it. Occasionally when doing very fast RAM switching such as diagnostics, due to the access time specification of the RAM, the data transfer may not be reliable causing video failures. To correct this change the video select timing from 10ns to 100ns.

Refer to Figure 1 and cut the trace on the component side at U32 pin 7. Add a jumper wire from U32 pin 7 to U32 pin 12.

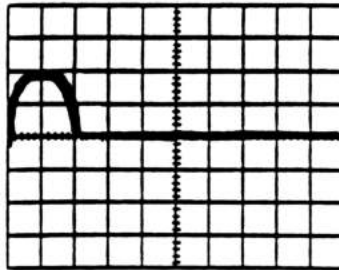
Figure 1

200 nano seconds
TP10 .1 usec/div

5. Connect the scope probe to TP10 and adjust R50 to attain a positive pulse-width of 200ns. Refer to Figure 1.
6. Connect the scope probe to TP8 and adjust R51 to attain a positive pulse-width of 500ns. Refer to Figure 2.
7. After these three adjustments have been done, replace jumper E30-E31 back to its original position, E31-E49.
8. Perform a system RESET then insert a Floppy Disk and proceed with diagnostic check-out.

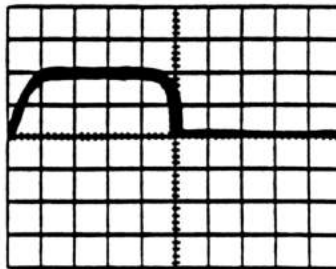
Figure 2

500 nano seconds
TP8 .1 usec/div

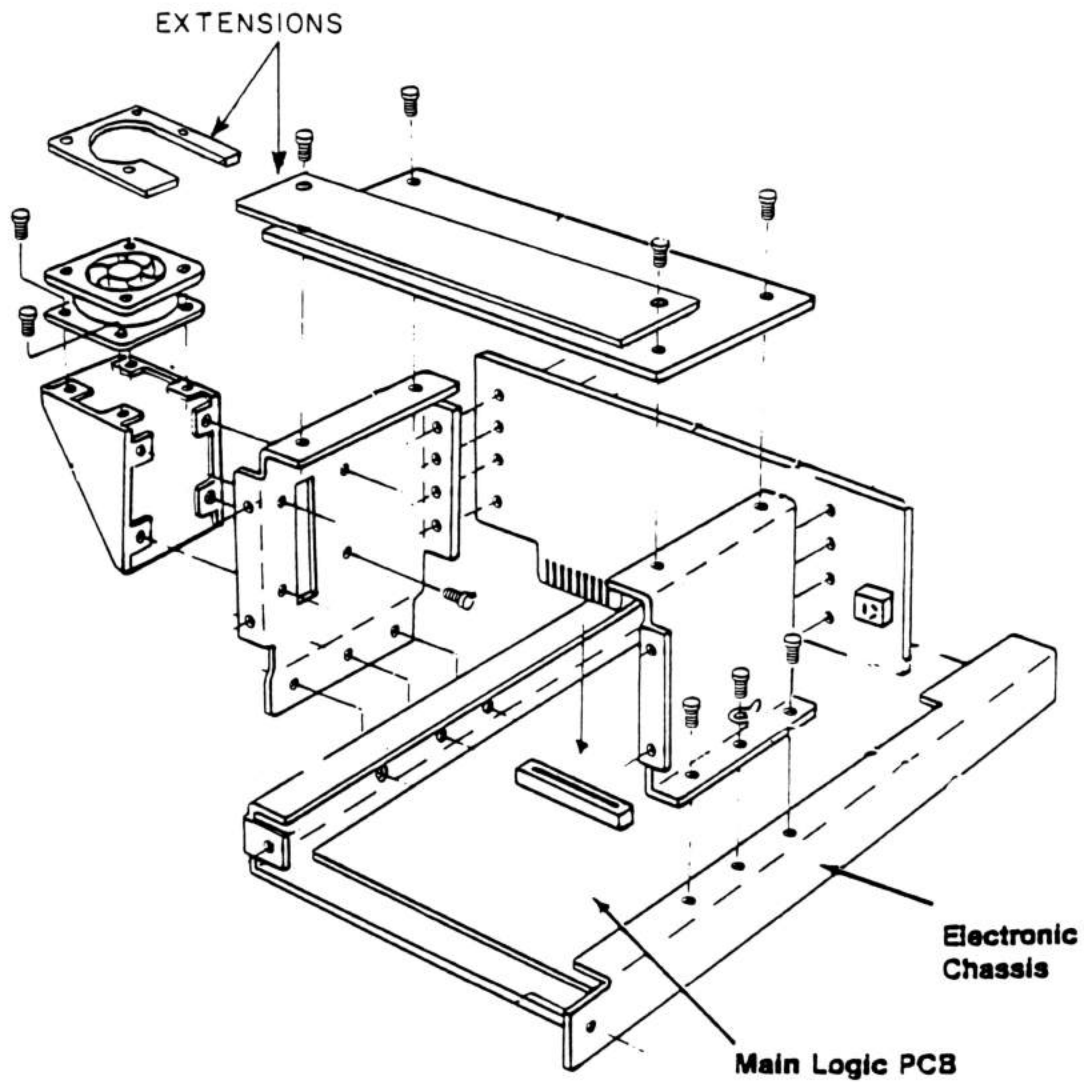
Figure 1

Due to continuous breaking of the guides and the unsecure fit of the circuit boards, the metal card guides in the card cage need to be replaced with plastic guides.

2. Remove the 6 screws that hold the card cage to the chassis.
Disconnecting the motherboard power plug and the fan wires will allow the card cage assembly to be pulled up and removed.
 3. Remove the top plate, fan flume, and motherboard.
 4. Replace the left and right side plates with the corresponding part numbers listed above.
 5. Reassemble the card cage and the computer and check for proper operation.
-

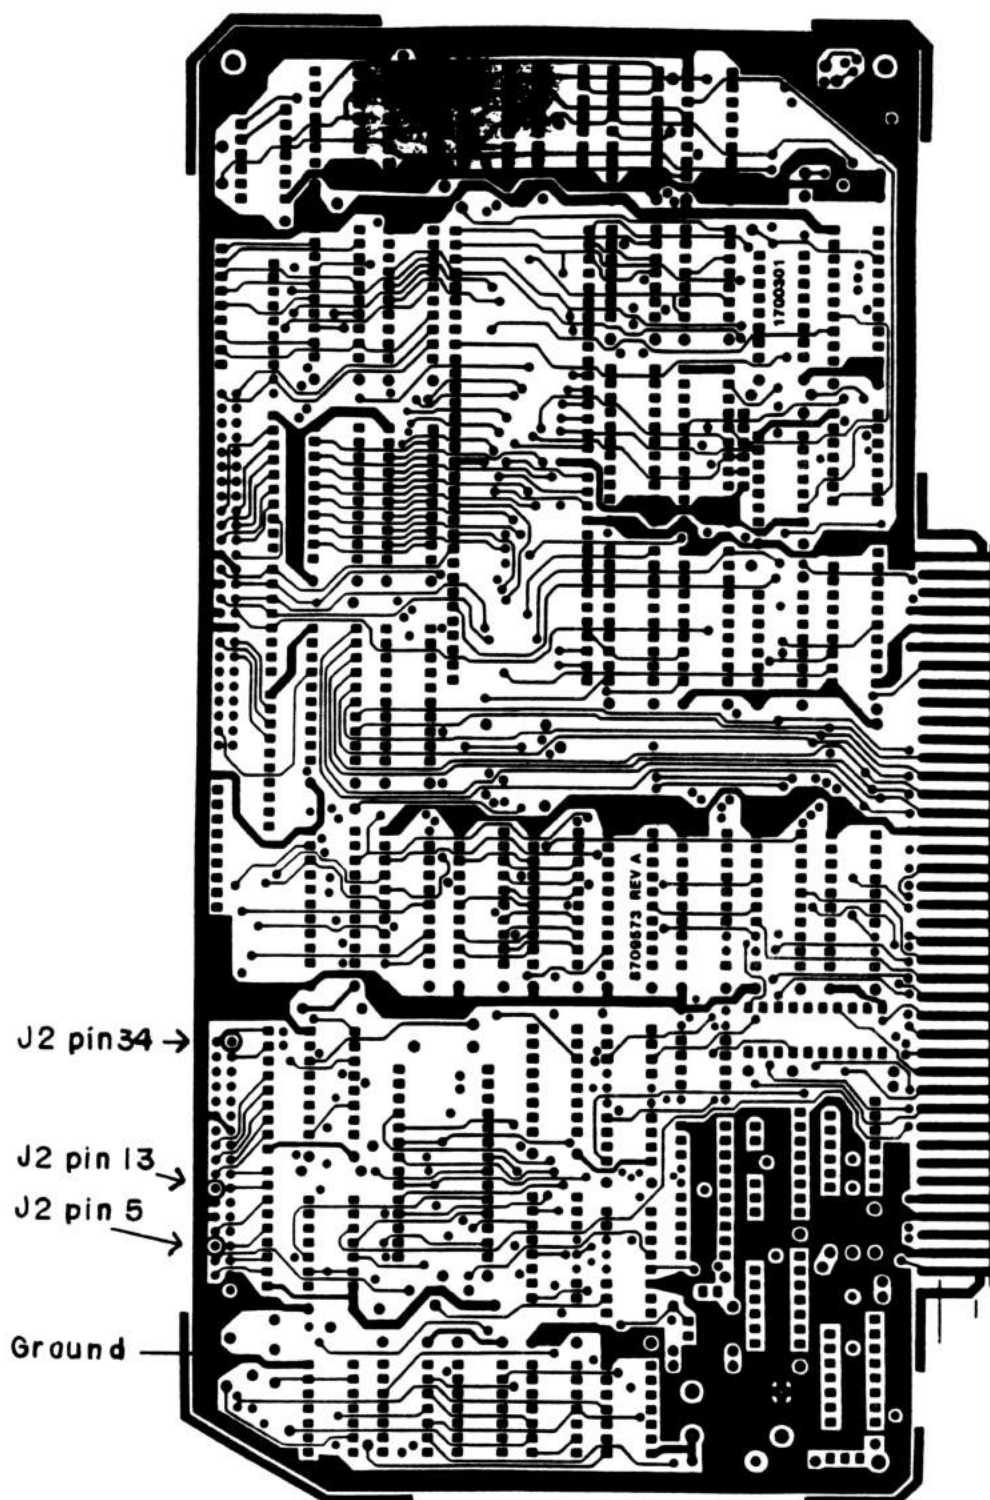
SOLDER SIDE (LAYER 4)

A timing error has been found involving signals BERR* and DTACK* on the 8 MHz 68000 CPU board.

- (1) Jumper J2, pin 5 to ground.
- (2) Jumper J2, pin 13 to ground.
- (3) Jumper J2, pin 34 to ground.

Ground may be found at the feed-throughs on the ground plane near J2 on the solder side on the board.

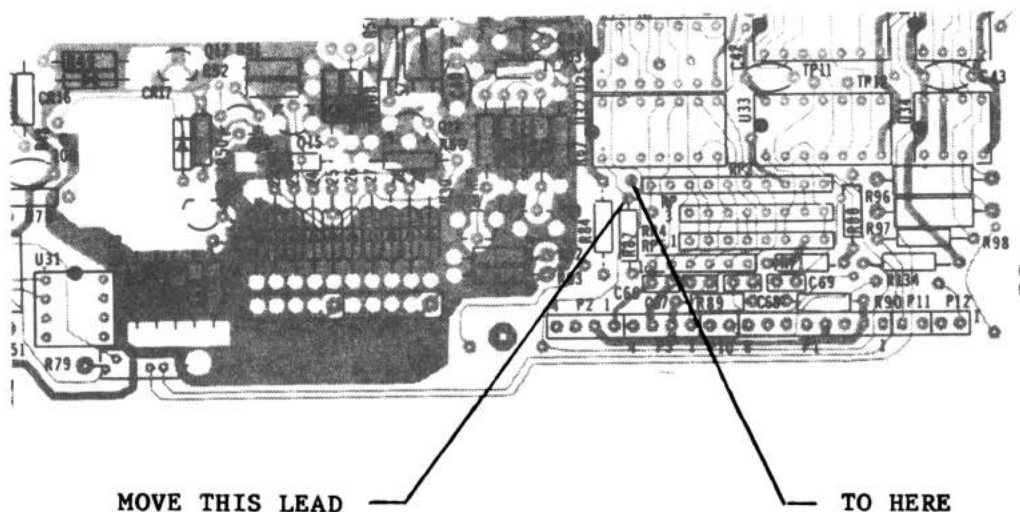
DISCUSSION: Some Tandon Belt Drive Logic Boards (Rev. Y) have come from the vendor with R87, a 150 ohm pullup resistor, installed incorrectly. These boards may be identified by the existence of a small white sticker (bearing a bar code, three numbers, and the letter "Y") attached to the board right next to the "REV" marking. The defective boards will not see the index pulses at all and will not recognize an inserted diskette, i.e. will remain at the "Insert Diskette" prompt even after a diskette is inserted and the drive door is closed.

PROCEDURE: Locate R87 on the Drive Logic Board. Note that one lead is connected to a feedthrough which has a trace running to U32, pin 1. Unsolder this lead of R87 and resolder it to the feedthrough right above it. The correct feedthrough is a +5V trace.
