TECHNICAL BULLETIN INDEX  
Sorted by Bulletin Number  
06/25/86

DATE: May 12, 1982  
REVISION DATE: May 13, 1983  
BULLETIN NO: 16:1  
PRODUCT: 26-6001/2 Model 16  
SUBASSEMBLY: AX-9241 FDC Board (Redesign)

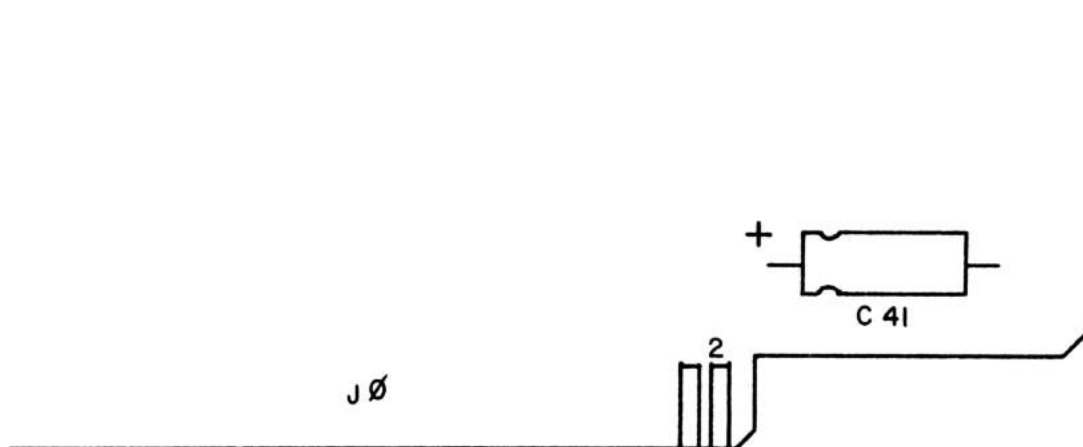
FIG 1

DISCUSSION: On early Rev D boards C41 was installed backwards. This board and earlier revisions have had the (+) sign silk screened onto the board at the wrong end of the cap. The heavy trace attached to the capacitor on the component side of the PCB is ground and the positive lead of the cap should go to the other hole on the PCB.

PROCEDURE: Check all computers that are brought into the shop for this capacitor. If it is reversed, replace it with a new 33 mfd. cap with a voltage rating between 16 and 50 volts (Refer to Figure 1 for correct installation).

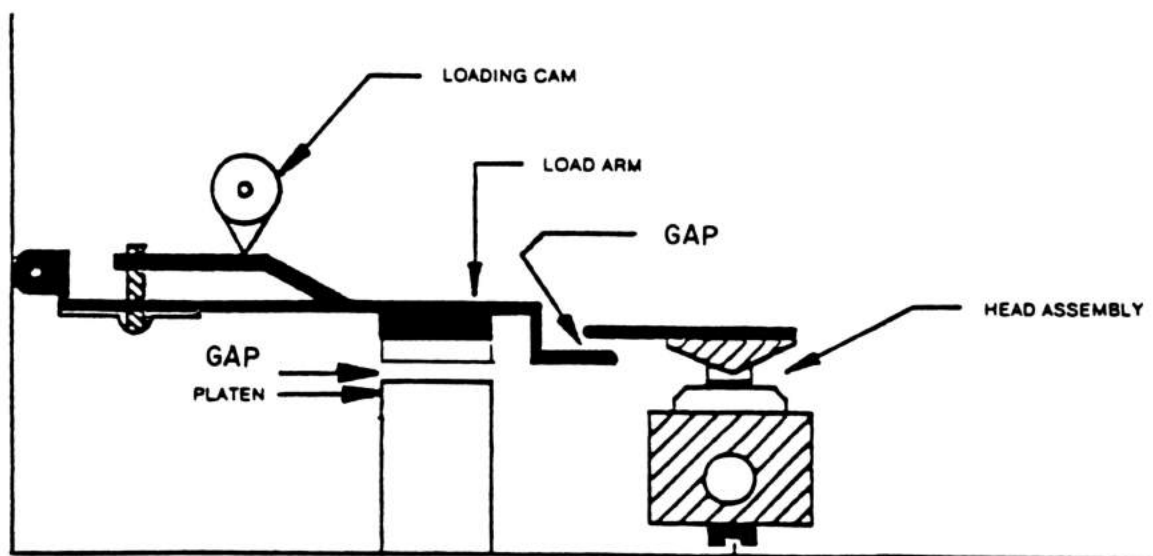
FIG 1

DISCUSSION: On some thinline drives the foam pad under the head load arm has been misadjusted so that the foam pad arm applies too much pressure to the diskette not allowing it to turn as it should. This problem can be solved by adjusting the head load arm. Also, on some drives the disk ejector has been pressing against the arm that presses the cone into the diskette. When this happens the diskette is not held as tightly as it should be. To correct this problem the trigger for the disk ejector can be adjusted.

The head load arm should be adjusted so that there is about a .015-.030 inch gap between the foam pad and the platen (Refer to Figure 1) with the door closed and no diskette installed. Once this has been adjusted there should be a visible gap between the foam pad and the platen with the door closed and no diskette installed. Check that the upper head does not rub against the head load arm with a diskette installed and that the upper head does not hit the diskette when the diskette is being inserted or removed.

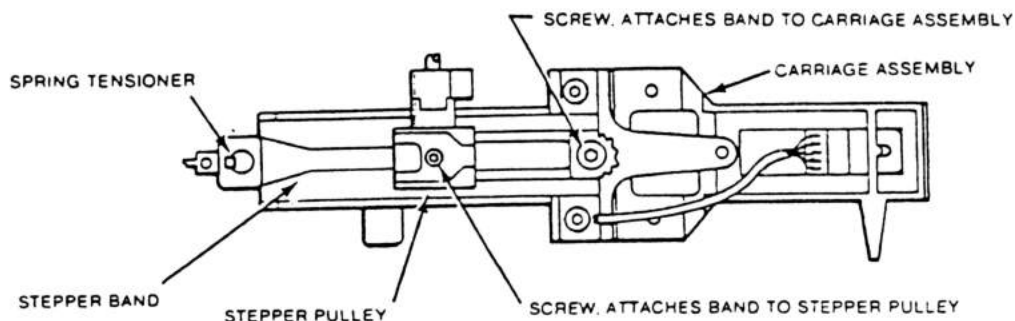
**DISCUSSION:** Early production models of the Tandon 8 inch slimline drive may have a problem with the stepper band assembly. The screw used to fasten the band to the stepper motor may allow slippage of the band assembly, therefore changing the head radial alignment. There should be only several hundred early production drives which have this problem. All recently manufactured drives will be using the new screw and washer to secure the stepper band assembly. The part numbers for these parts are AHD-2568 (screw) and AHD-8763 (washer) and they are now available at National Parts using catalog number 26-4167.

**PROCEDURE:** Install the longer screw and the larger washer in the place of the old screw. The larger washer applies more contact to the stepper band and the longer screw is needed due to the increased thickness of the washer. After replacement it is essential that you perform a drive alignment to verify that the drive meets Radio Shack specifications.

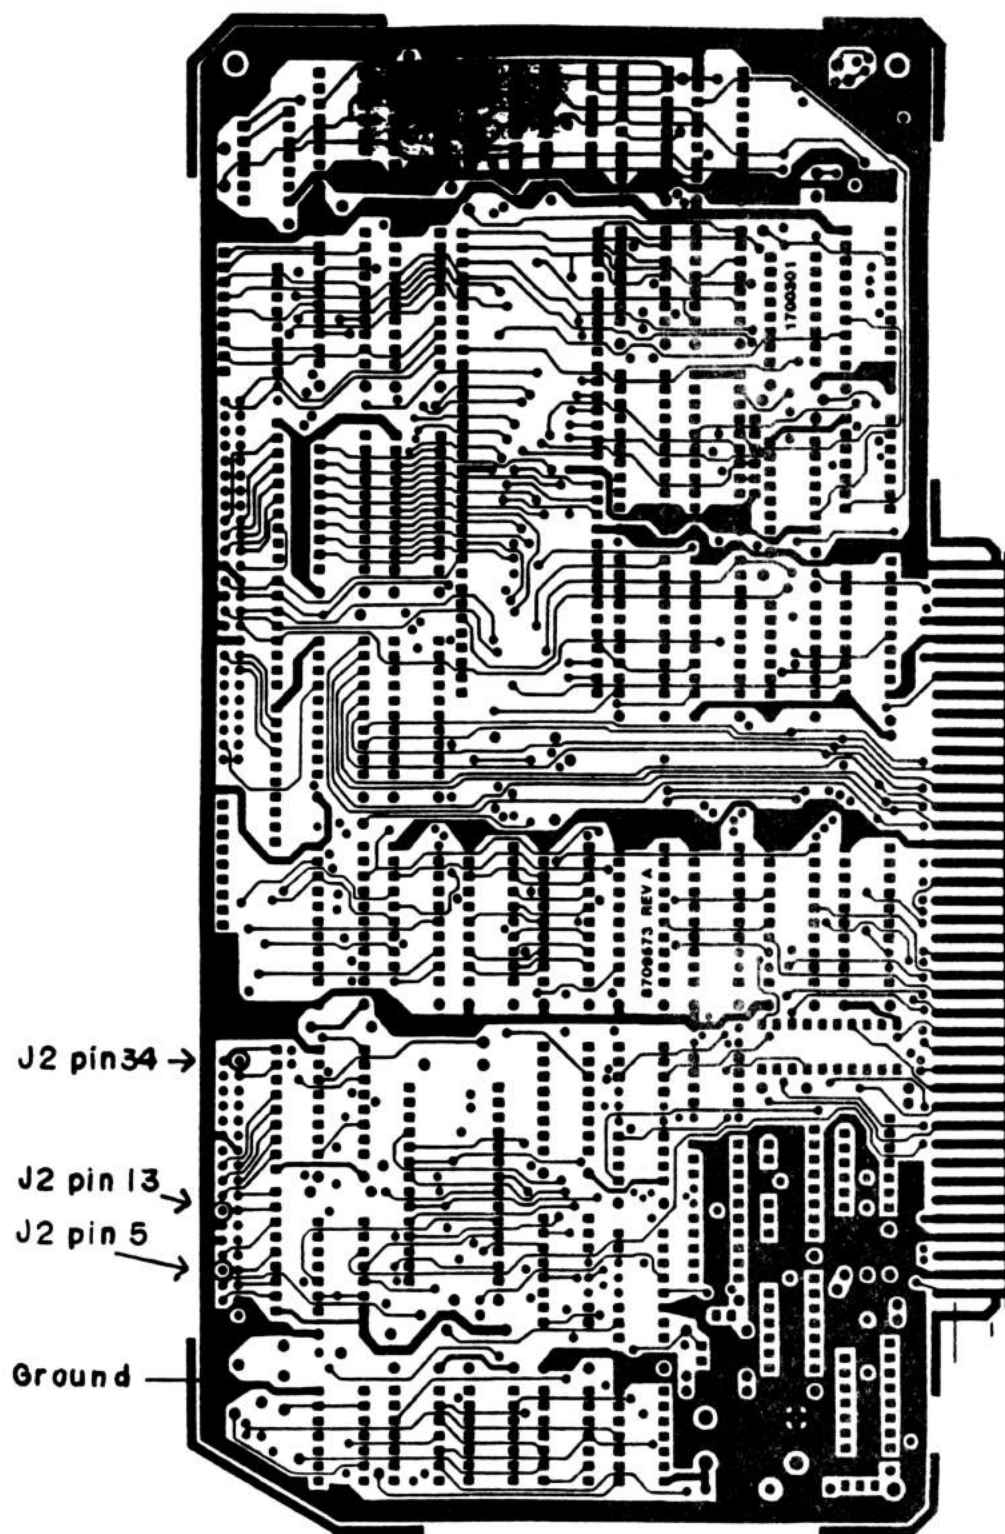
SOLDER SIDE (LAYER 4)

Due to an error in the artwork on early revision (Revision A) boards, a modification to insure good ground connections between the 68000 CPU board and associated memory boards is required.

Using wire wrap wire, install the following jumpers on the solder side of the 68000 CPU board:

- (1) Jumper J2, pin 5 to ground.
- (2) Jumper J2, pin 13 to ground.
- (3) Jumper J2, pin 34 to ground.

Ground may be found at the feed-throughs on the ground plane near J2 on the solder side on the board.

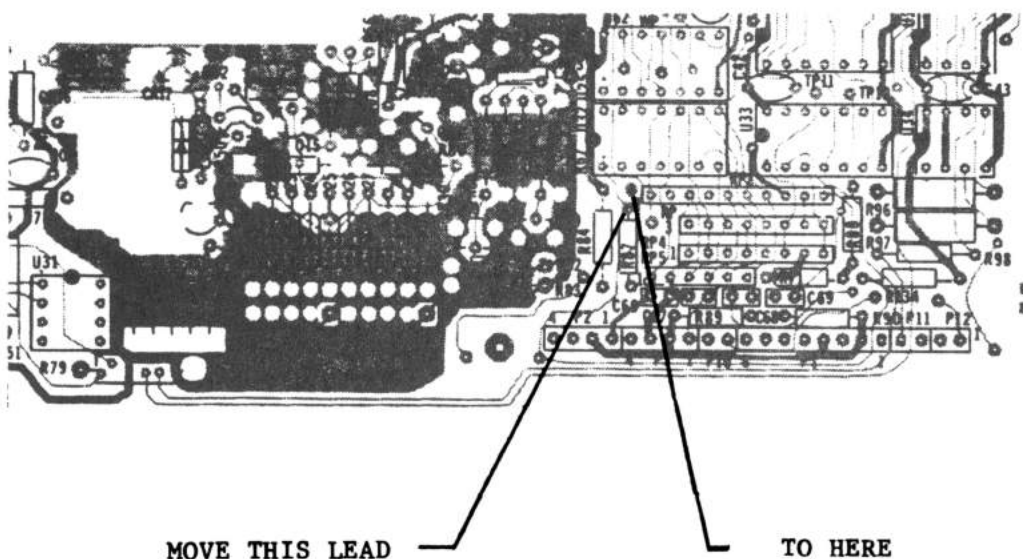
**DISCUSSION:** Some Tandon Belt Drive Logic Boards (Rev. Y) have come from the vendor with R87, a 150 ohm pullup resistor, installed incorrectly. These boards may be identified by the existence of a small white sticker (bearing a bar code, three numbers, and the letter "Y") attached to the board right next to the "REV" marking. The defective boards will not see the index pulses at all and will not recognize an inserted diskette, i.e. will remain at the "Insert Diskette" prompt even after a diskette is inserted and the drive door is closed.

**PROCEDURE:** Locate R87 on the Drive Logic Board. Note that one lead is connected to a feedthrough which has a trace running to U32, pin 1. Unsolder this lead of R87 and resolder it to the feedthrough right above it. The correct feedthrough is a +5V trace.
