TECHNICAL BULLETIN INDEX
Sorted by Bulletin Number
04/03/86

PRODUCT: 26-4001/2 Model II

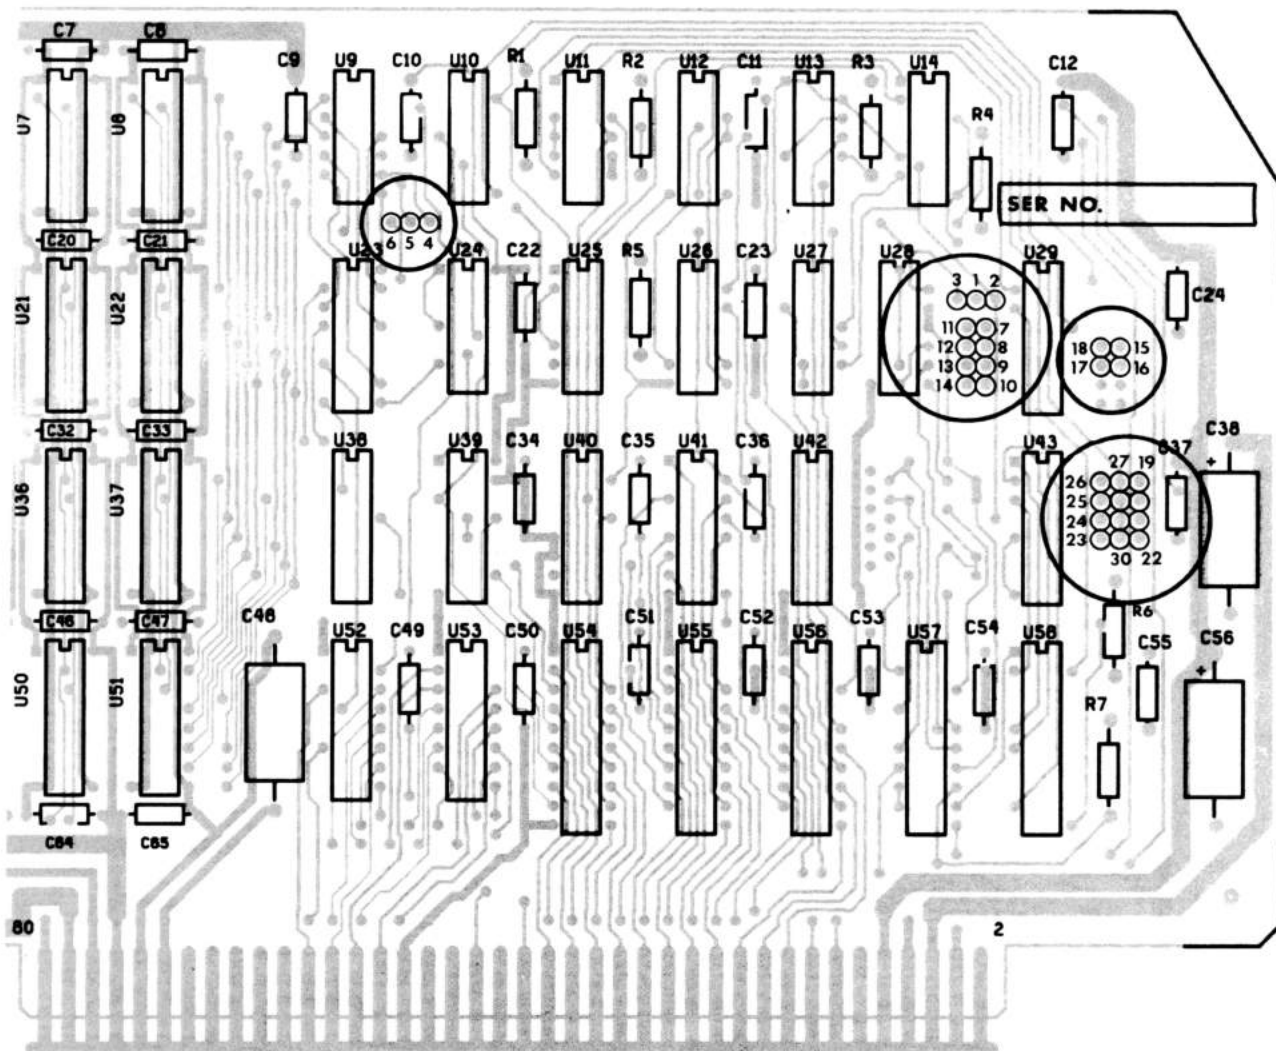
Figure 1

- 1-2 Pulls up an input to U27 that was floating
- 5-6 Pulls up an input to U9 that was floating

Use MEMII Diagnostic to check each memory board for correct jumpering and proper operation.

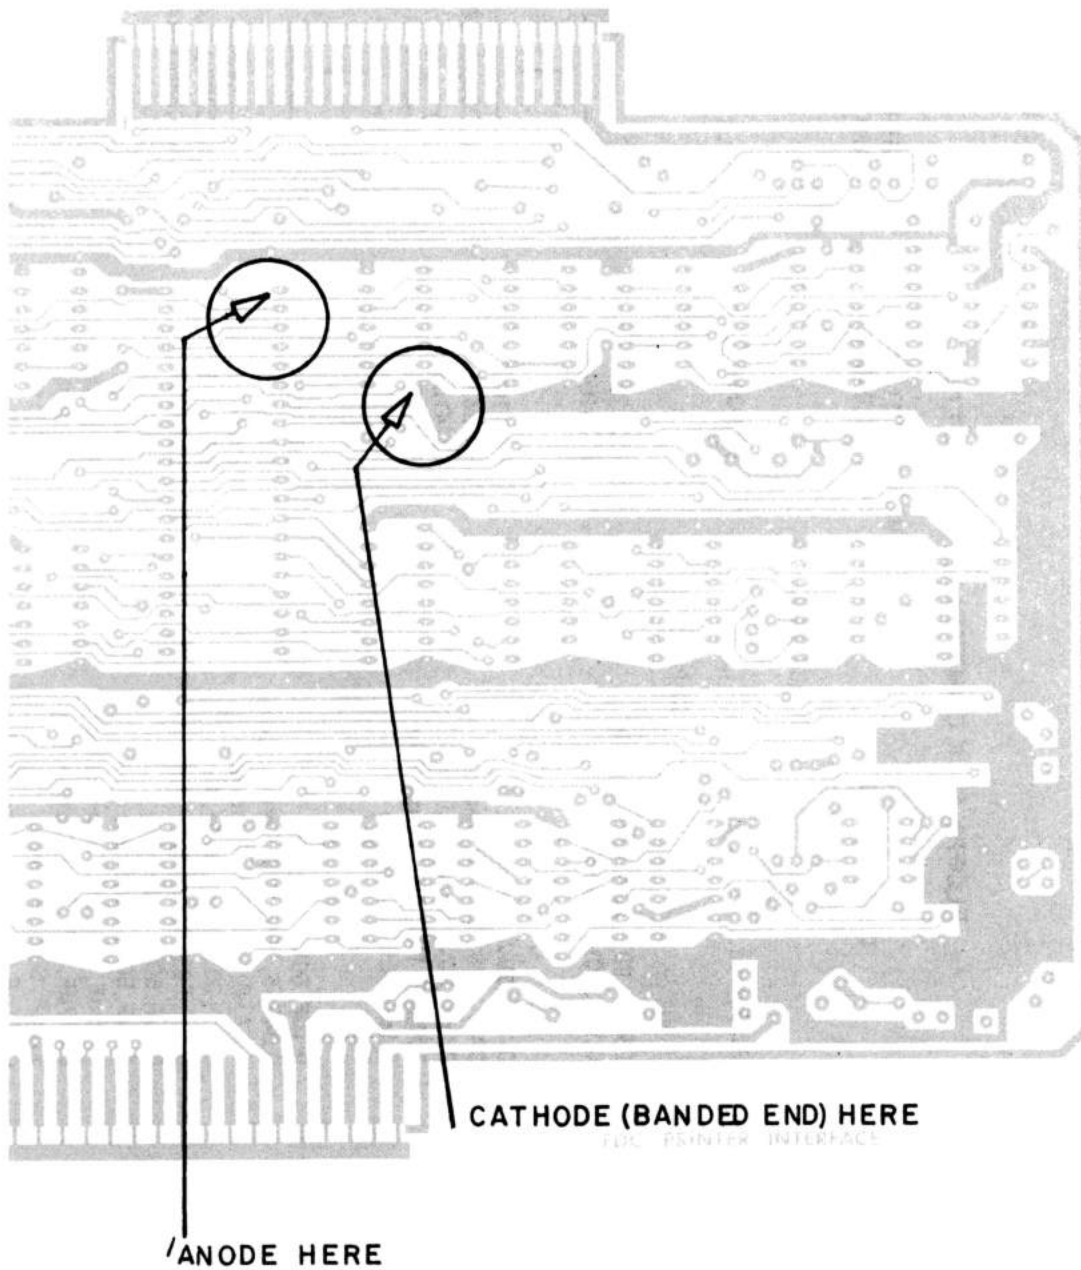
Figure 1

PURPOSE: To correct thermal failure of FDC IC (U6) causing Read/Write errors, and other intermittent disk I/O failures.

DISCUSSION: Early FDC chips developed thermal failures causing disk I/O failures and Read/Write errors. To correct this problem a 2.7V Zener diode MUST be installed from U6 Pin 1 to U5 Pin 7. On new and factory repaired assemblies this change will already have been installed.

PROCEDURE: Check to see if this modification has been done, if not, install diode as per Figure 1. Be sure to use sleeving for insulation of leads to prevent shorts. This diode can be ordered from National Parts using part number ADX-1382 and catalog number 26-4001.

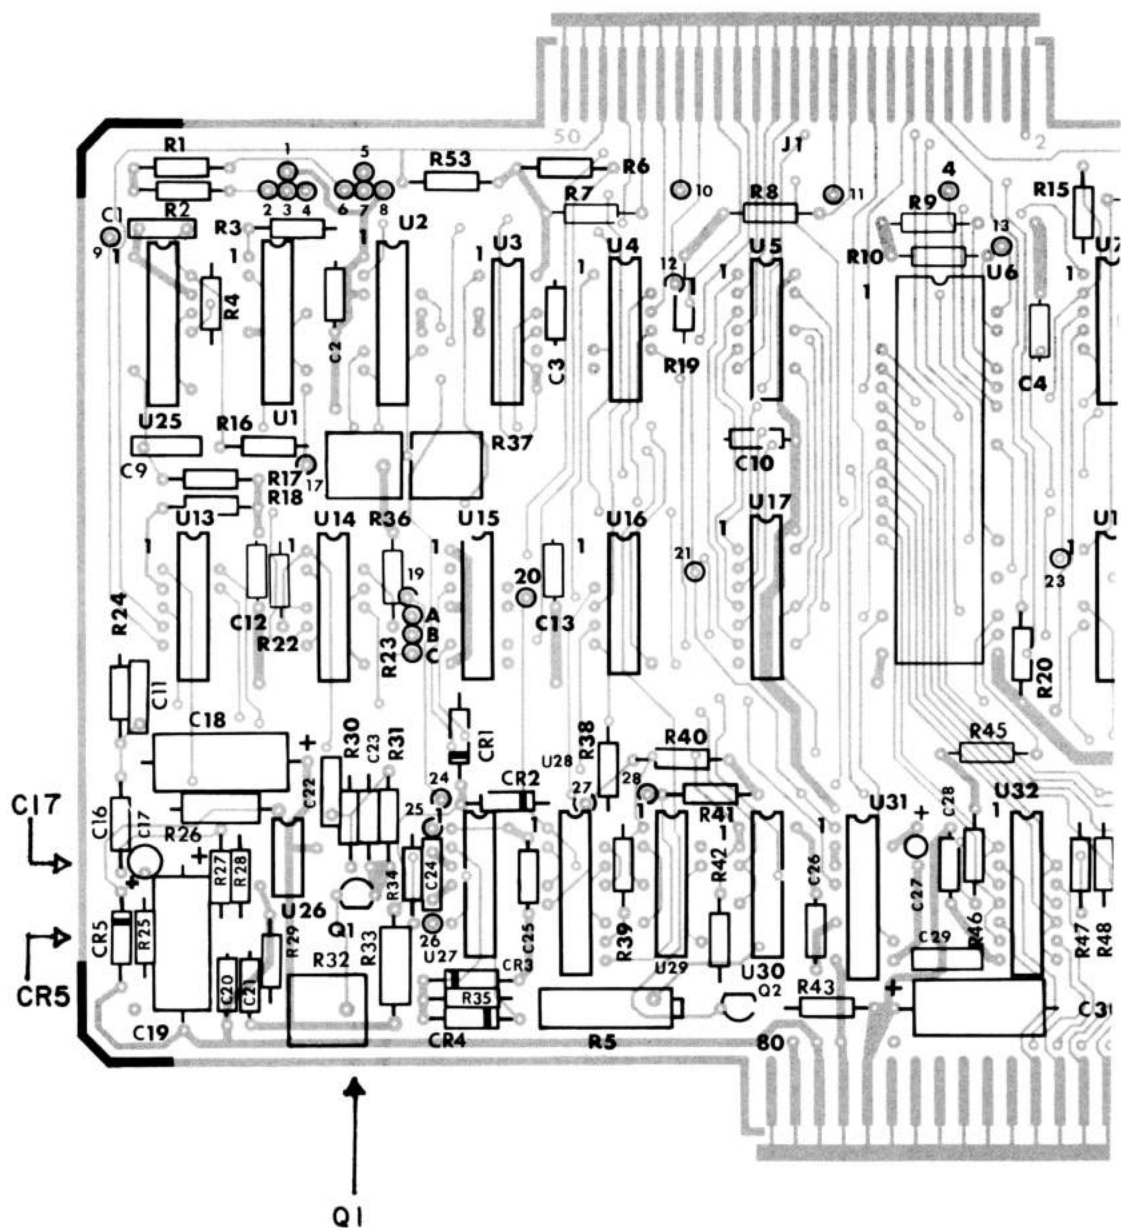
Figure 1

DISCUSSION: Early FDC boards had a problem with C17 installed backwards. Rev A boards were not marked with polarity. Rev B boards and early Rev C boards were marked with the polarity backwards. This problem was corrected on later Rev C boards. C17 is a .47 ufd tantalum capacitor with a 33V rating. Installed backwards it will eventually break down due to approximately -6V across the capacitor. Note that CR5 is referenced to -12V. This capacitor installed backwards can cause intermittent problems and will eventually cause circuit failure. Over a period of time the capacitor will smoke causing CR5 and possibly Q1 to be damaged.

PROCEDURE: Check C17 on all units in for service to insure the positive(+) lead is going to ground. The most accurate method of checking this is by actually checking with an ohm meter continuity between the positive lead of C17 to ground. If capacitor is installed backwards replace with a new .47ufd tantalum capacitor(ACC-474MGTP). Do not just turn the old capacitor around as it has started degrading and life expectancy shortened.

If the capacitor actually smoked then you must replace it and the diode CR5 (ADX-1279). Also check Q1, a 2N2222A transistor (AMX-4263), because it may have been damaged also, replace if necessary.

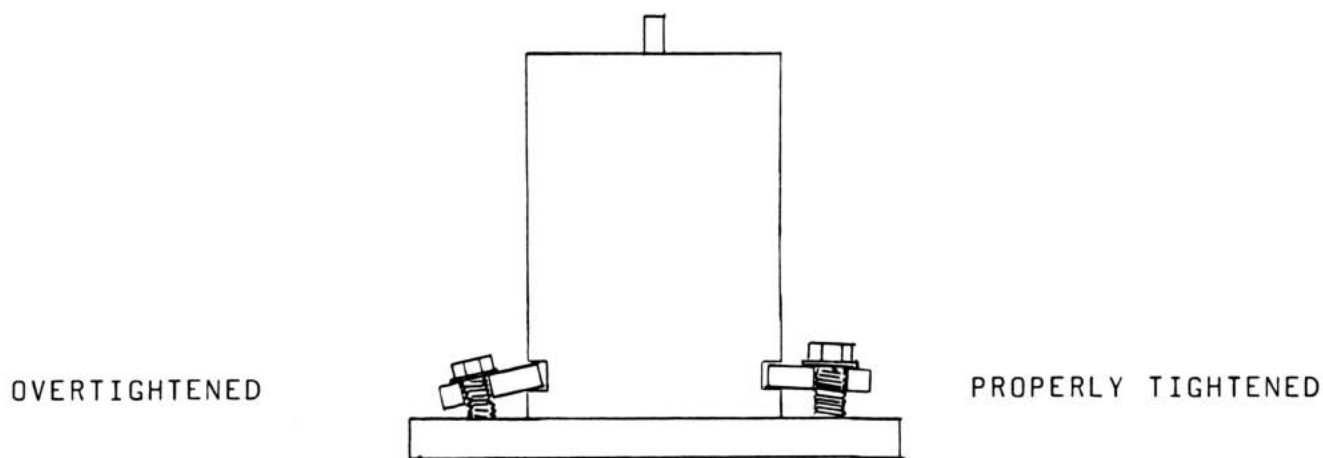
FIG. 1

DISCUSSION: After aligning Head Radial DO NOT OVERTIGHTEN bracket screws when securing the stepper motor. Excessive tightening will cause bracket and screws to bend and eventually damage the screw holes in the stepper motor plate, making proper alignment almost impossible.

PROCEDURE: After Head Radial Alignment tighten bracket screws only enough to secure stepper motor. If the stepper motor cannot be secured without excessively bending the bracket (Refer to Figure 1), or if the screw holes in the plate are damaged, replace the drive chassis.

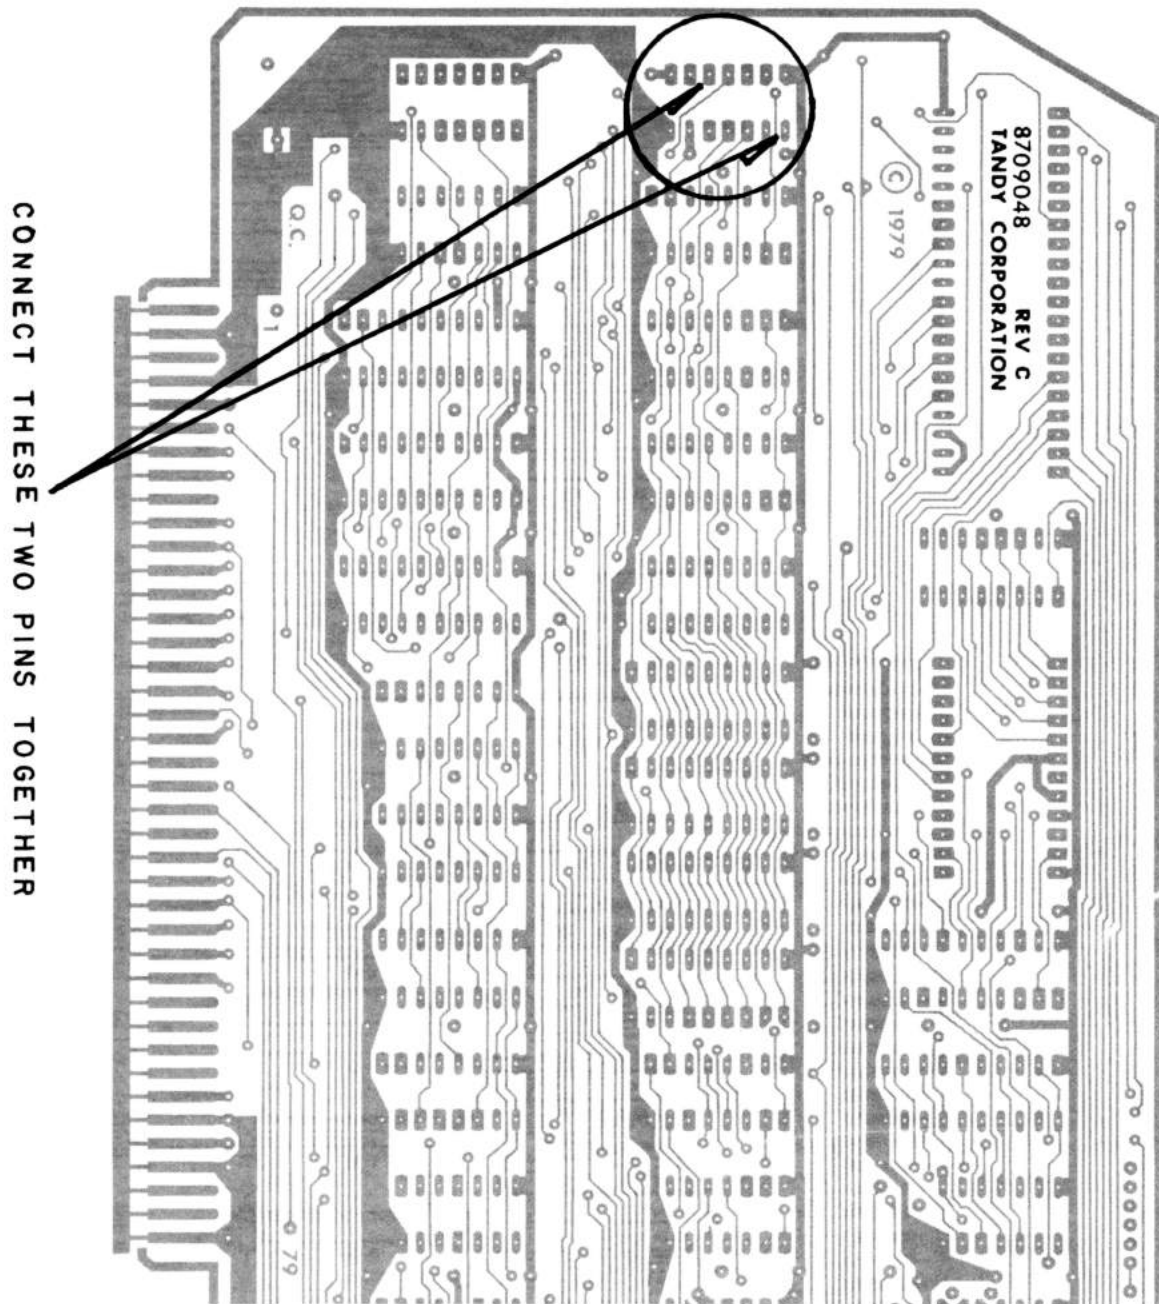
Figure 1

DISCUSSION: Rev A and B VDG boards have a problem with dual addressing. Addresses FC through FF are decoded on the VDG board for use by the Model II. There is an image of these addresses from 7C through 7F. Most systems will not have hardware port mapped at these addresses so no problem will appear. The only time a problem may arise is if a system has hardware installed that is port mapped in the range of 7C through 7F. This problem was corrected on Rev C VDG boards.

PROCEDURE: Whenever a Rev C VDG board is replaced with a Rev A or B VDG board jumper pin 1 to pin 10 of U27 on the Rev A or B board to insure no addressing conflict of the VDG board (Refer to Figure 1).

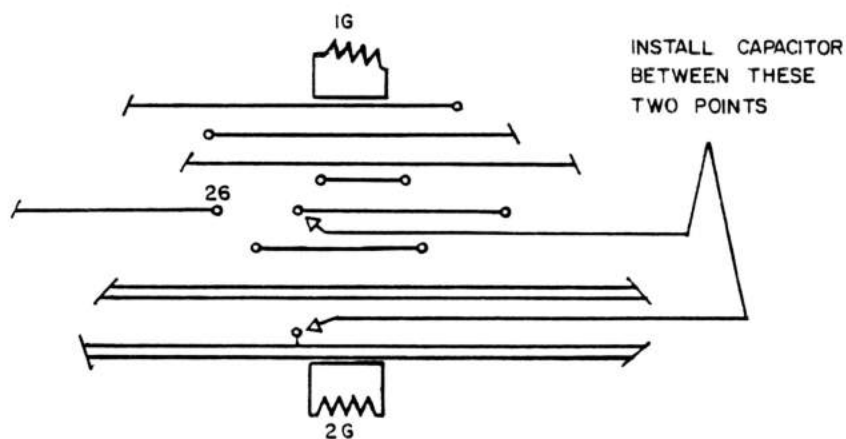
INSTALL CAPACITOR
BETWEEN THESE
TWO POINTS

DISCUSSION: To correct booting errors the Ready line on the Shugart discrete logic board should be bypassed to ground with a .01ufd disc capacitor. All discrete boards should have this capacitor installed as a preventive measure. Any system that exhibits an unexplained booting problem not related to a hardware fault should be checked for this capacitor. This is now being done at the factory to new discrete boards. This capacitor is NOT to be added to Shugart LSI logic boards.

PROCEDURE: Check Ready line for .01ufd installed to ground. If capacitor is not present install .01ufd disk capacitor to ground (Refer to Figure 1).

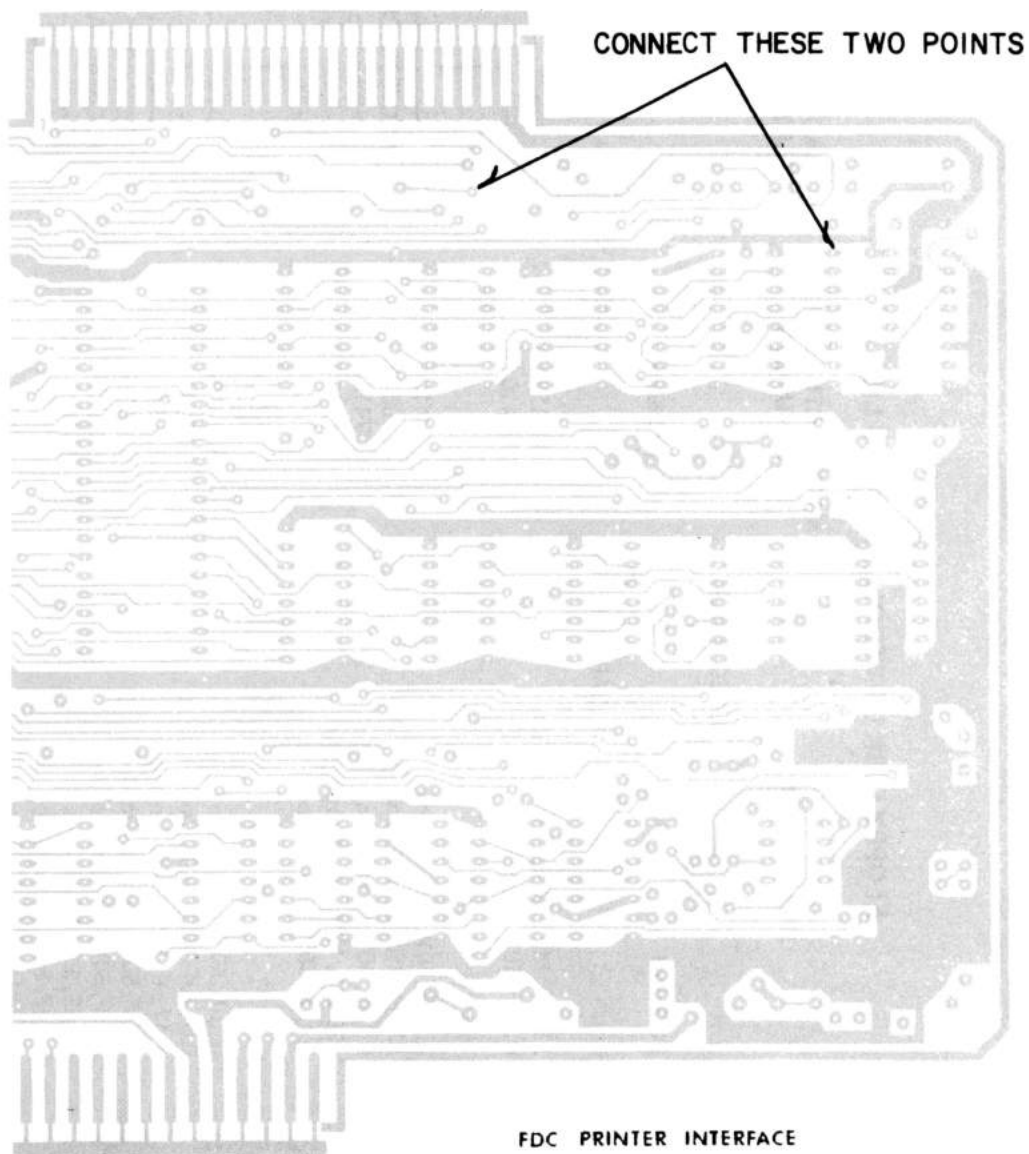
FIG 2

DISCUSSION: Some early FDC boards may not be able to format past Track 43 with precomp set at the required specification of 250 nsec. This problem will occur ONLY with the SY1791-02 FDC chip (not the FD1791-02 FDC chip) because the EARLY pulse ends slightly sooner on the SY1791-02. This could lead to a double pulse being picked off the shift register. To correct this problem the data out is tied to the RESET of the shift register. As soon as the data triggers the one-shot, it then clears the shift register, preventing double data pulses (Refer to Figure 1).

PROCEDURE: On unmarked, Rev A, or Rev B boards make sure the "one shot" modification has been installed (Refer to Technical Bulletin II:9), or that long jumpers are installed on the back of the board running to U37. Disregard this step on Rev C and D boards as they have this modification incorporated into their circuitry. On ALL revisions of the current board with a SY1791-02 FDC chip installed, add a jumper wire on the back side of the board from U1 pin 1 to the trace connected to TP10 (Refer to Figure 2).

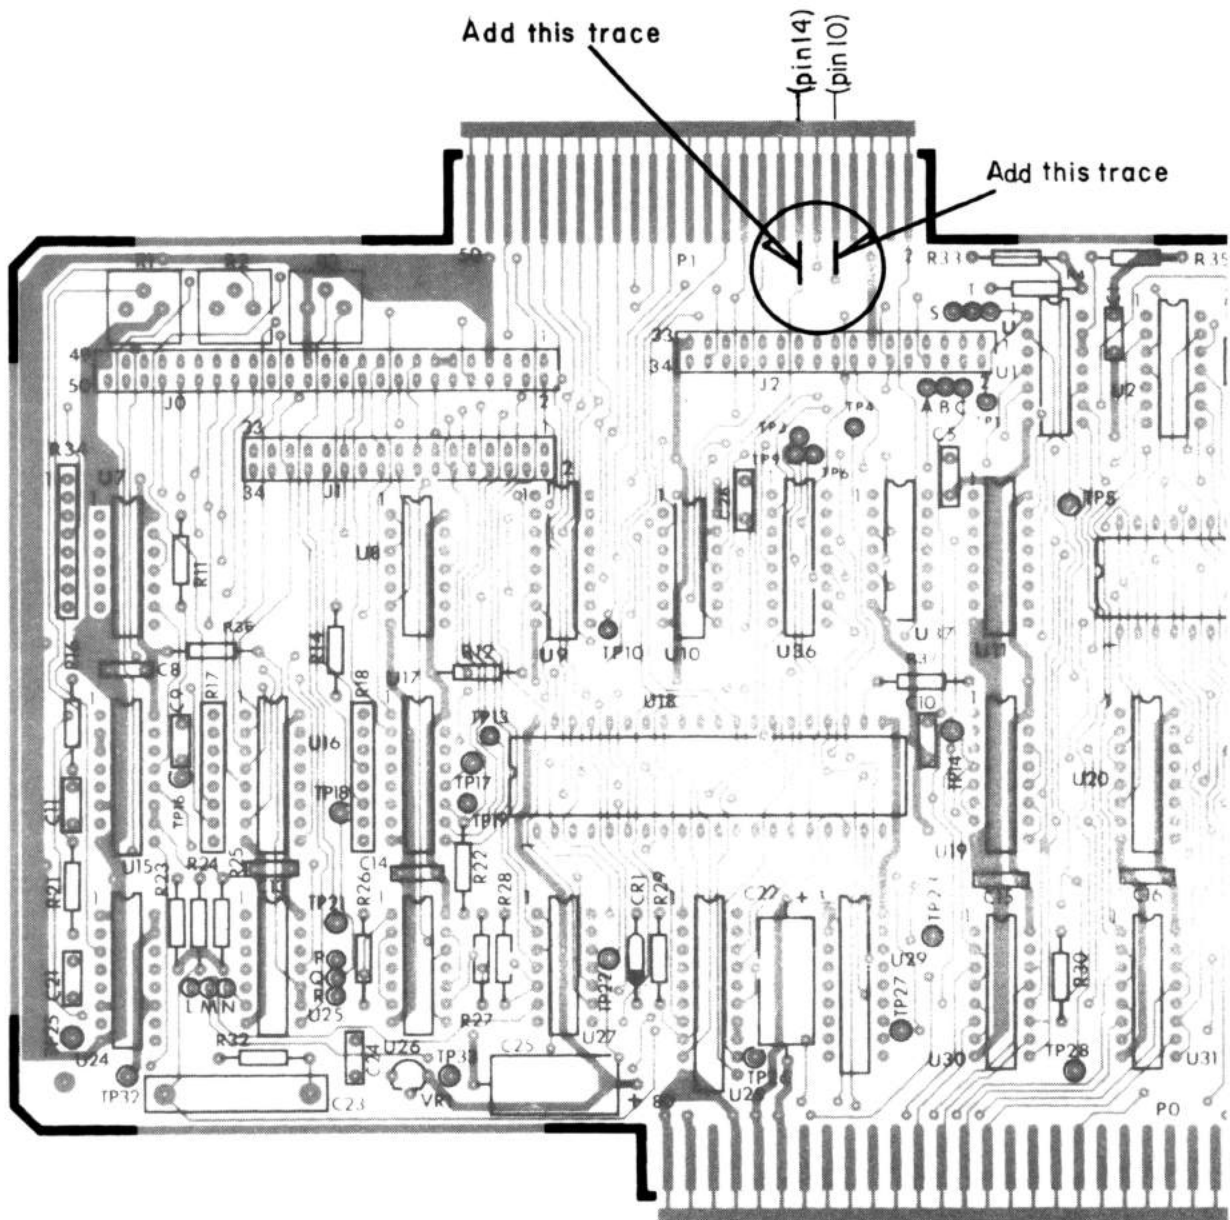
DISCUSSION: The trace that supplies the side select signal to the external drive connector on the Late Design FDC board (Rev Blank) is missing. Also, on some boards the trace that supplies the TWOSIDE* signal from the external drives to the FDC board is not present. Without these traces double sided drives cannot be used externally with the computer and will cause a problem with some diagnostics.

PROCEDURE: Refer to Figure 1 for the location of these traces. Run a jumper from pin 14 of connector P1 to the feedthru on the PCB that is directly in from the connector. Also run a jumper from pin 10 of connector P1 to the feedthru that is directly in from the connector.

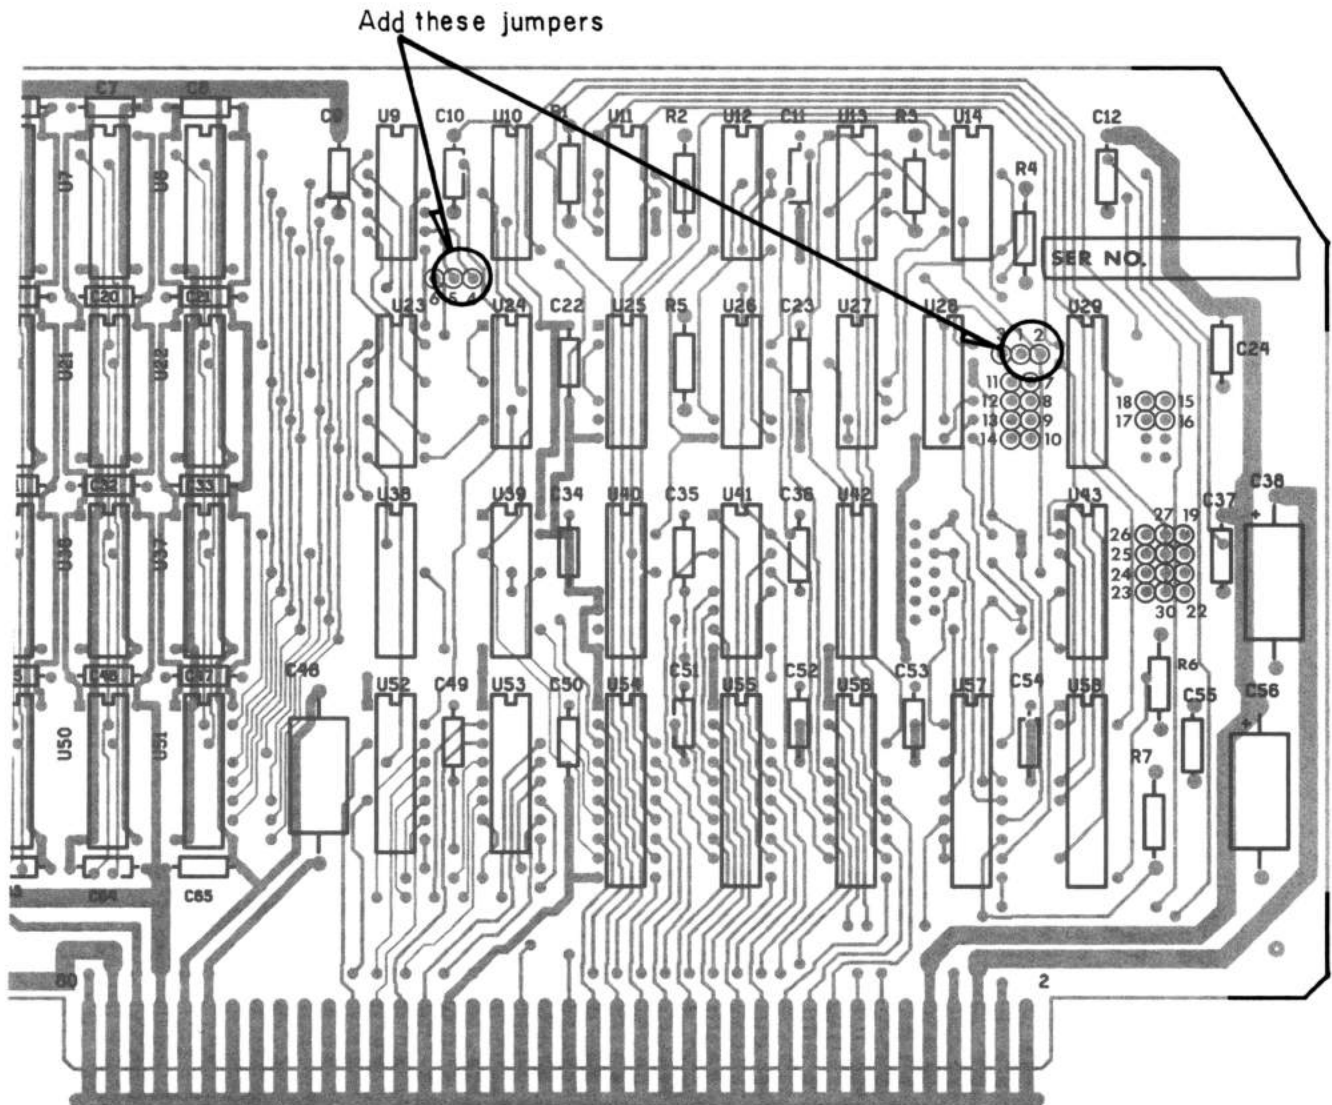
DISCUSSION: Pullups are needed on memory boards for inputs to gates. Intermittent problems can occur without these pullups installed. Some of the Model II memory boards may be missing staking pins for push on connectors and appropriate markings. In this case, use wirewrap to jumper the pads and refer to Figure 1 for pad locations.

PROCEDURE: Check boards for proper jumpering and install jumpers if they are missing. For physical locations of jumpering positions refer to Figure 1 for the memory board and Figure 2 for the Interface board.

Model II Memory boards:
Jumper 1-2 and 5-6

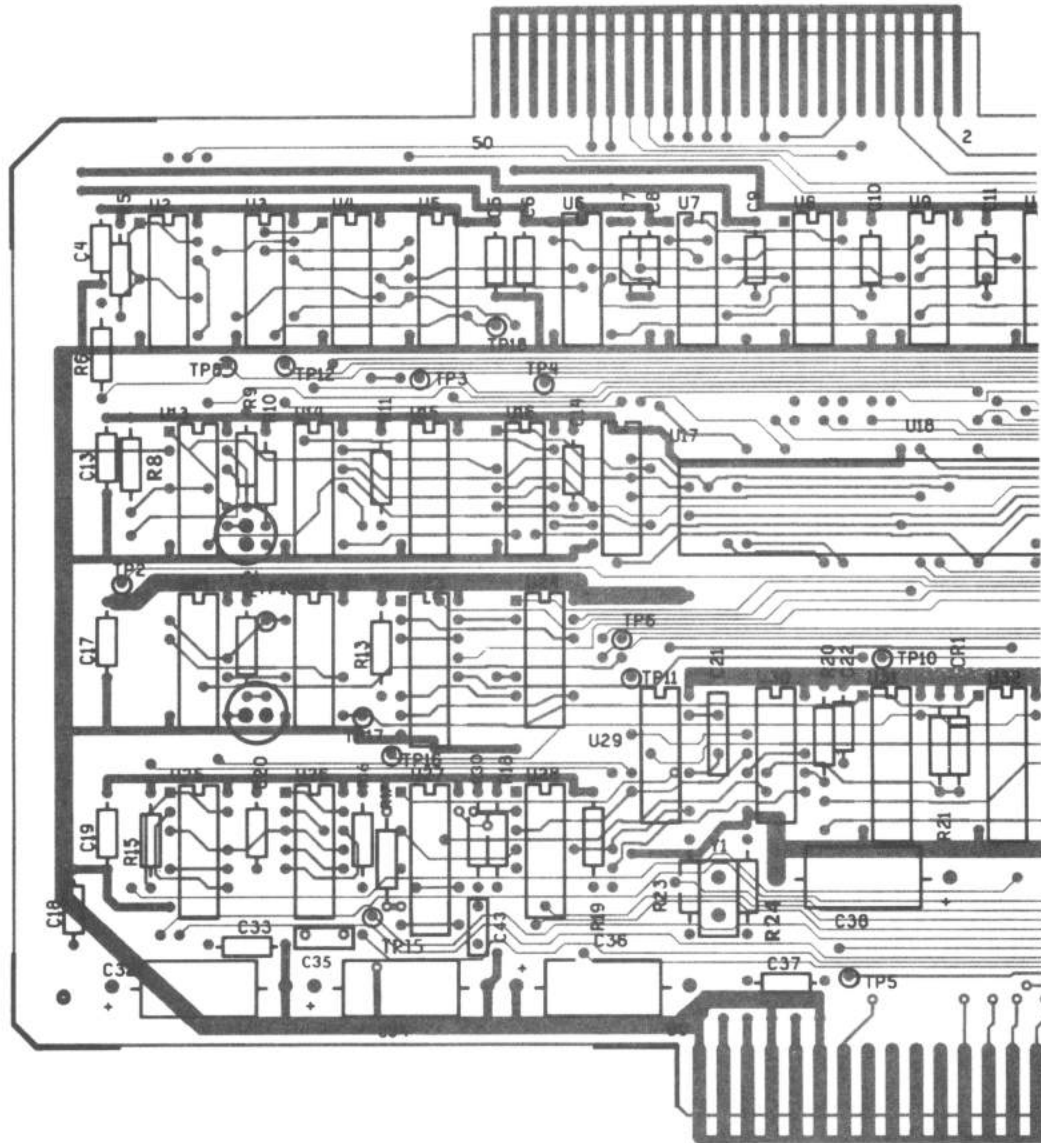
Figure 1

DISCUSSION: Problems using wait states and software timing loops may be caused by two missing jumpers on the CPU board. The jumper locations are physically the same on all revision boards, but may be marked differently or not marked at all.

PROCEDURE: Check all CPU boards for jumpers and install if missing.

E3-E4 and E0-E1

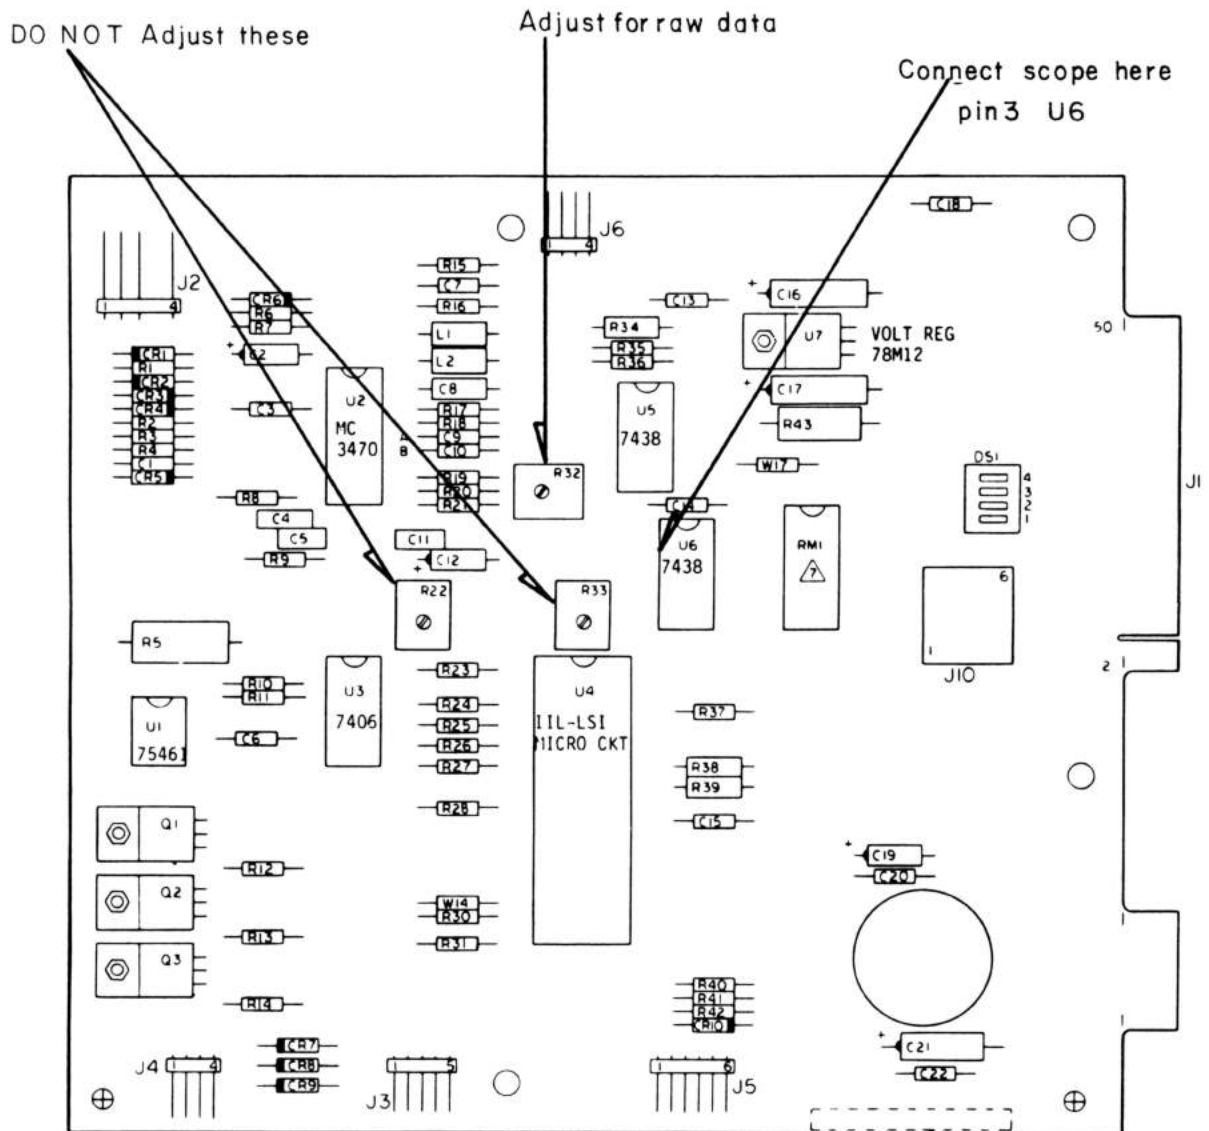
Figure 1

DISCUSSION: The LSI board has three adjustments R22, R23, and R32 (Refer to Figure 1). R22 and R33 are for adjusting the oscillator and write current to the head. These adjustments ARE NOT to be done in the field. The reason for this is because a test jig is needed, excessive time is required to complete the adjustments, and there is a high probability of damaging the head or the LSI chip. Once these adjustments have been done by the factory there is no reason for them to change unless the LSI chip fails. R32 controls the read symmetry (raw data) adjustment and it should be adjusted in the field.

PROCEDURE: Whenever doing drive alignment raw data should be checked with a blank BULK ERASED diskette. Connect scope to U6 pin 3 and proceed to step 8 of the TDC diagnostic. Adjust R32 so that the jitter of the first data pulse is less than 200nsec.
