TECHNICAL BULLETIN INDEX
Sorted by Bulletin Number
04/03/86

BULLETIN NO: II:1

PRODUCT: 26-4001/2 Model II

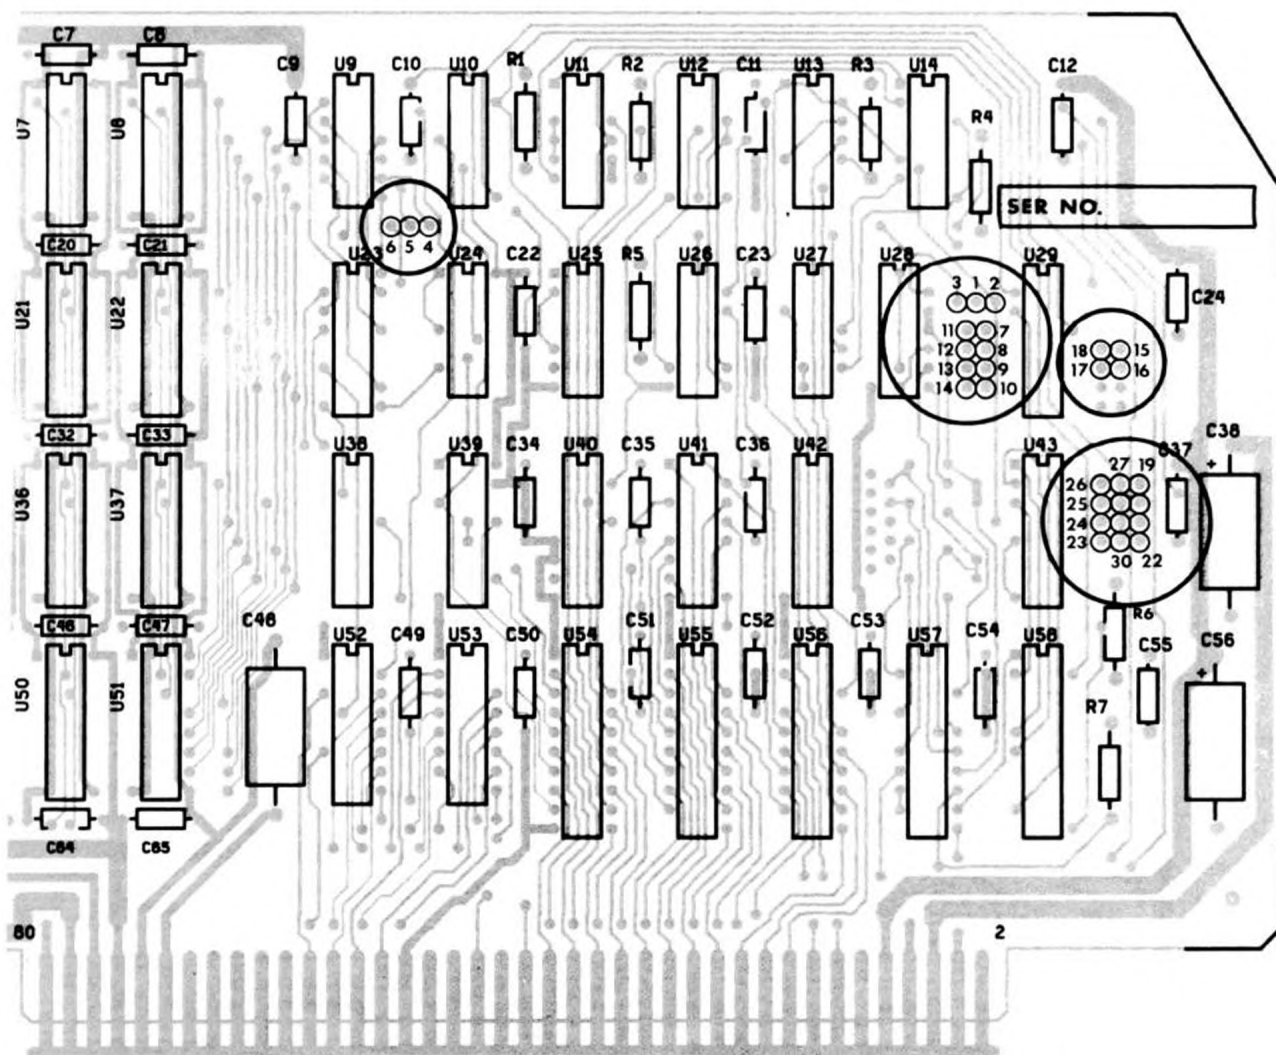
Figure 1

PURPOSE: To correctly identify proper jumper configurations for the Model II Memory Boards.

DISCUSSION: There are three possible memory board configurations for the Model II. A 32K Ram board, a second 32K Ram board to upgrade from 32K to 64K Ram, and a single 64K Ram board. Jumper configurations are different for each board.

PROCEDURE: The correct jumper configurations are:

First 32K Memory board:

- 16-17 Selects the first 16K of the base page
- 15-18 Selects the second 16K of the base page

Second 32K Memory board:

- 26-27 Enables the next jumpers on page 1 of the memory map
- 9-11 Selects the first 16K of page 1
- 10-12 Selects the second 16K of page 1

- 1-2 Pulls up an input to U27 that was floating
- 5-6 Pulls up an input to U9 that was floating

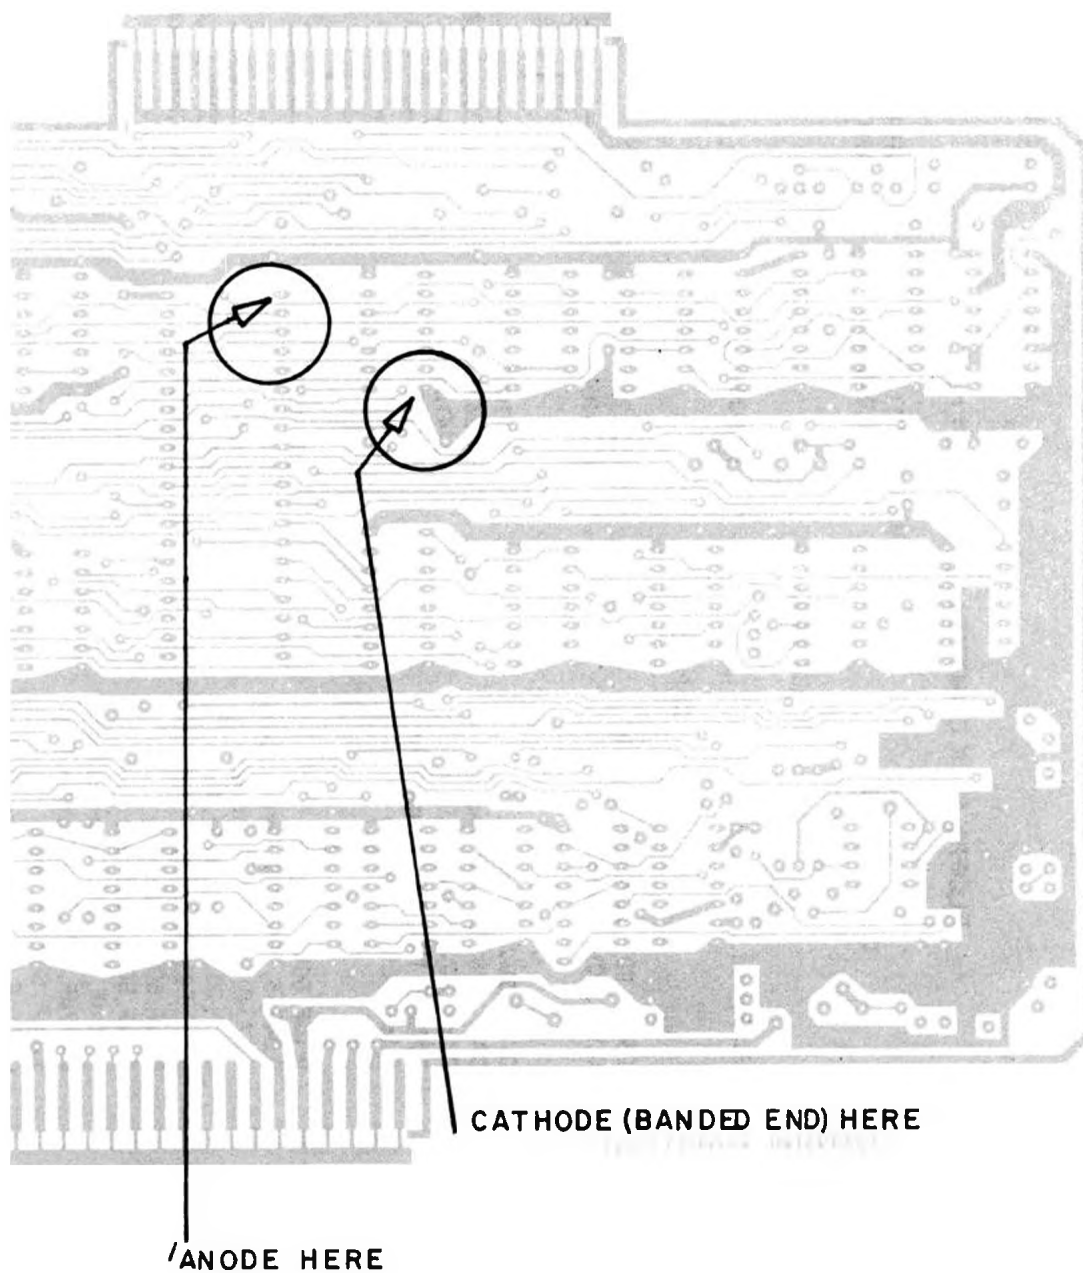
Figure 1

PURPOSE: To correct thermal failure of FDC IC (U6) causing Read/Write errors, and other intermittent disk I/O failures.

DISCUSSION: Early FDC chips developed thermal failures causing disk I/O failures and Read/Write errors. To correct this problem a 2.7V Zener diode MUST be installed from U6 Pin 1 to U5 Pin 7. On new and factory repaired assemblies this change will already have been installed.

PROCEDURE: Check to see if this modification has been done, if not, install diode as per Figure 1. Be sure to use sleeving for insulation of leads to prevent shorts. This diode can be ordered from National Parts using part number ADX-1382 and catalog number 26-4001.

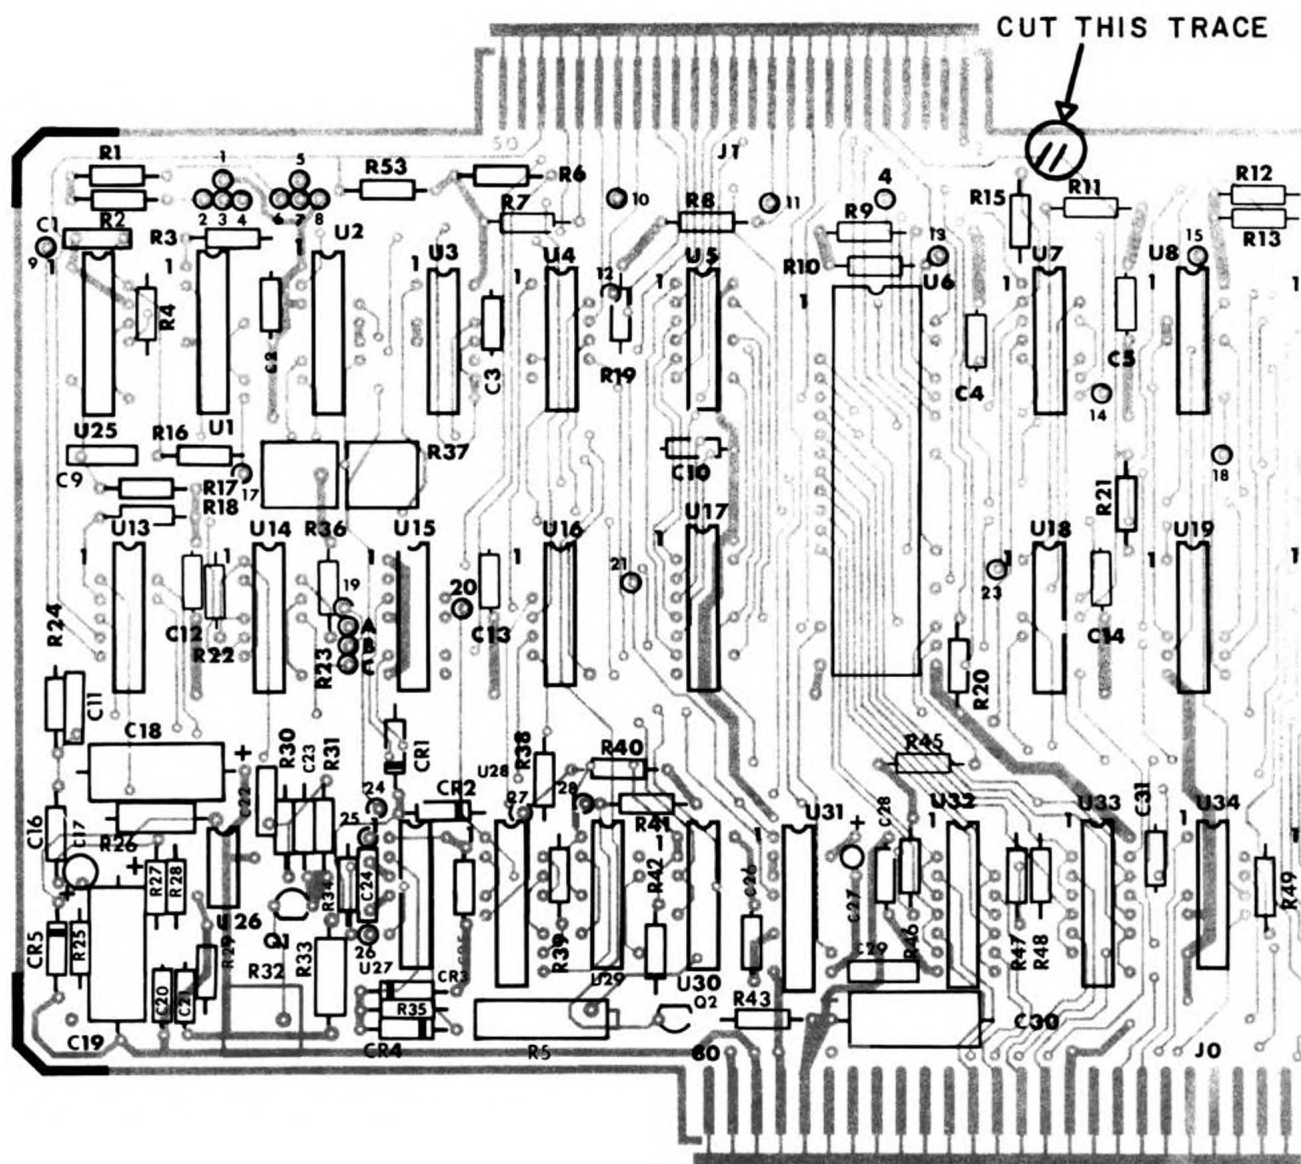
Figure 1

NOTE: This modification will cause the PIO SYSTEM test to fail. In cutting this trace you are removing a signal path connected to PIO channel A pin 14 through an inverter IC U18. This signal is A1 from the PIO. The PIO SYSTEM test will output a write out of channel B and then read the data back in channel A. With this trace cut, channel A will have bit A1 stuck high and thus the incorrect data read back in will produce an error in the SYSTEM test. The fact that this error will occur after this modification needs to be noted by the technician and therefore the SYSTEM test should be run before the modification is done.

PROCEDURE: Locate and cut the trace connected to pin 10 of the disk drive connector on the FDC board (Refer to Figure 1).

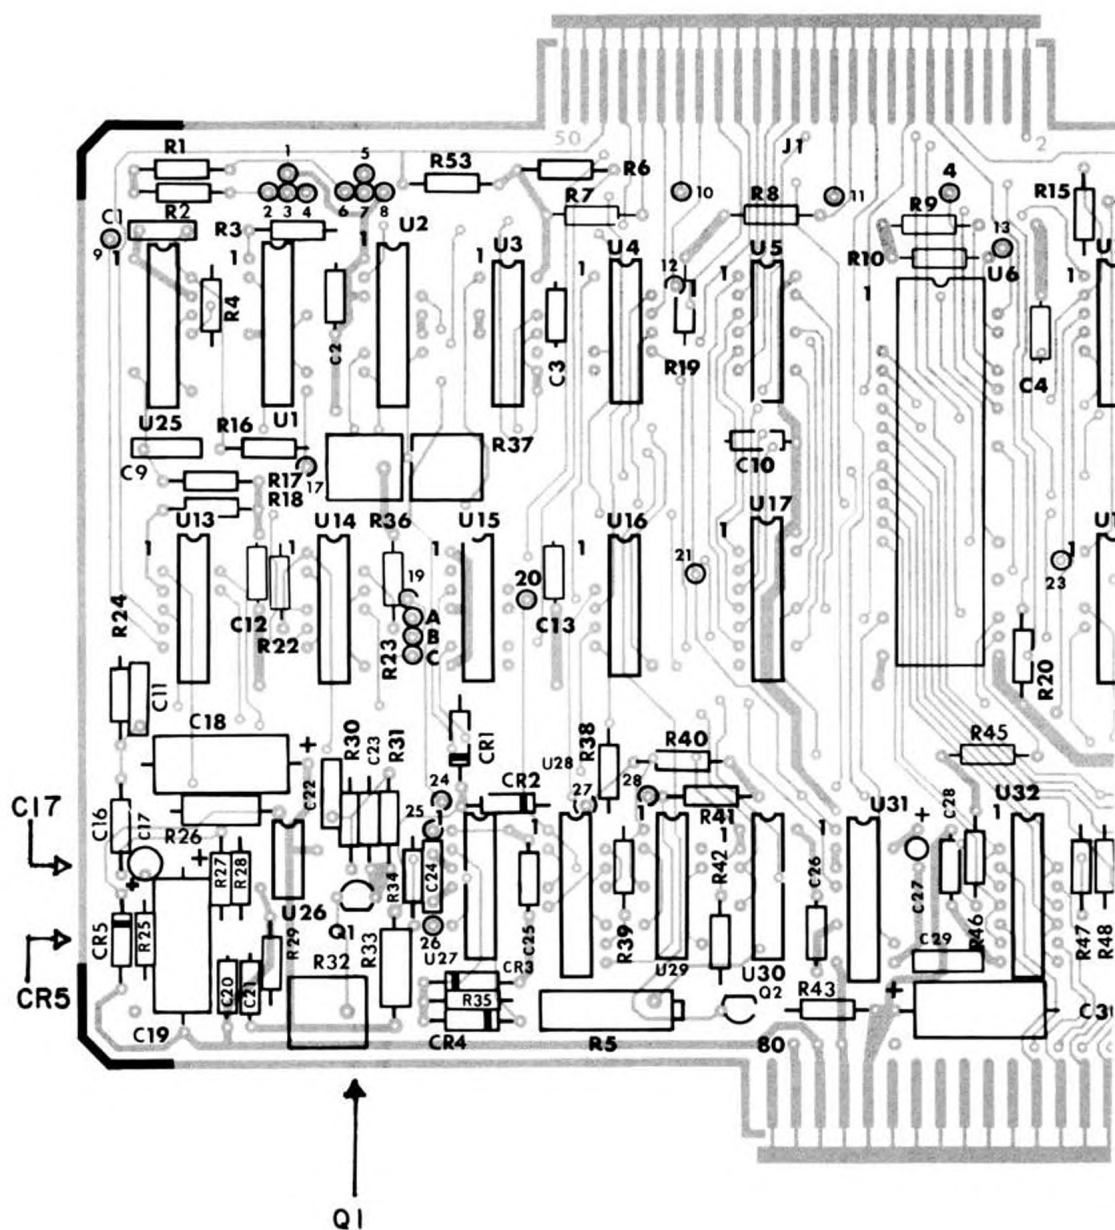
Figure 1

DISCUSSION: Early FDC boards had a problem with C17 installed backwards. Rev A boards were not marked with polarity. Rev B boards and early Rev C boards were marked with the polarity backwards. This problem was corrected on later Rev C boards. C17 is a .47 ufd tantalum capacitor with a 33V rating. Installed backwards it will eventually break down due to approximately -6V across the capacitor. Note that CR5 is referenced to -12V. This capacitor installed backwards can cause intermittent problems and will eventually cause circuit failure. Over a period of time the capacitor will smoke causing CR5 and possibly Q1 to be damaged.

PROCEDURE: Check C17 on all units in for service to insure the positive(+) lead is going to ground. The most accurate method of checking this is by actually checking with an ohm meter continuity between the positive lead of C17 to ground. If capacitor is installed backwards replace with a new .47ufd tantalum capacitor(ACC-474MGTP). Do not just turn the old capacitor around as it has started degrading and life expectancy shortened.

If the capacitor actually smoked then you must replace it and the diode CR5 (ADX-1279). Also check Q1, a 2N2222A transistor (AMX-4263), because it may have been damaged also, replace if necessary.

If any parts are replaced check the alignment and full operation of the FDC Board.

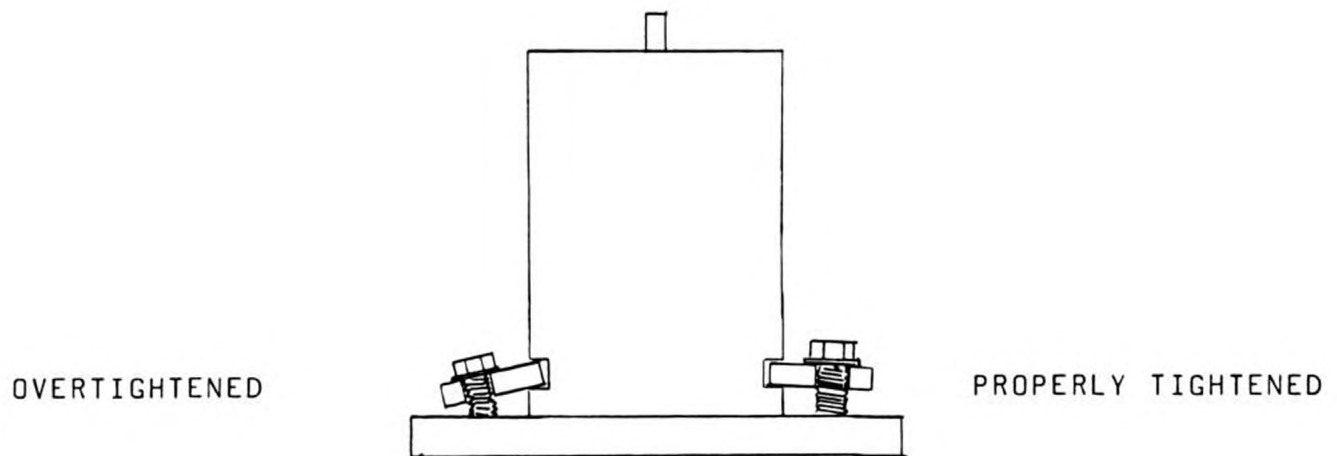
FIG. 1

DISCUSSION: After aligning Head Radial DO NOT OVERTIGHTEN bracket screws when securing the stepper motor. Excessive tightening will cause bracket and screws to bend and eventually damage the screw holes in the stepper motor plate, making proper alignment almost impossible.

PROCEDURE: After Head Radial Alignment tighten bracket screws only enough to secure stepper motor. If the stepper motor cannot be secured without excessively bending the bracket (Refer to Figure 1), or if the screw holes in the plate are damaged, replace the drive chassis.

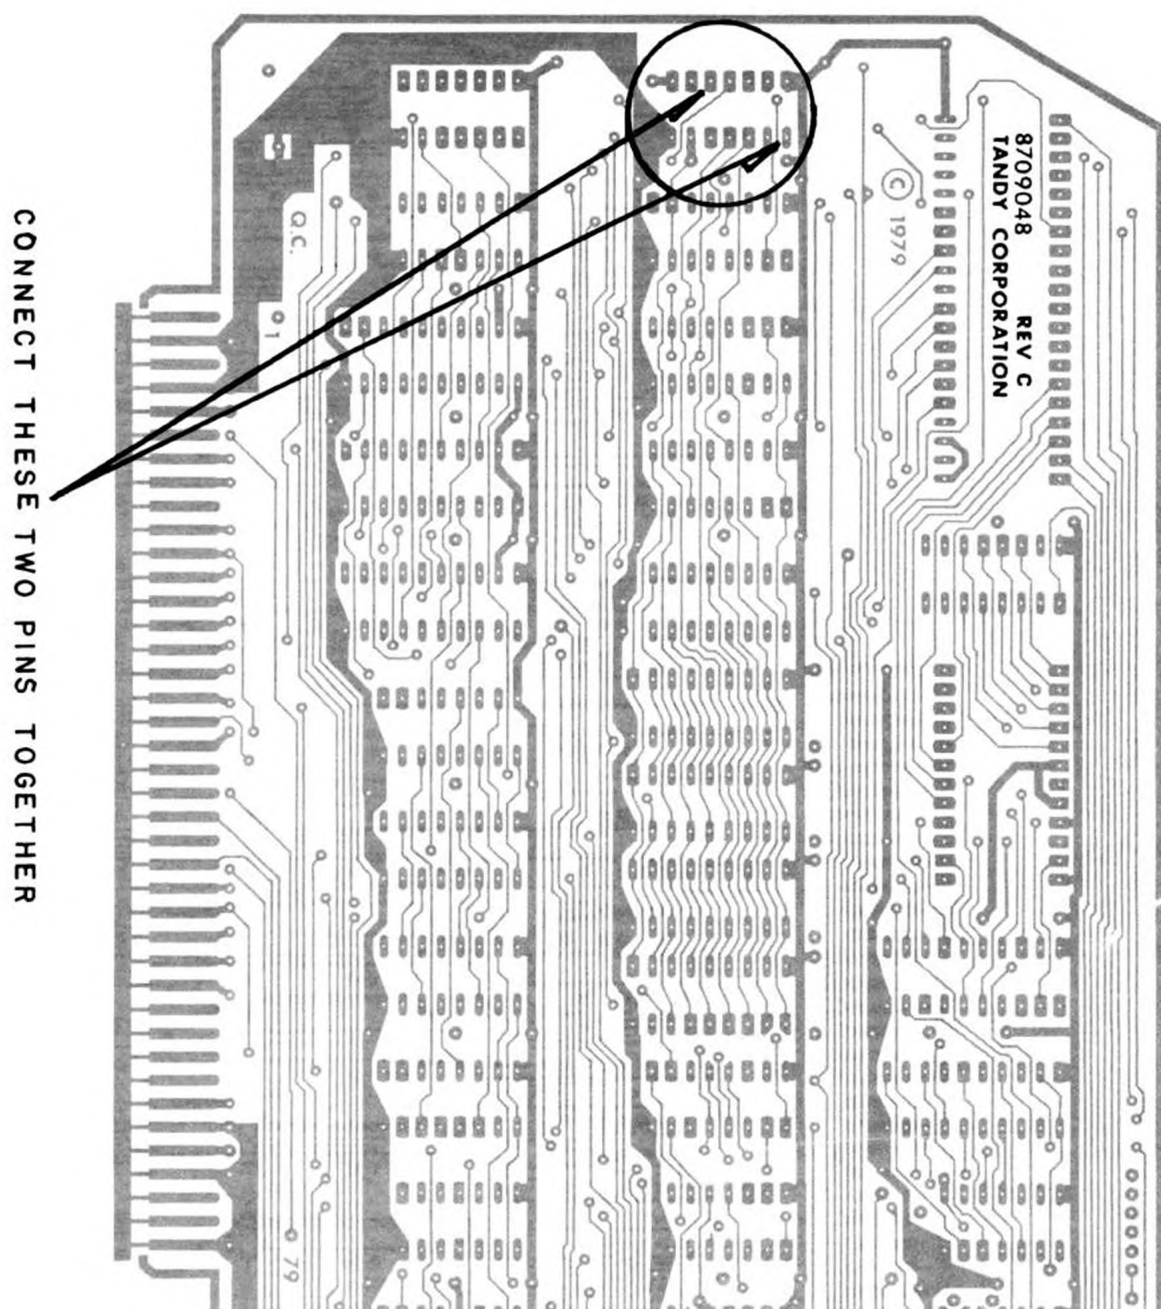
Figure 1

DISCUSSION: Rev A and B VDG boards have a problem with dual addressing. Addresses FC through FF are decoded on the VDG board for use by the Model II. There is an image of these addresses from 7C through 7F. Most systems will not have hardware port mapped at these addresses so no problem will appear. The only time a problem may arise is if a system has hardware installed that is port mapped in the range of 7C through 7F. This problem was corrected on Rev C VDG boards.

PROCEDURE: Whenever a Rev C VDG board is replaced with a Rev A or B VDG board jumper pin 1 to pin 10 of U27 on the Rev A or B board to insure no addressing conflict of the VDG board (Refer to Figure 1).

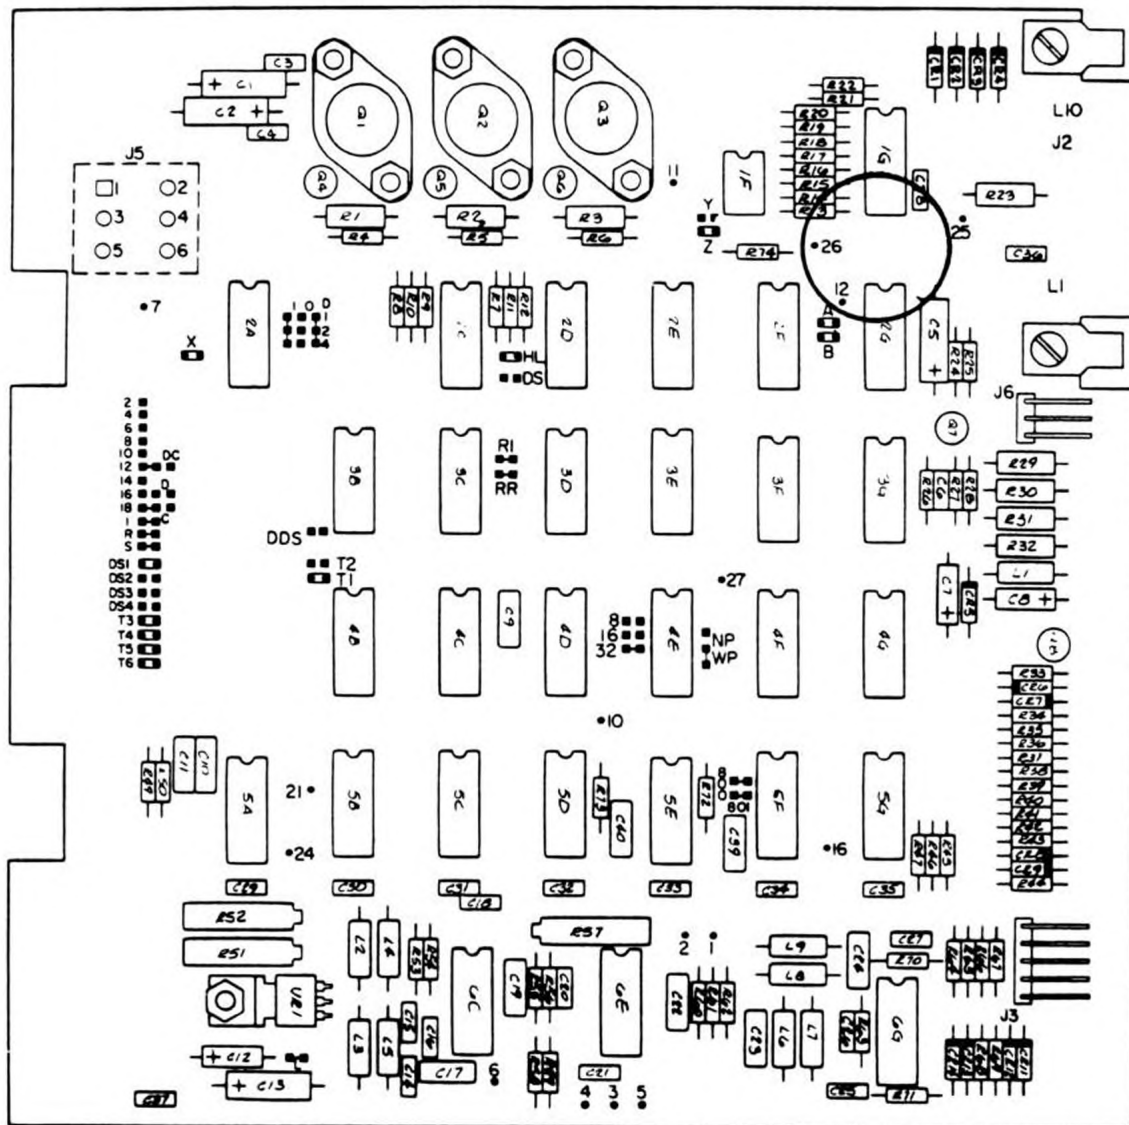
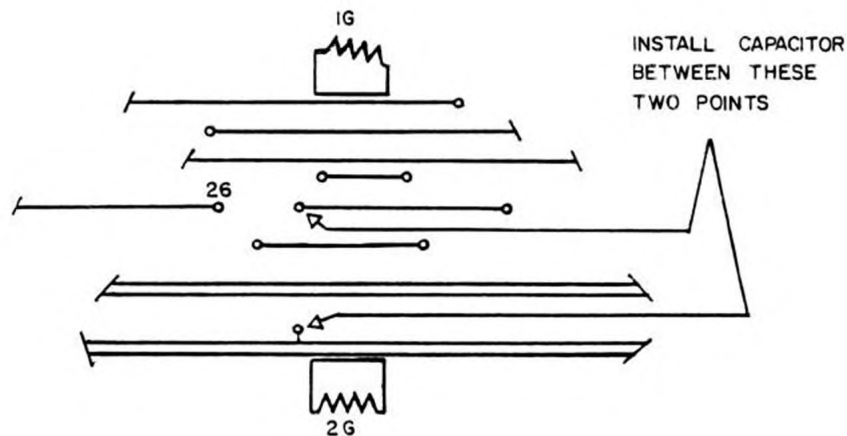
DISCUSSION: To correct booting errors the Ready line on the Shugart discrete logic board should be bypassed to ground with a .01ufd disc capacitor. All discrete boards should have this capacitor installed as a preventive measure. Any system that exhibits an unexplained booting problem not related to a hardware fault should be checked for this capacitor. This is now being done at the factory to new discrete boards. This capacitor is NOT to be added to Shugart LSI logic boards.

PROCEDURE: Check Ready line for .01ufd installed to ground. If capacitor is not present install .01ufd disk capacitor to ground (Refer to Figure 1).

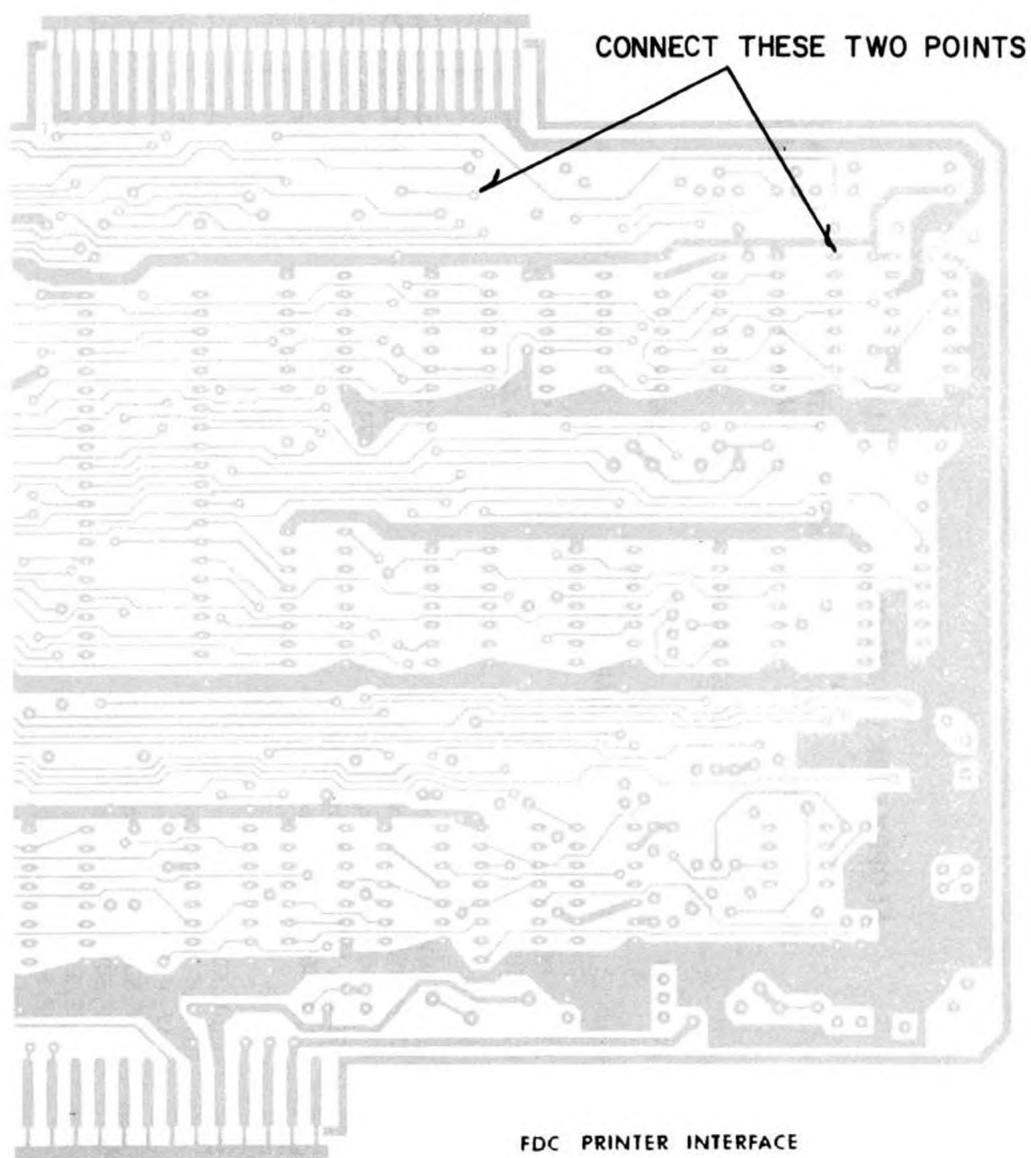
FIG 2

DISCUSSION: Some early FDC boards may not be able to format past Track 43 with precomp set at the required specification of 250 nsec. This problem will occur ONLY with the SY1791-02 FDC chip (not the FD1791-02 FDC chip) because the EARLY pulse ends slightly sooner on the SY1791-02. This could lead to a double pulse being picked off the shift register. To correct this problem the data out is tied to the RESET of the shift register. As soon as the data triggers the one-shot, it then clears the shift register, preventing double data pulses (Refer to Figure 1).

PROCEDURE: On unmarked, Rev A, or Rev B boards make sure the "one shot" modification has been installed (Refer to Technical Bulletin II:9), or that long jumpers are installed on the back of the board running to U37. Disregard this step on Rev C and D boards as they have this modification incorporated into their circuitry. On ALL revisions of the current board with a SY1791-02 FDC chip installed, add a jumper wire on the back side of the board from U1 pin 1 to the trace connected to TP10 (Refer to Figure 2).

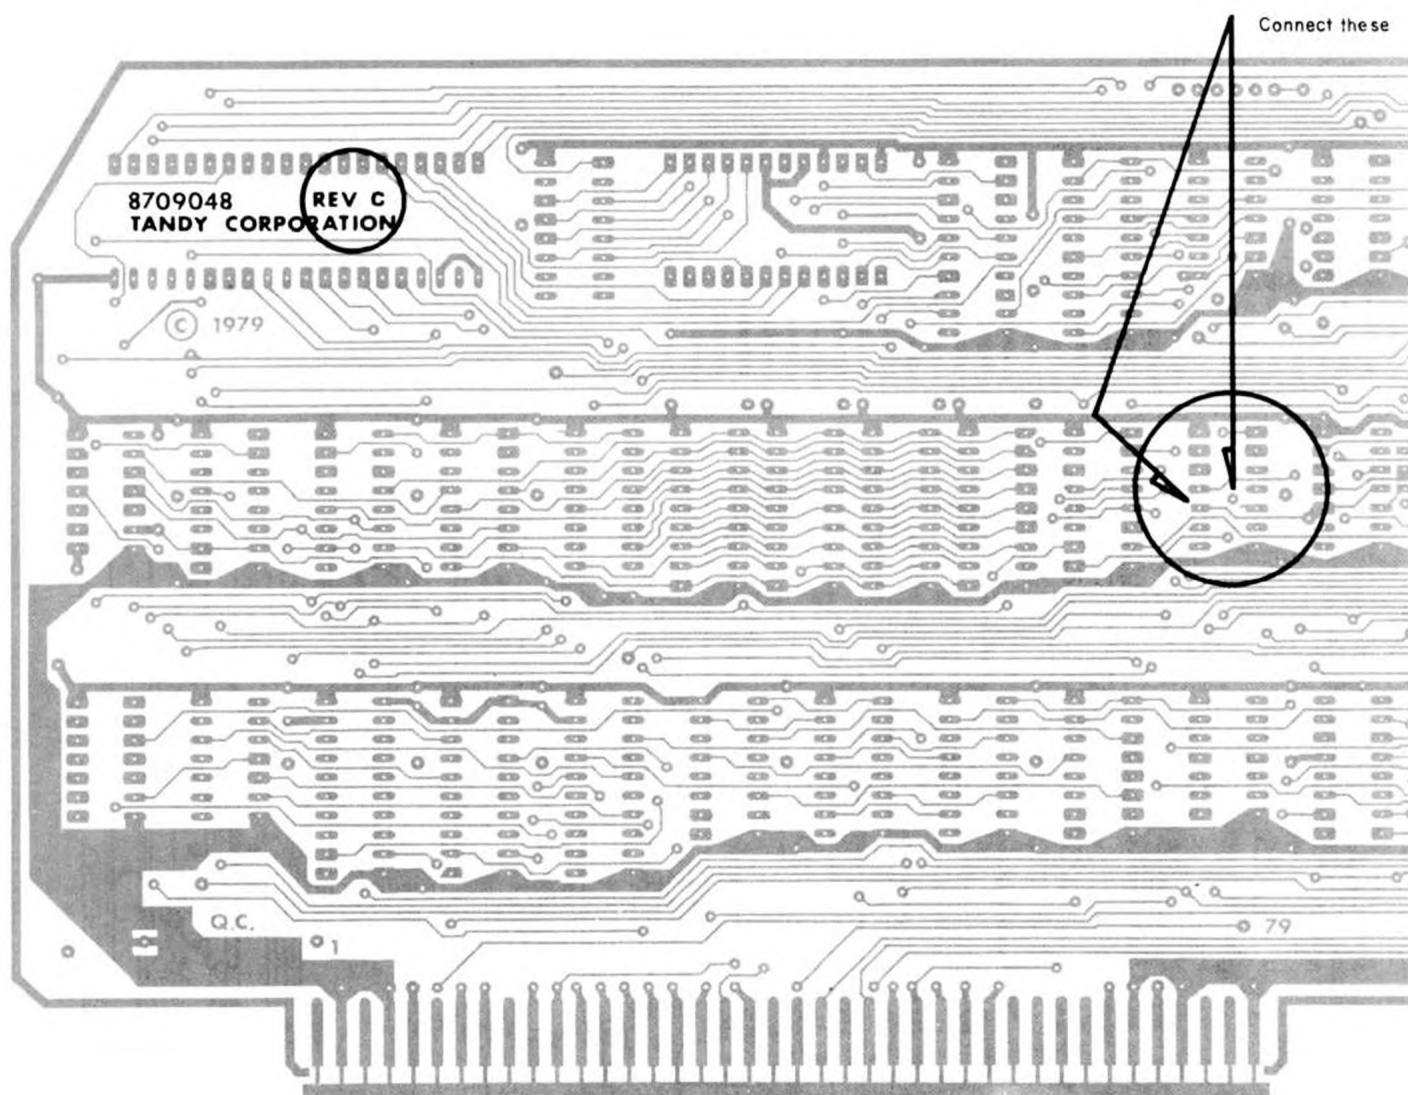
Figure 1

DISCUSSION: On Rev C VDG boards made by Lika there is a trace missing to the clear line on the latch (U17) that generates KBIRQ*. This can generate random interrupts that may or may not be fatal. To correct this problem a jumper is added to correct the missing trace which is a pullup to the clear line of U17. To identify the board as being manufactured by Lika, look for the Rev C marking on the solder side of the board under the 6845 chip and by LEI etched also on the solder side the crystal. This is the ONLY board to which this fix applies.

PROCEDURE: On the solder side of the board there is a feedthru located beneath the middle of U17 that is not connected to anything. Run a short piece of wire from that feedthru to U17 Pin 10 (Refer to Figure 1).

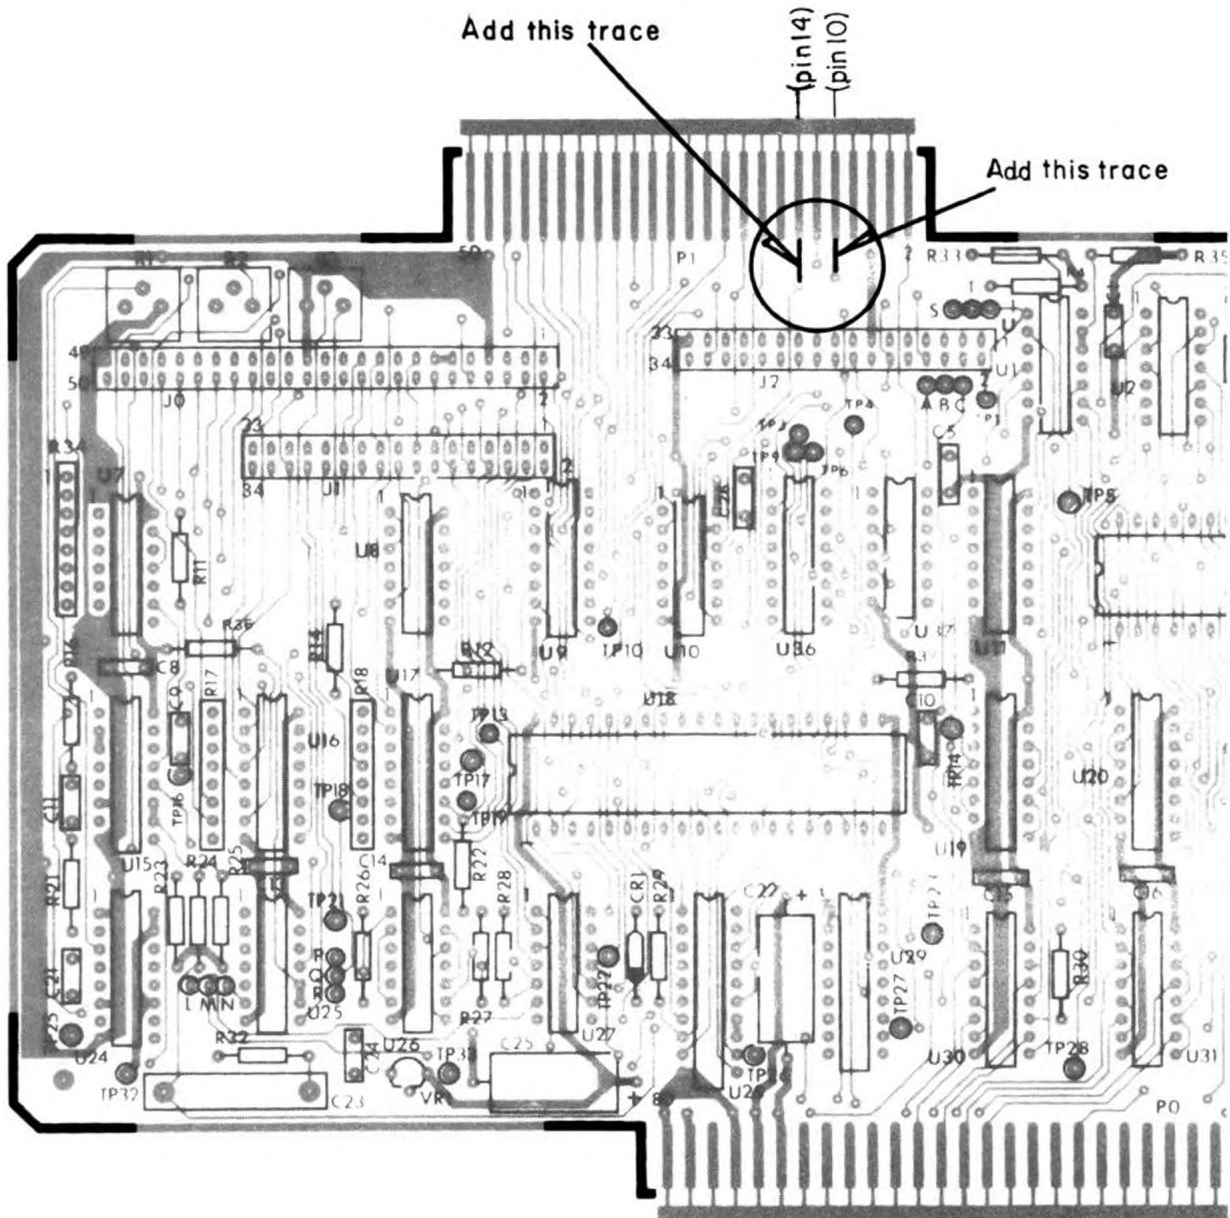
DISCUSSION: The trace that supplies the side select signal to the external drive connector on the Late Design FDC board (Rev Blank) is missing. Also, on some boards the trace that supplies the TWOSIDE* signal from the external drives to the FDC board is not present. Without these traces double sided drives cannot be used externally with the computer and will cause a problem with some diagnostics.

PROCEDURE: Refer to Figure 1 for the location of these traces. Run a jumper from pin 14 of connector P1 to the feedthru on the PCB that is directly in from the connector. Also run a jumper from pin 10 of connector P1 to the feedthru that is directly in from the connector.

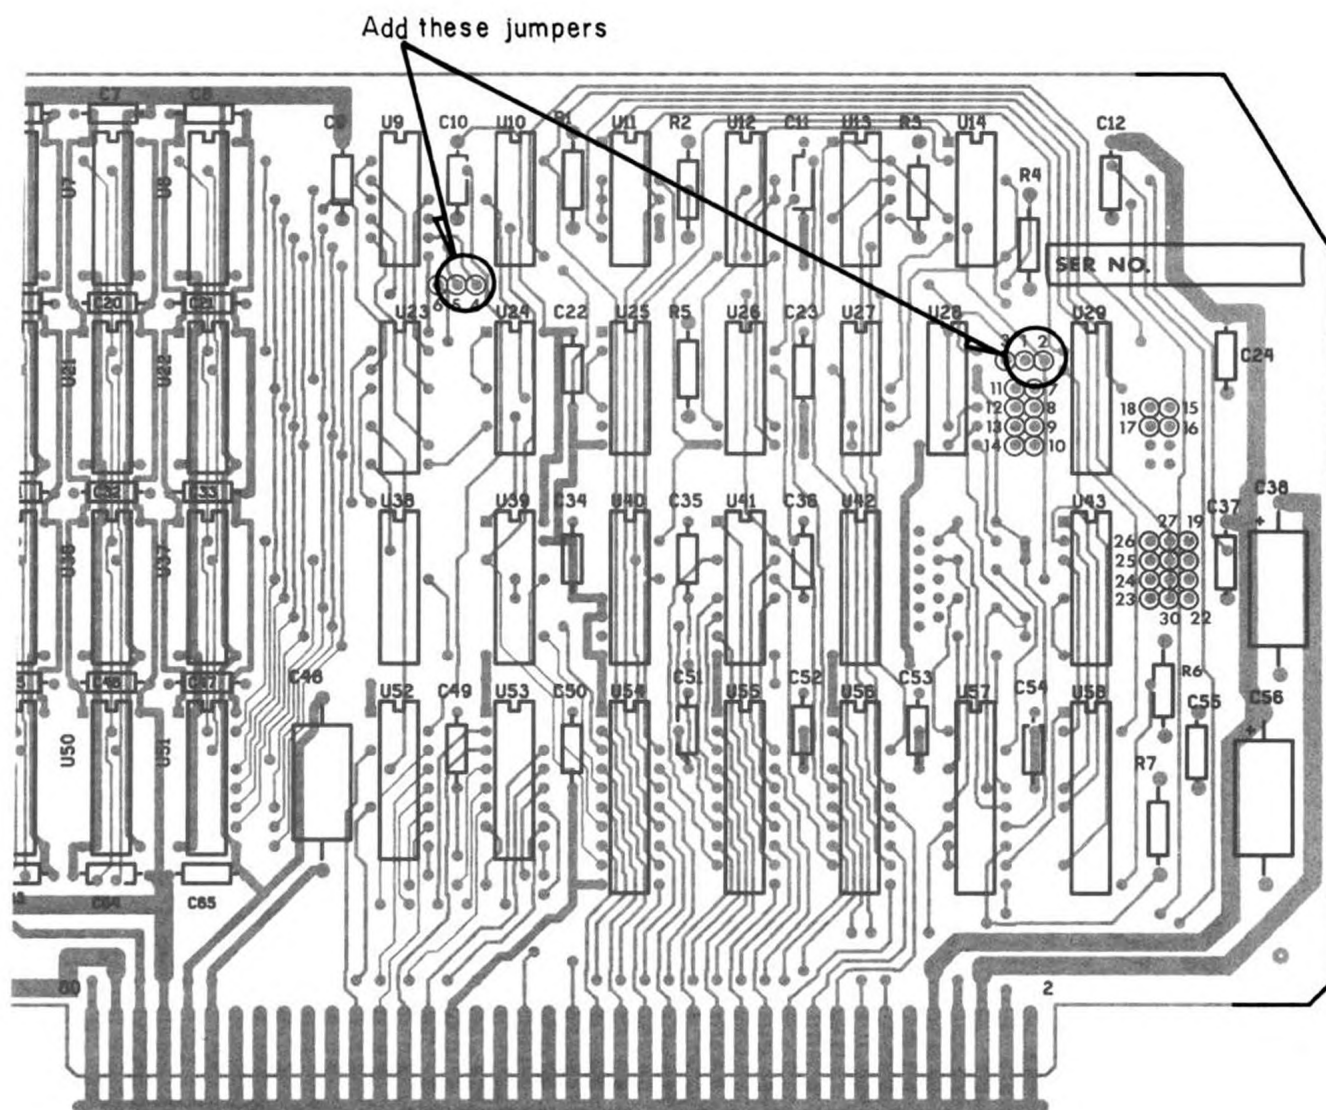
DISCUSSION: Pullups are needed on memory boards for inputs to gates. Intermittent problems can occur without these pullups installed. Some of the Model II memory boards may be missing staking pins for push on connectors and appropriate markings. In this case, use wirewrap to jumper the pads and refer to Figure 1 for pad locations.

PROCEDURE: Check boards for proper jumpering and install jumpers if they are missing. For physical locations of jumpering positions refer to Figure 1 for the memory board and Figure 2 for the Interface board.

Model II Memory boards:
Jumper 1-2 and 5-6

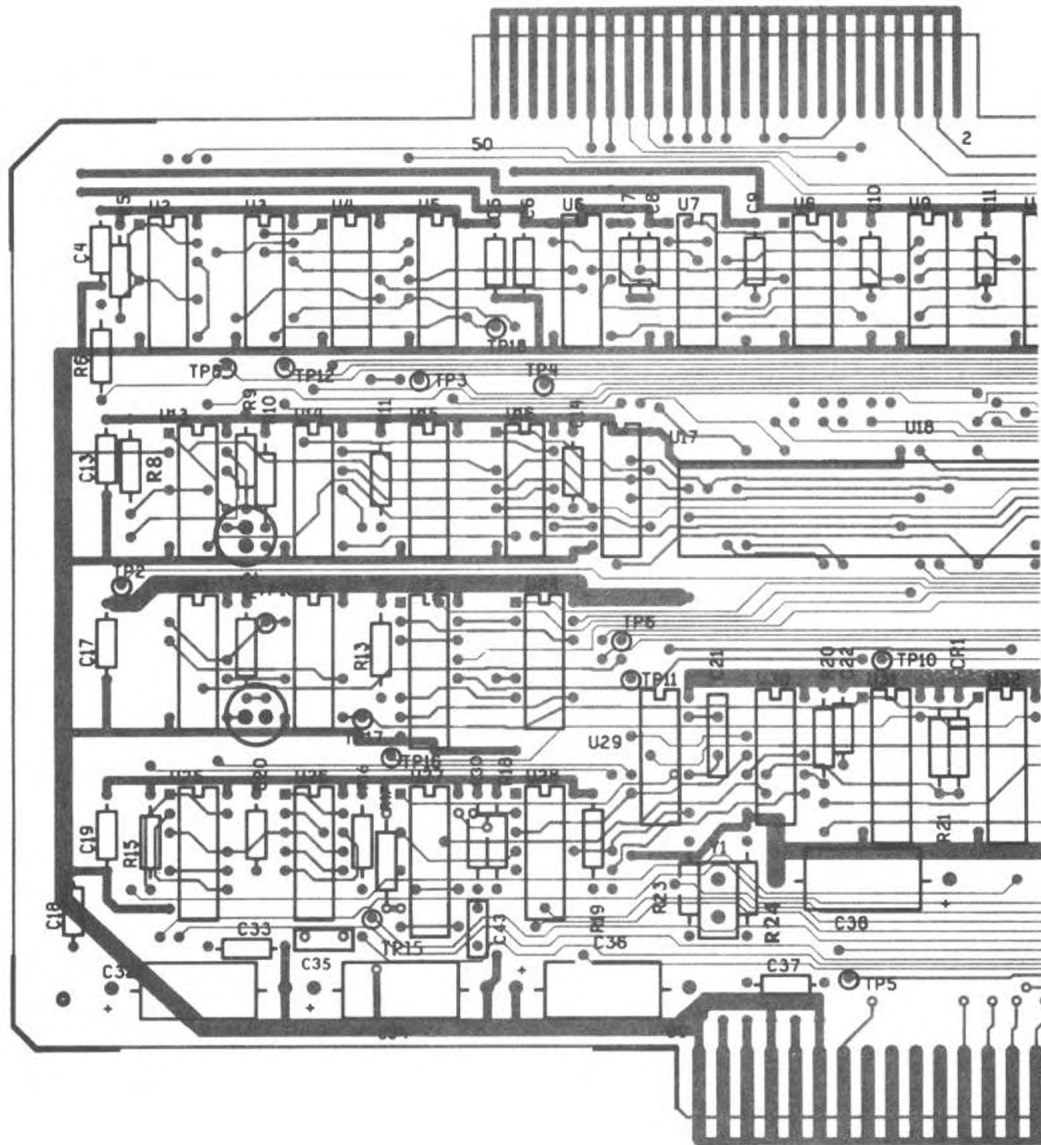
Figure 1

PURPOSE: To insure problems using wait states and software timing loops are not caused by possible missing jumpers on the Z-80 CPU.

DISCUSSION: Problems using wait states and software timing loops may be caused by two missing jumpers on the CPU board. The jumper locations are physically the same on all revision boards, but may be marked differently or not marked at all.

PROCEDURE: Check all CPU boards for jumpers and install if missing.

E3-E4 and E0-E1

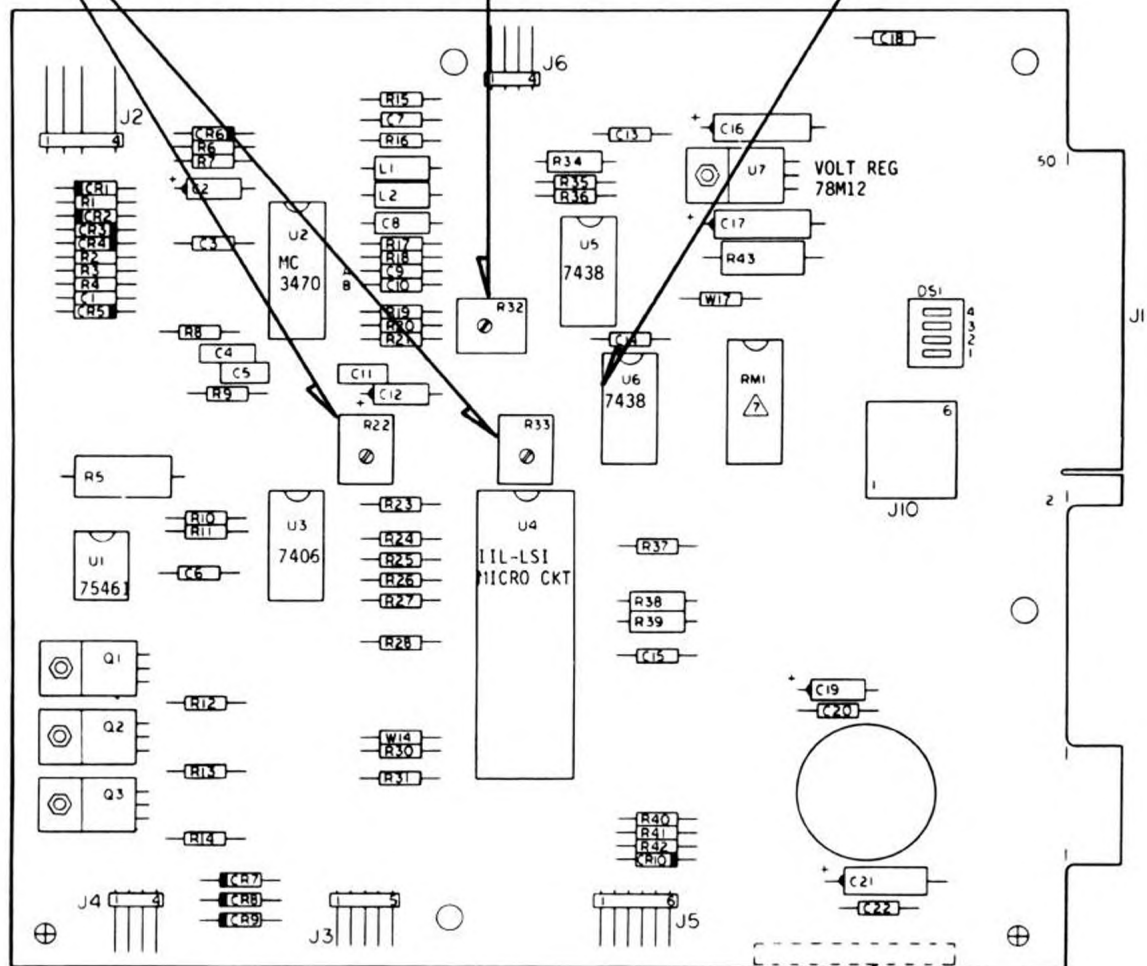
Figure 1

DISCUSSION: The LSI board has three adjustments R22, R23, and R32 (Refer to Figure 1). R22 and R33 are for adjusting the oscillator and write current to the head. These adjustments ARE NOT to be done in the field. The reason for this is because a test jig is needed, excessive time is required to complete the adjustments, and there is a high probability of damaging the head or the LSI chip. Once these adjustments have been done by the factory there is no reason for them to change unless the LSI chip fails. R32 controls the read symmetry (raw data) adjustment and it should be adjusted in the field.

Adjust for raw data

Connect scope here
pin3 U6
