TECHNICAL BULLETIN INDEX  
Sorted by Bulletin Number  
04/03/86

BULLETIN NO: II:1

PRODUCT: 26-4001/2 Model II

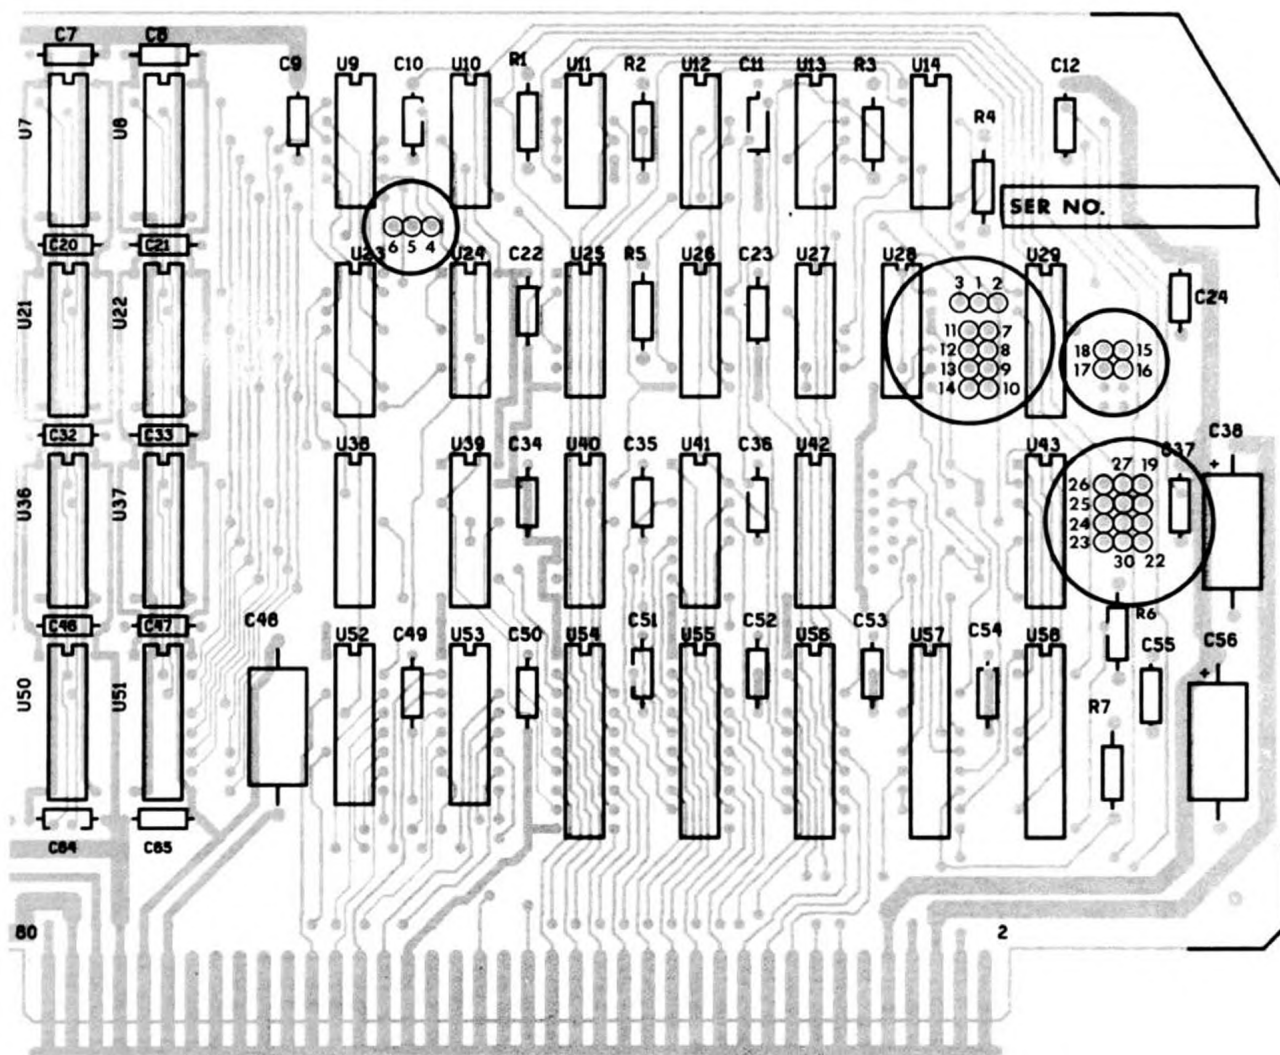
Figure 1

1-2 Pulls up an input to U27 that was floating  
5-6 Pulls up an input to U9 that was floating

Use MEMII Diagnostic to check each memory board for correct jumpering and proper operation.

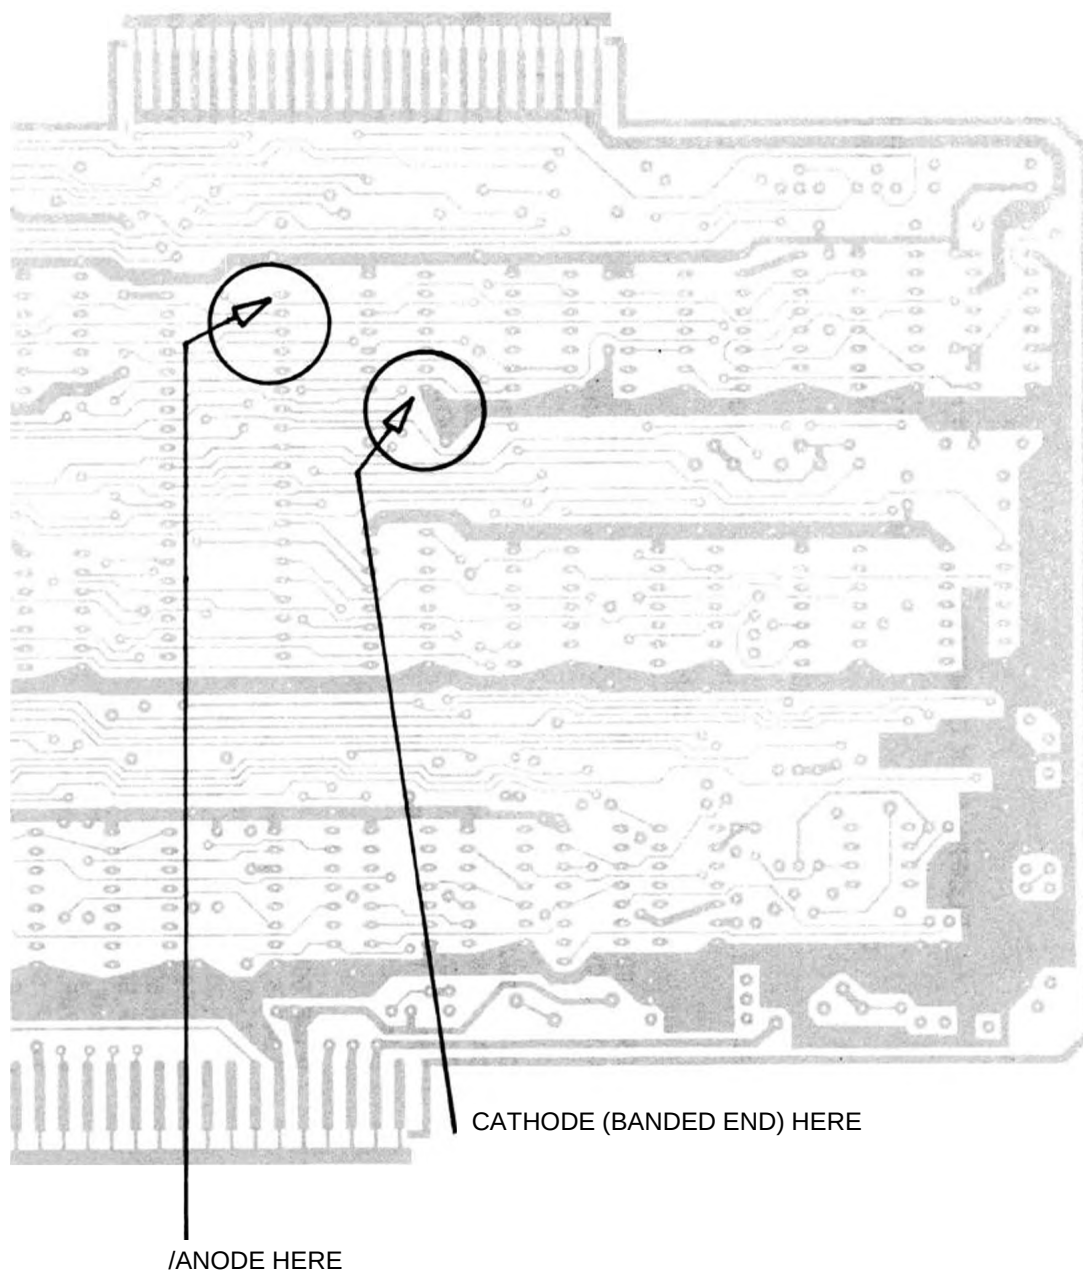
Figure 1

PURPOSE: To correct thermal failure of FDC IC (U6) causing Read/Write errors, and other intermittent disk I/O failures.

DISCUSSION: Early FDC chips developed thermal failures causing disk I/O failures and Read/Write errors. To correct this problem a 2.7V Zener diode MUST be installed from U6 Pin 1 to U5 Pin 7. On new and factory repaired assemblies this change will already have been installed.

PROCEDURE: Check to see if this modification has been done, if not, install diode as per Figure 1. Be sure to use sleeving for insulation of leads to prevent shorts. This diode can be ordered from National Parts using part number ADX-1382 and catalog number 26-4001.

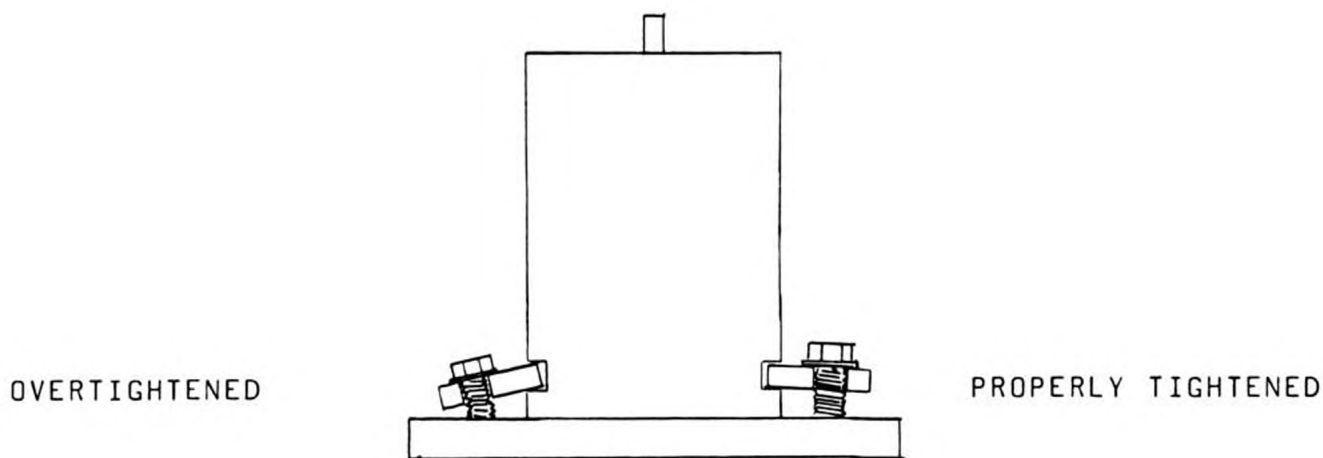
FIG. 1

**DISCUSSION:** After aligning Head Radial DO NOT OVERTIGHTEN bracket screws when securing the stepper motor. Excessive tightening will cause bracket and screws to bend and eventually damage the screw holes in the stepper motor plate, making proper alignment almost impossible.

**PROCEDURE:** After Head Radial Alignment tighten bracket screws only enough to secure stepper motor. If the stepper motor cannot be secured without excessively bending the bracket (Refer to Figure 1), or if the screw holes in the plate are damaged, replace the drive chassis.
