TECHNICAL BULLETIN INDEX
Sorted by Bulletin Number
06/25/86

DATE: January 16, 1985
REVISION DATE: February 13, 1985
BULLETIN NO.: 6000:1
PRODUCT: 26-6021/2 (Tandy 6000)
26-6014 (8 MHz CPU upgrade kit)
SUBASSEMBLY: 8 MHz 68000 CPU board

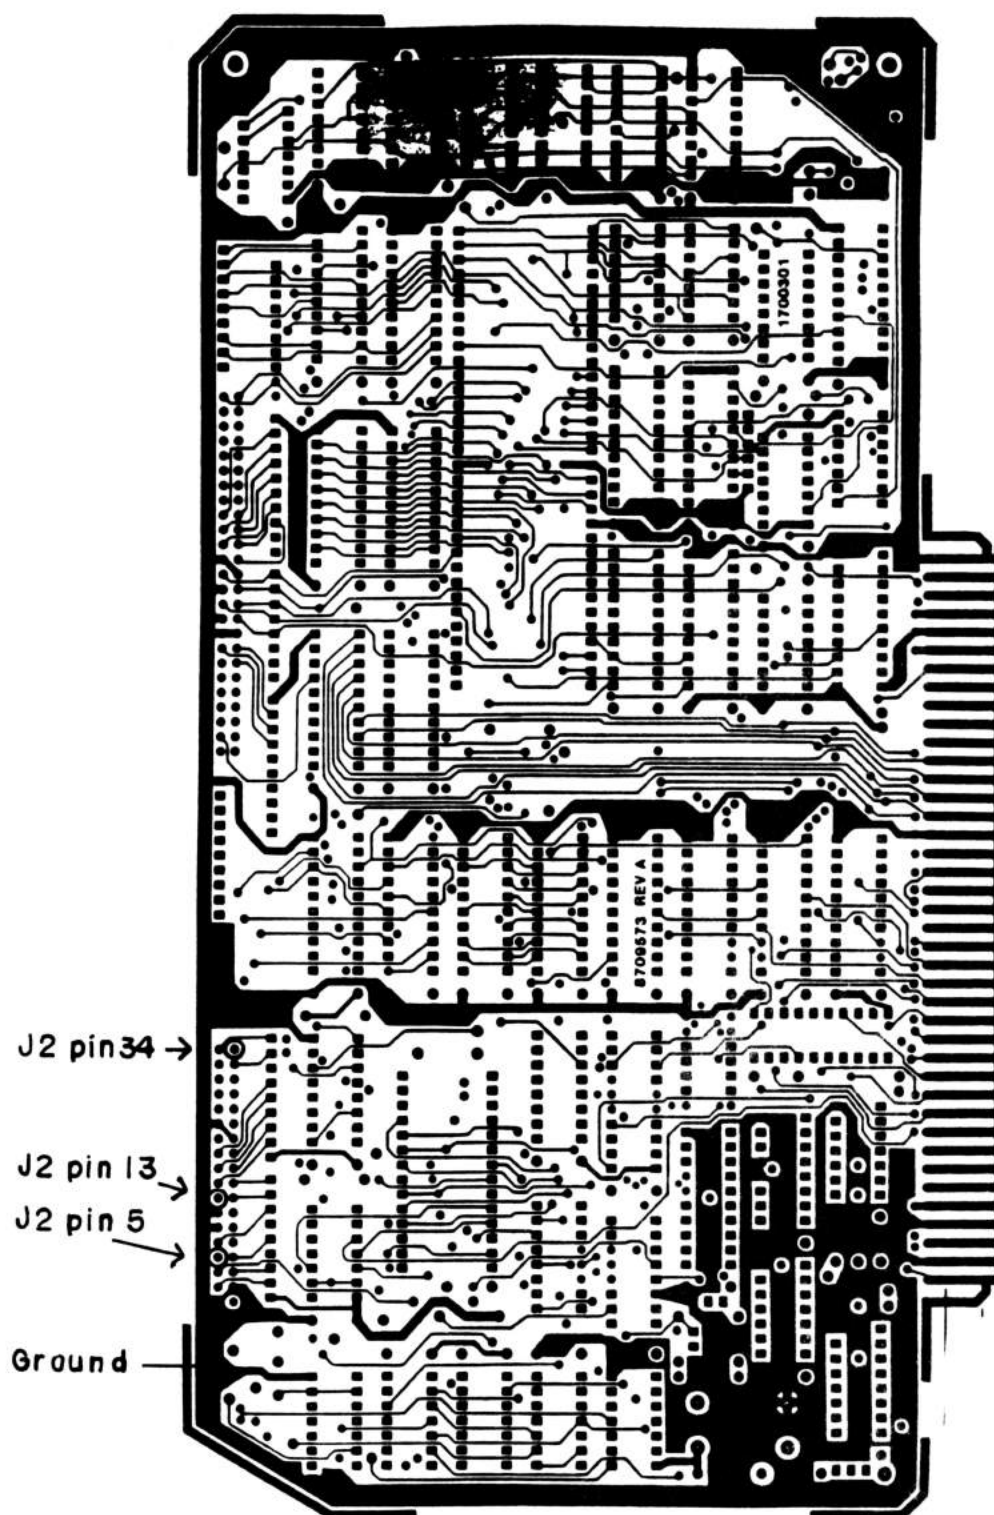
SOLDER SIDE (LAYER 4)

Due to an error in the artwork on early revision (Revision A) boards, a modification to insure good ground connections between the 68000 CPU board and associated memory boards is required.

Using wire wrap wire, install the following jumpers on the solder side of the 68000 CPU board:

- (1) Jumper J2, pin 5 to ground.
- (2) Jumper J2, pin 13 to ground.
- (3) Jumper J2, pin 34 to ground.

Ground may be found at the feed-throughs on the ground plane near J2 on the solder side on the board.

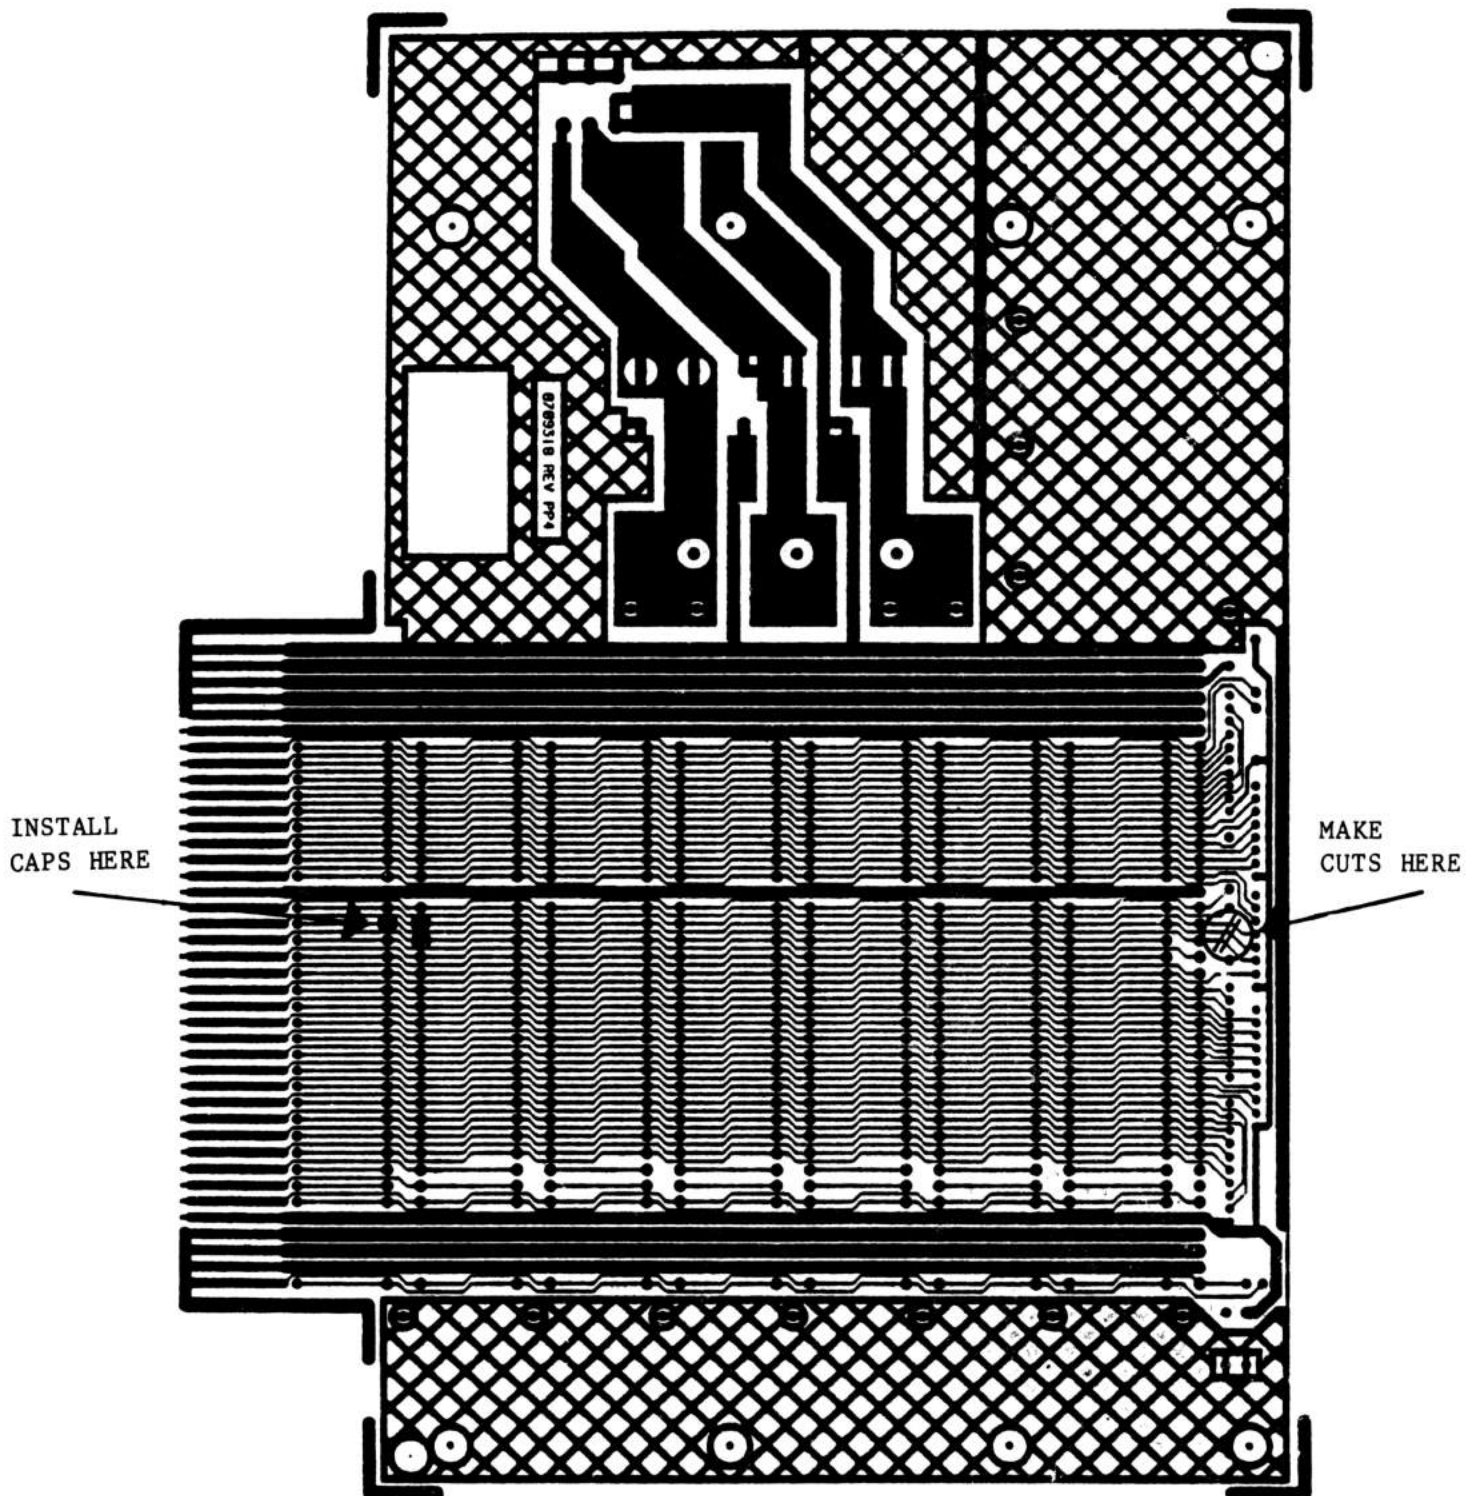
PURPOSE: To correct errors in artwork and prevent bus errors.

To prevent bus errors, three traces need to be cut away from a resistor pack and three capacitors need to be installed on the card cage mother board.

On mother boards of revision levels prior to Rev. B, pins 3, 4, and 5 on resistor pack R6 need to be cut.

On mother boards of revision level Rev. B or later, pins 4, 5, and 6 on resistor pack R6 need to be cut.

On boards of all revision levels, three (3) 220 pf caps should be jumpered from pins 44, 45, and 46 to ground on the bottom-most connector. These pins correspond to the traces cut on the resistor pack R6. See Figure 1 for clarification. The capacitors needed for this modification may be ordered as:

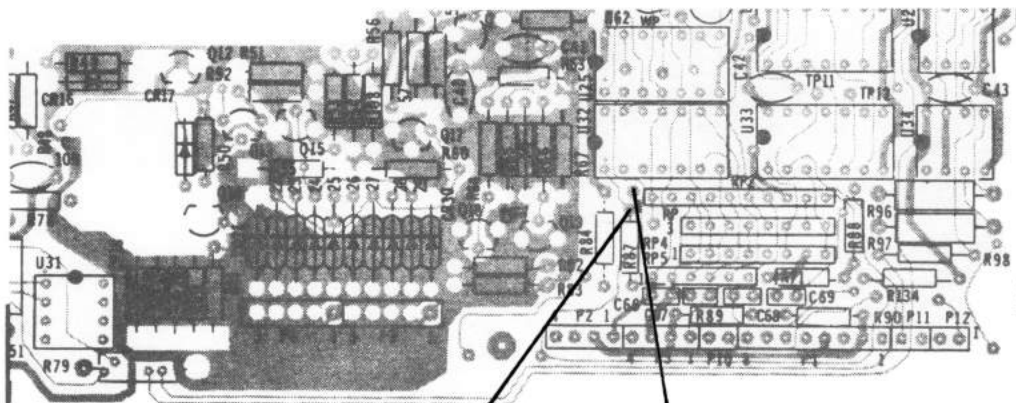
DISCUSSION: Some Tandon Belt Drive Logic Boards (Rev. Y) have come from the vendor with R87, a 150 ohm pullup resistor, installed incorrectly. These boards may be identified by the existence of a small white sticker (bearing a bar code, three numbers, and the letter "Y") attached to the board right next to the "REV" marking. The defective boards will not see the index pulses at all and will not recognize an inserted diskette, i.e. will remain at the "Insert Diskette" prompt even after a diskette is inserted and the drive door is closed.

PROCEDURE: Locate R87 on the Drive Logic Board. Note that one lead is connected to a feedthrough which has a trace running to U32, pin 1. Unsolder this lead of R87 and resolder it to the feedthrough right above it. The correct feedthrough is a +5V trace.

MOVE THIS LEAD

TO HERE

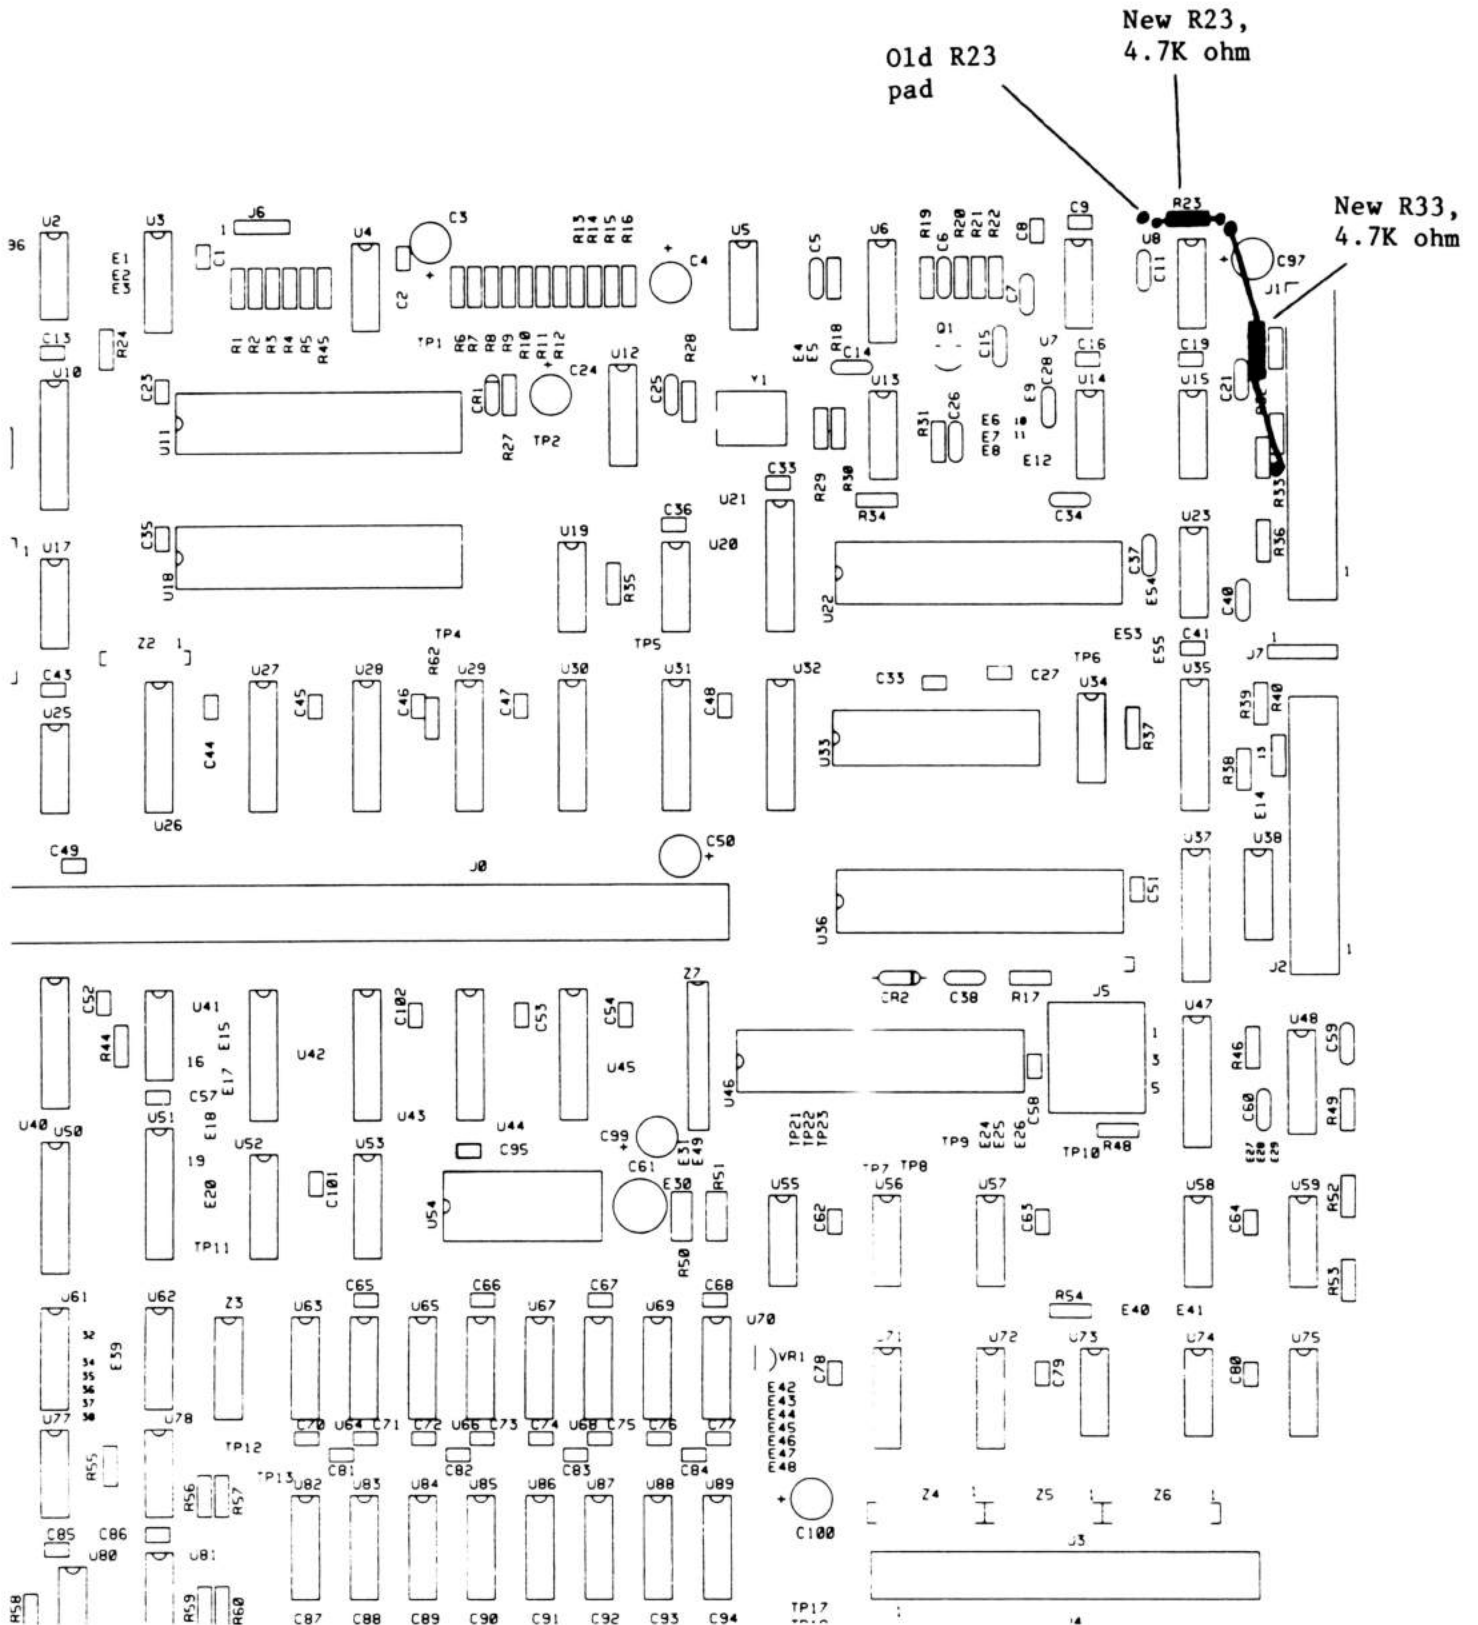
To make the serial ports more reliable the pullups for SIO control signals need to be changed. The pullup for carrier detect needs to be changed not only in value, but from -12V to +12V so that it is normally true. This modification is required on all Rev. Blank boards.

On some boards which display problems initializing port B in Xenix operation (i.e. boards which refuse to communicate with terminals on port B), an additional modification may be necessary, which pulls carrier detect normally true on port B as well as on port A. This modification may be necessary on both Rev. Blank and Rev. A main logic boards.

Change R21, R23, R25, R32, R36 from 10K ohm to 4.7K ohm resistors. Remove resistor R33. On the component side of the board, install a 4.7K ohm resistor with one lead attached to the old R33 solder connection closest to R36 and the other lead attached to the +12V line at the feedthrough adjacent to R23 between U8 and C97 (refer to figure 1). The leads should be insulated to prevent them from shorting.

Remove resistor R23. On the component side of the board, install a 4.7K ohm resistor with one lead attached to the old R23 solder connection closest to C97, and the other lead attached to the +12V line at the feedthrough adjacent to the remaining R23 solder connection. The +12V line in question also connects directly to U7, pin 14 (refer to figure 1).
