TECHNICAL BULLETIN
Sorted by Bulletin Number
September 28, 1988

TANDY COMPUTER PRODUCTS

DATE: December 8, 1983

BULLETIN NO: 20000:1

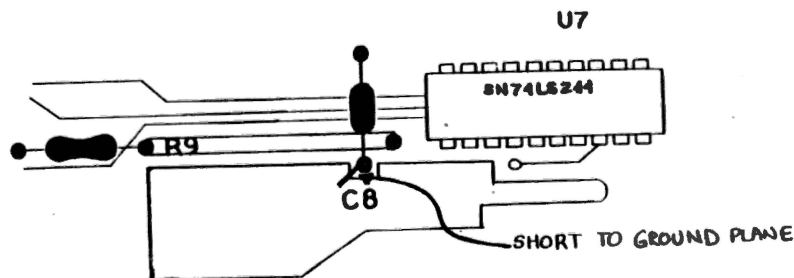
Figure 1

DISCUSSION/PROCEDURE: Some early production hard drive controller boards were missing a resistor (R28), had two wrong valued capacitors installed (C5 and C6), and had one capacitor which was not grounded properly (C8). All Tandy 2000 hard drive controller boards should be checked for the following:

1. Make sure R28 has a 470 ohm 1/4 watt 5% resistor installed in that silk screen position.
2. Check C5 and C6 to insure 100 pfd capacitors are installed and not 150 pfd capacitors.
3. Check C8 to insure that the open pin is attached to the ground plane nearest it (Refer to Figure 1).

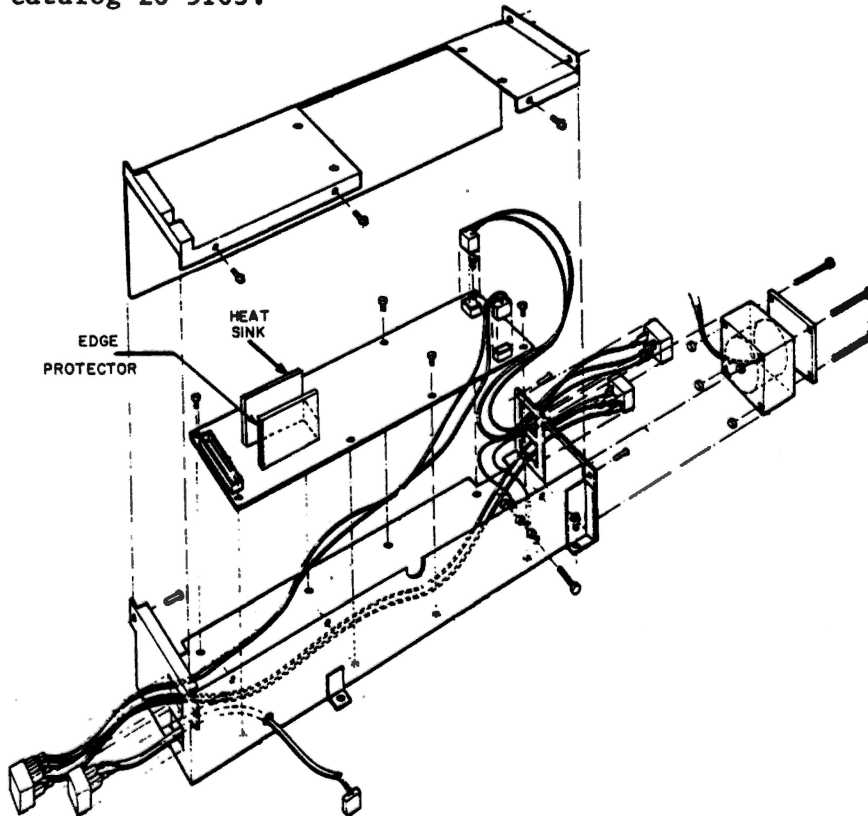
Due to the close fit of the power and reset switch wiring harness to the large heat sink on the power supply, it is possible the heat sink could rub against the wires causing a short. To prevent this, an insulating edge protector should be installed on the right side of the heat sink.

The edge protector is available from National Parts under part number AHC-3100 and catalog 26-5103.

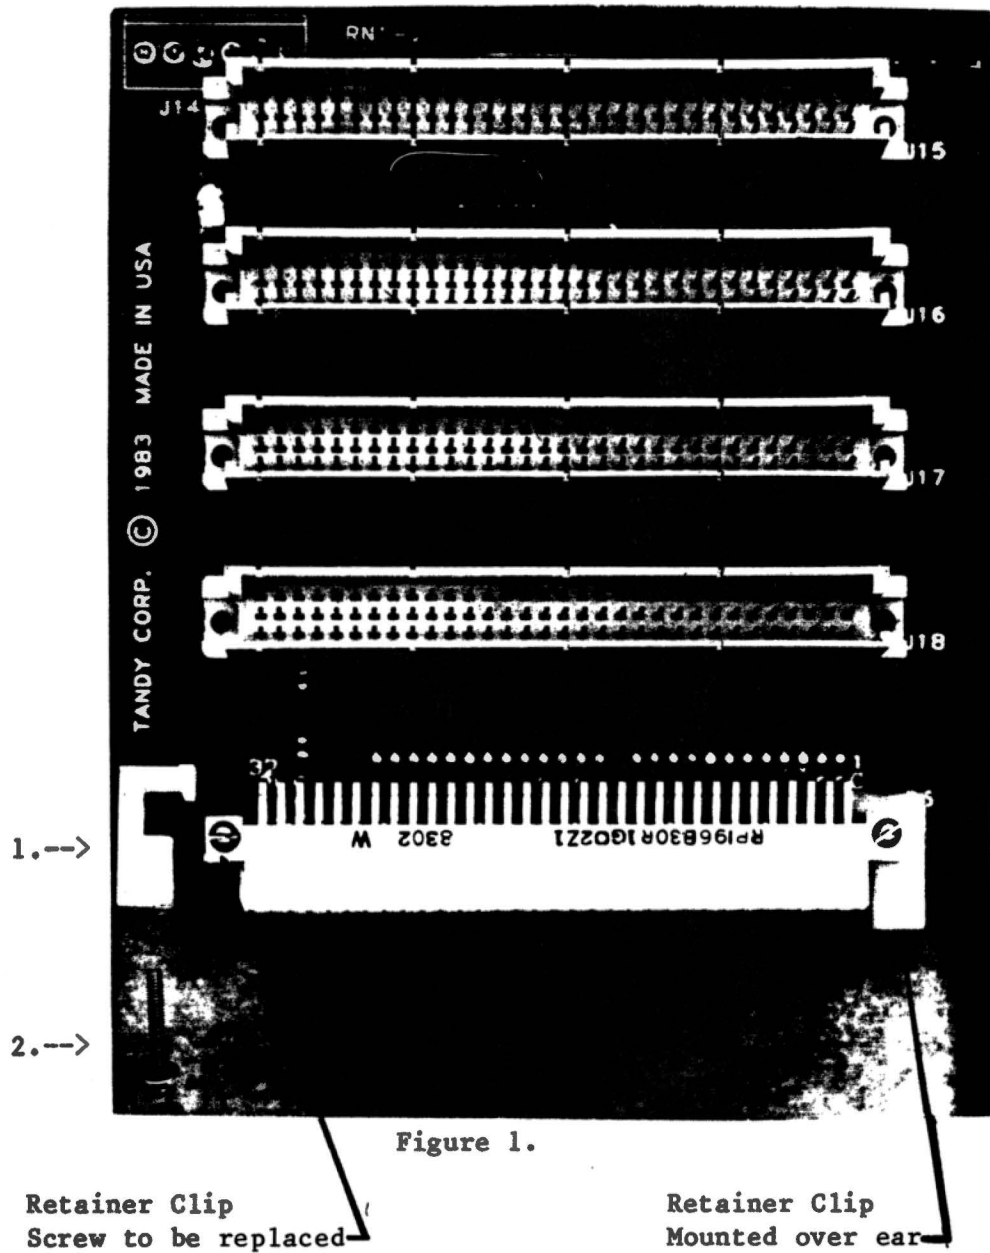
DISCUSSION: Due to improper seating of the mother board to the main logic board, intermittent bootup, video, or power problems may occur. The four screws which hold the main logic board and pan to the plastic case often times become stripped and creates a bad connection to the motherboard. To insure proper connection is made between the main logic and motherboard, a Retainer Kit is to be installed on the motherboard.

3. (Refer to figure 1.) Remove screws and nuts holding (P6)(96-pin connector) to the motherboard. Replace the original screws with the #4 x 1/4" screws and the #6 lock washers. These are used to hold the retainer clips tightly in place.

4. (Refer to figure 1.) Place the retainer clips over the screw ears of the connector (P6) behind #6 lock washer if used.
5. Reattach the main logic board to the pan. Reinstall the mother board and insert the two screws into standoff's from bottom side. Thread the two screws into the retainer clips, pulling the two boards together for a tight fit. WARNING: Do not over tighten the screws or you will strip out the retainers.
6. Reassemble unit and test for proper operation.

1. Retainer clip is inserted over (P6) connector mounting ears.
2. Insert screw through bottom of main logic board pan standoff's under the (J5) connector on main logic board.

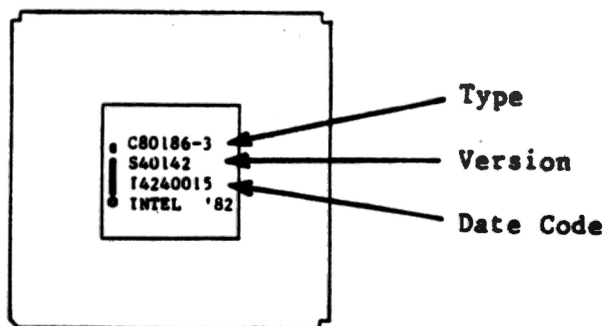
Several versions of the 80186 CPU have been used in the Tandy 2000. Some of these may have missing command functions. Some are 6 MHz speed chips instead of the required 8 MHz. These CPU chips may not exhibit any problems, or only have problems with certain application programs such as a CAD package. Proper identification, and replacement if necessary, is required to insure proper operation.

There are two items to check, clock speed and version number. If either one, or both of these numbers are incorrect the chip must be replaced. Figure 1 shows a typical 80186 CPU chip.

Identification markings may be made on either side of the chip. If the Intel name and logo are not visible from the top side, then the markings are made on the contact, or bottom side of the chip. This requires removal of the chip from it's socket for identification. Refer to Technical Bulletin 2000:19 for CPU removal and replacement procedures.

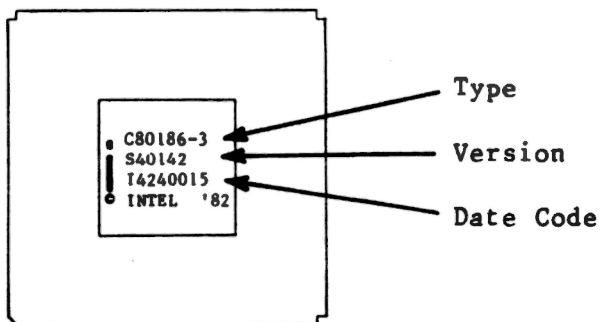
Figure 1.

Several versions of the 80186 CPU have been used in the Tandy 2000. Some of these may have missing command functions. Some are 6 MHz speed chips instead of the required 8 MHz. These CPU chips may not exhibit any problems, or only have problems with certain application programs such as a CAD package. Proper identification, and replacement if necessary, is required to insure proper operation.

There are two items to check, clock speed and version number. If either one, or both of these numbers are incorrect the chip must be replaced. Figure 1 shows a typical 80186 CPU chip.

Identification markings are made on the contact, or bottom, side of the chip. This requires the chip to be removed from it's socket for identification. Refer to Technical Bulletin 2000:19 for removal and replacement of the CPU chip from it's socket.

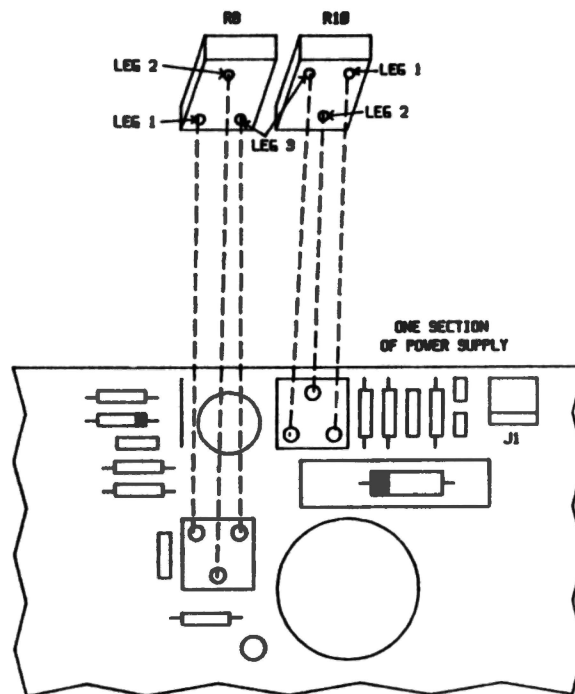
The power supply for the Tandy 2000 has two potentiometers. One to adjust the +5 volts (R10) and another to adjust the +12 volts (R8). During operation it has been found that these potentiometers will change value. This could cause the voltage to increase which in turn causes the power supply to go into current limiting mode; shutting itself down and rebooting the computer.

To eliminate this voltage fluctuation, the potentiometers must be replaced with fixed resistors. Two items must be noted here. First, the required resistance may not be a standard value resistor which will indicate that a series and/or parallel resistor combination must be used. Secondly, the +5 volt potentiometer will require two resistors (or combinations) where as the +12 volt will only require one resistor (or combination). This is because the +12 volt potentiometer's slide arm is connected to one of its fixed legs.

5. Install the first fixed resistor between the holes on the power supply PCB vacated by Leg 1 and Leg 2. Install the second fixed resistor between the holes vacated by Leg 3 and Leg 2. This completes the replacement of the +5 volt potentiometer.

7. Install the fixed resistor between the holes on the power supply PCB vacated by Leg 1 and Leg 2. This completes the replacement of the +12 volt potentiometer.

8. Reinstall the power supply PCB and check for proper voltage levels on the +5 volt and +12 volt sections.
