DATE: May 14, 1982  
REVISION DATE: August 26, 1983  
BULLETIN NO.: I/O:41  
PRODUCT: 26-4104 Model II Hires Graphics Board  
SUBASSEMBLY: N/A

PURPOSE: To correct small hash marks in the first eight inches of the left side of the video display.

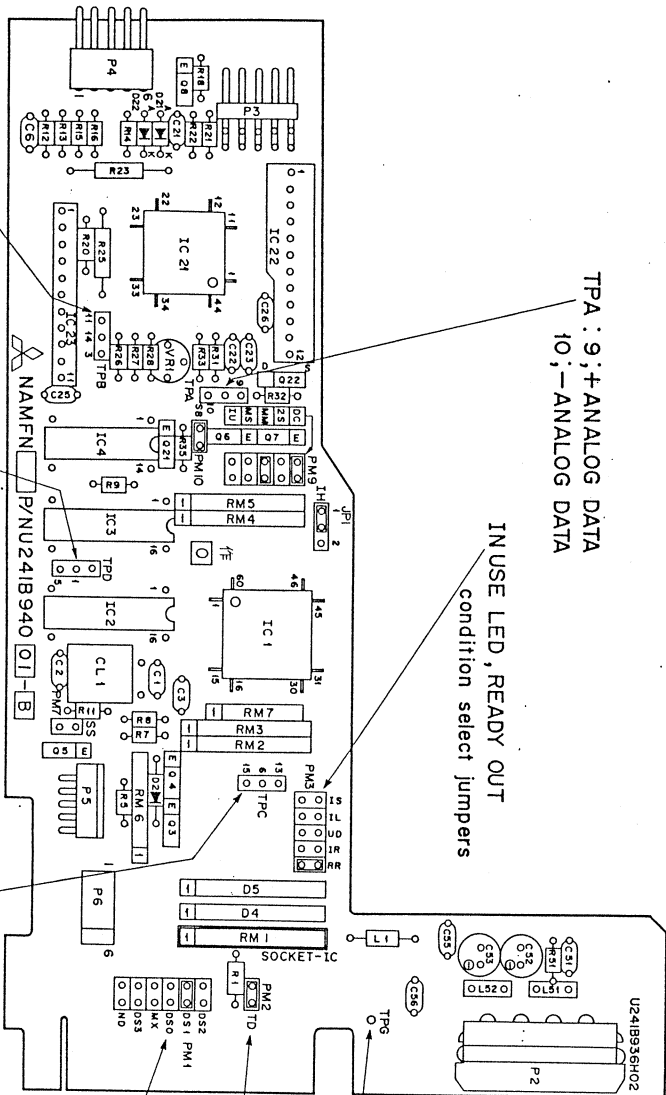
TPA: 9; + ANALOG DATA  
10; - ANALOG DATA

IN USE LED, READY OUT  
condition select jumpers

DRIVE SELECT TERMINATOR  
condition select jumper

DRIVE SELECT  
condition select jumpers
