Technical Bulletins Sorted By Bulletin Number
Generated 12/31/92

DATE: May 1, 1980
REVISION DATE: November 24, 1982
BULLETIN NO.: I/O:03
PRODUCT: 26-1157 WP50 Daisy Wheel Printer
SUBASSEMBLY: N/A

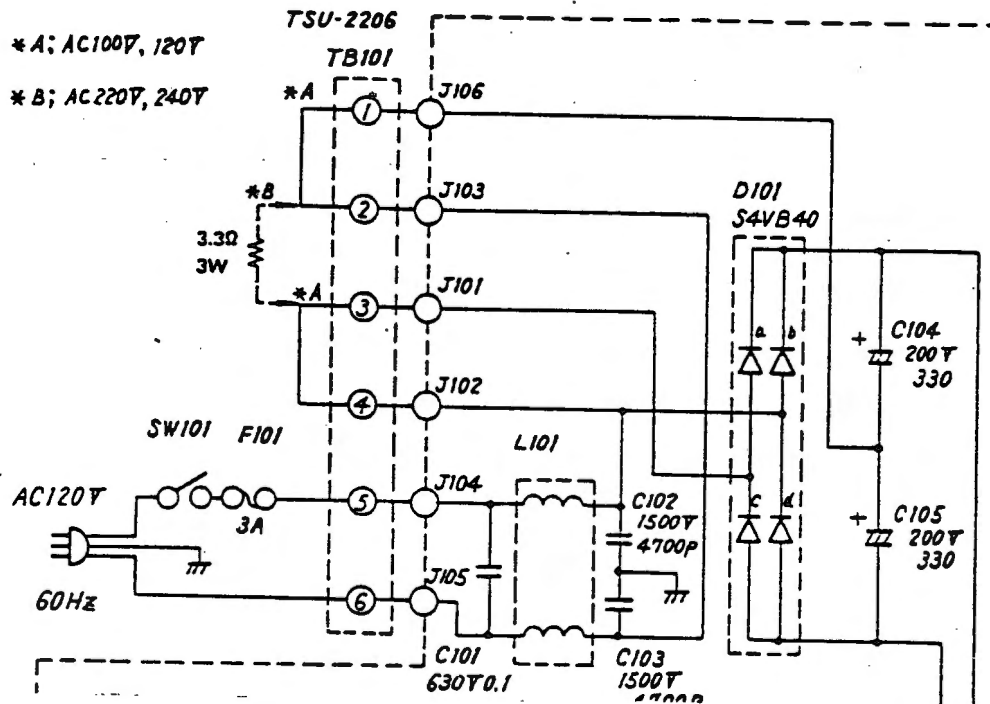
26-1156. POWER SUPPLY SCHEMATIC

DISCUSSION: The AC power supply connector block designators for the 26-1156 and the 26-1156A are not the same. Please note that this difference only applies to the AC connections. The DC connections are the same on both units. National Parts is only stocking the power supply for the 26-1156A (AX-8711) at the present time. There are still older units (26-1156) which have not been in for service. These will still have the older version of the power supply so pay special attention to these units.

PROCEDURE: Before installing any power supply in the Line printer III verify that it is the correct version power supply for that unit. To determine the power supply version open the power supply case and physically compare the AC power supply designators (J101-J106) to the attached schematic. If necessary make a continuity check from the individual connections to the components shown in the schematic. Once the version has been determined install the inputs to the AC terminal block as shown in the corresponding schematic for that version of the power supply.

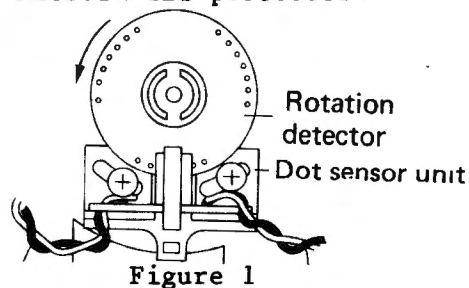
DISCUSSION/PROCEDURE: When ordering the AX-8731 it is possible to receive one of five logic boards. The boards are identified by a number stamped at the bottom of the boards. The numbers are MB-1, MB-2, MB-3, MB-4, and MB-5 (modified). The MB-1 through MB-4 are physically and electronically the same. The modified MB-5 is electronically the same, but physically different. This board has two cuts and two jumpers on the solder side. All five versions of this board have a MB8881N-122 processor installed. The rotation detector used with these boards has three groups of holes around its outside edge (see figure 1). This rotation detector can only be used with the MB8881N-122 processor.

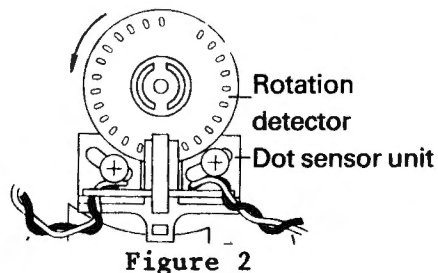
When ordering the AX-9269 an unmodified MB-5 logic board should be received. The MB-5 received should have no cuts or jumpers and have a MB8881N-157 processor installed. The rotation detector used has hole all the around its outside edge (see figure 2). This rotation detector can only be used with the MB8881N-157 processor.

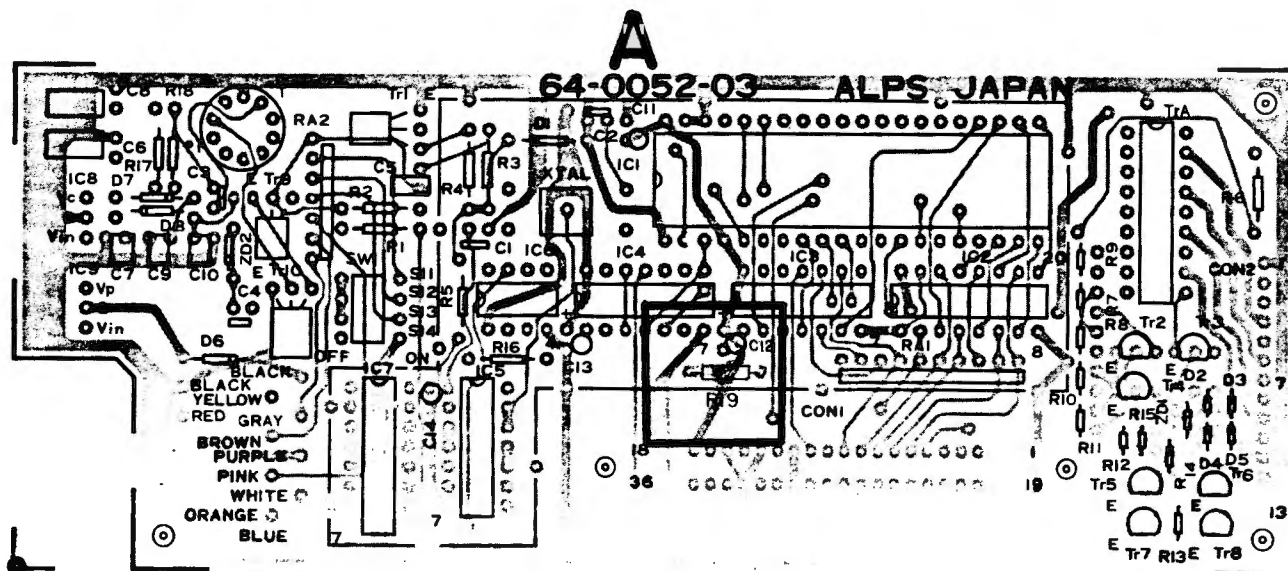
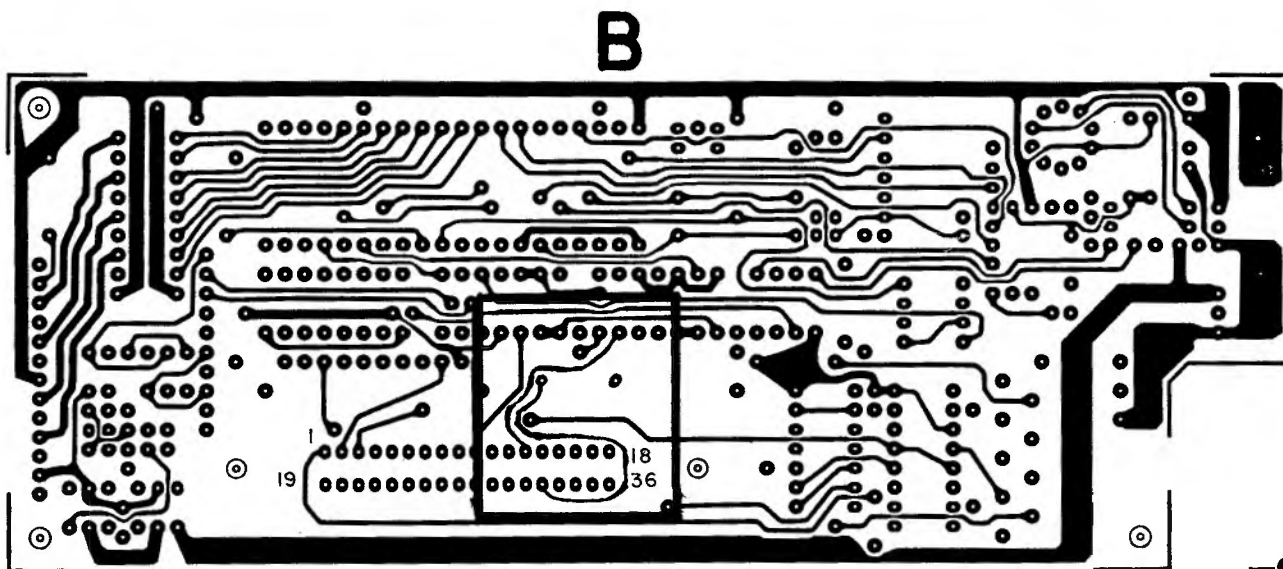
FIGURE 3
PCB CHANGES

Figure 3A and 3B show the changes to the PCB layout. On the TOP view, note the addition of R19, located between C12 and CON1. On the BOTTOM view, note the addition of two traces. One connects to CON1 pin 13, the other connects to CON1 pin 32.

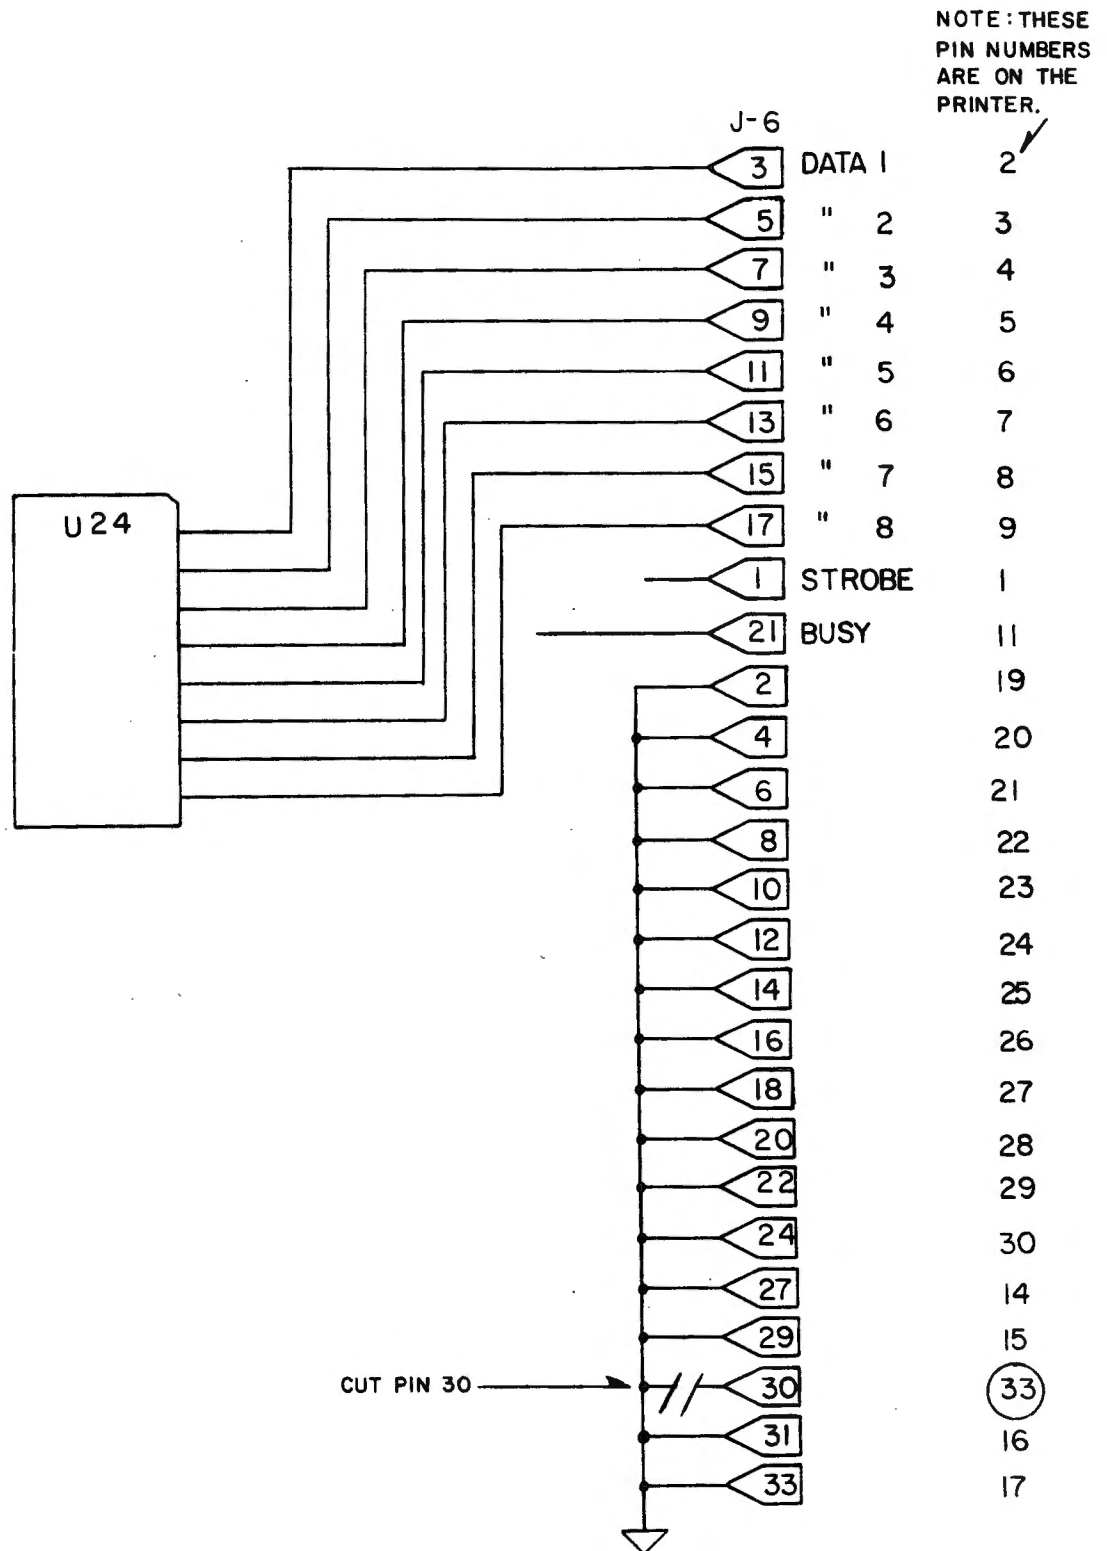
DISCUSSION: Pin 33 of the printer connector is wired to a reset line on the processor in the printer. At the DT-1 end, this pin is grounded. Thus, when the two are connected, the printer is always held in reset and will not do anything.

PROCEDURE: Since this reset function is used by IBM compatible hardware, it is not desirable to modify the printer. To modify the terminal simply cut pin 30 of connector J-6. See the attached illustration. A pull-up resistor is not required because there already is one in the printer.

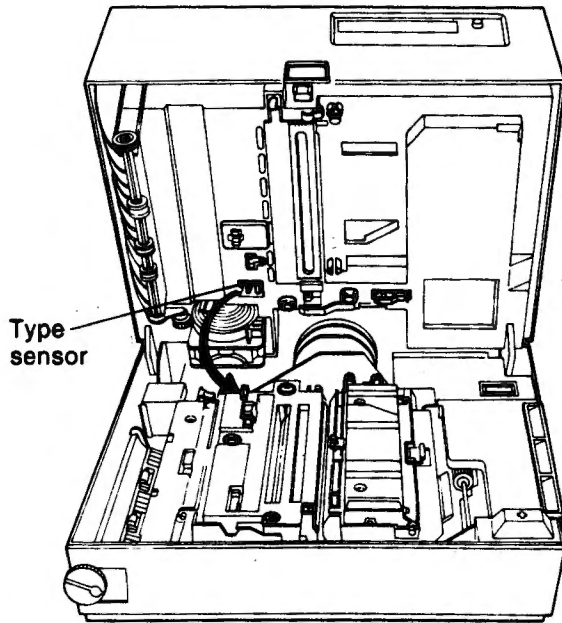
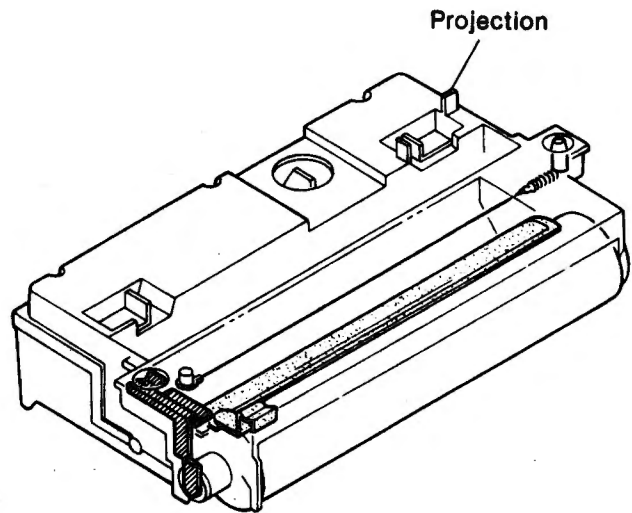
Cleaning unit, OPC drum
(OPC Magazine)

DISCUSSION: Inside the OPC magazine is a cleaning blade which touches the surface of the OPC drum as it rotates. This action provides a method for cleaning left over toner off the drum surface before it rotates past the main charger to begin the printing process again. In early versions of the magazine this blade vibrates at a frequency of 350 Hz. The vibration can be caused by several things including:

PROCEDURE: If a printer exhibits this problem replace the OPC magazine with one of the same type that is already present in the machine. The Kit A unit can be identified by a plastic projection on the rear of the assembly. The Kit B unit will have this projection removed. Refer to the figure on page 2. Do not replace Kit A with Kit B unless the printer indicates a need to do so. All kits (both in National Parts and TEW) have been modified for this fix.

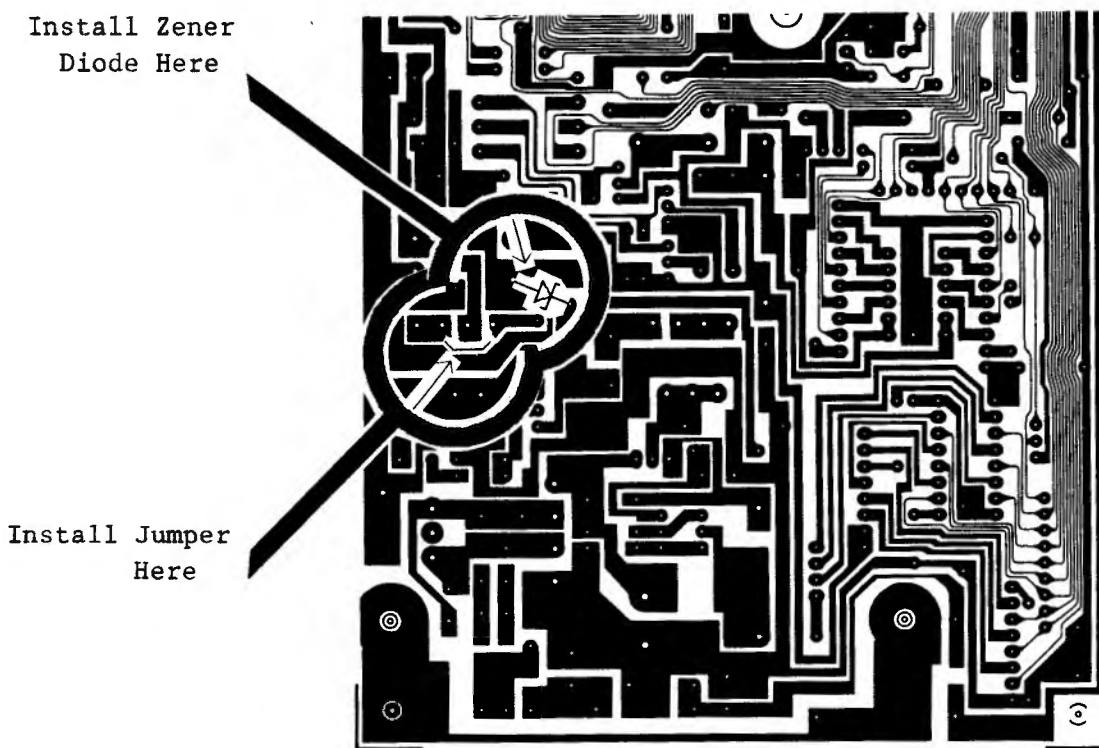
Figure 6

- 9.) On the solder side of the circuit board a jumper must be added. Locate the remaining hole on the solder pad for L1. This hole has a trace that leads to Q10 the 78L05 voltage regulator. Jumper from this point to the pad connecting coil L1 and the fuse using insulated wire of 20-22 GA. See figure 6.

- 10.) On the solder side of the circuit board a 27 volt zener diode must be added between the emitter of Q9 and ground with the cathode on the emitter. See figure 6.

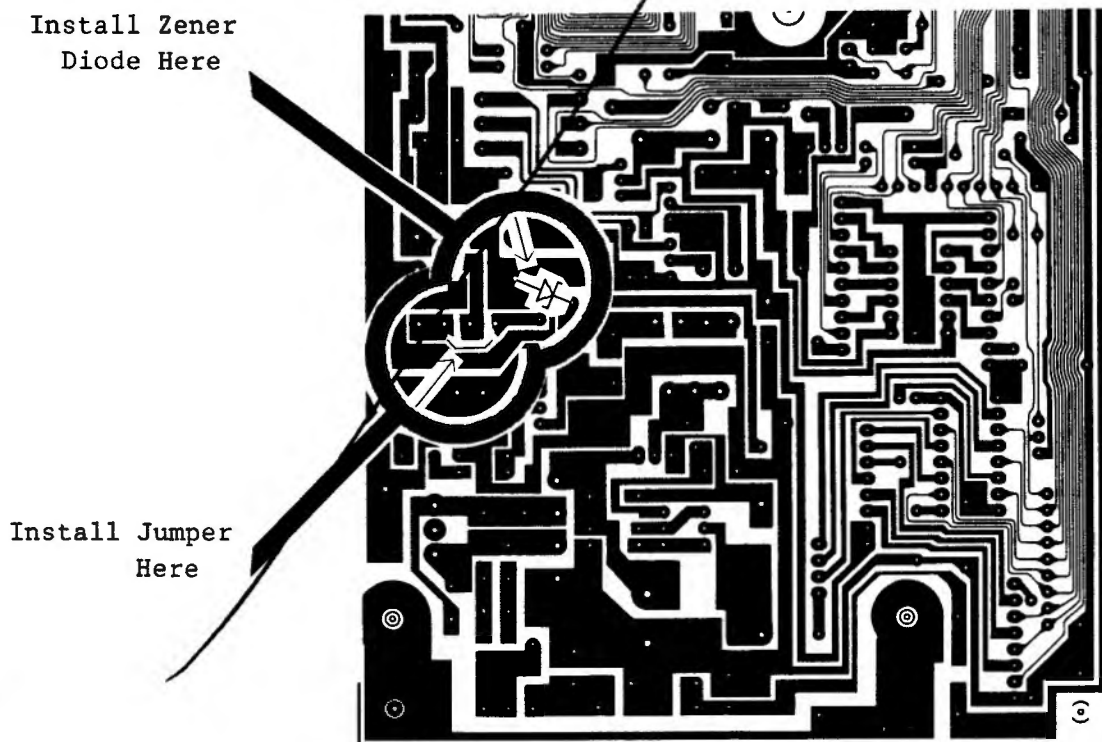
Figure 6

- 9.) On the solder side of the circuit board a jumper must be added. Locate the remaining hole on the solder pad for L1. This hole has a trace that leads to Q10, the 78L05 voltage regulator. Jumper from this point to the pad connecting coil L1 and the fuse, using insulated wire of 20-22 GA. See figure 6.

- 10.) On the solder side of the circuit board a 27 volt zener diode must be added between the emitter of Q9 and ground, with the cathode (banded side) connected to the emitter. See figure 6.

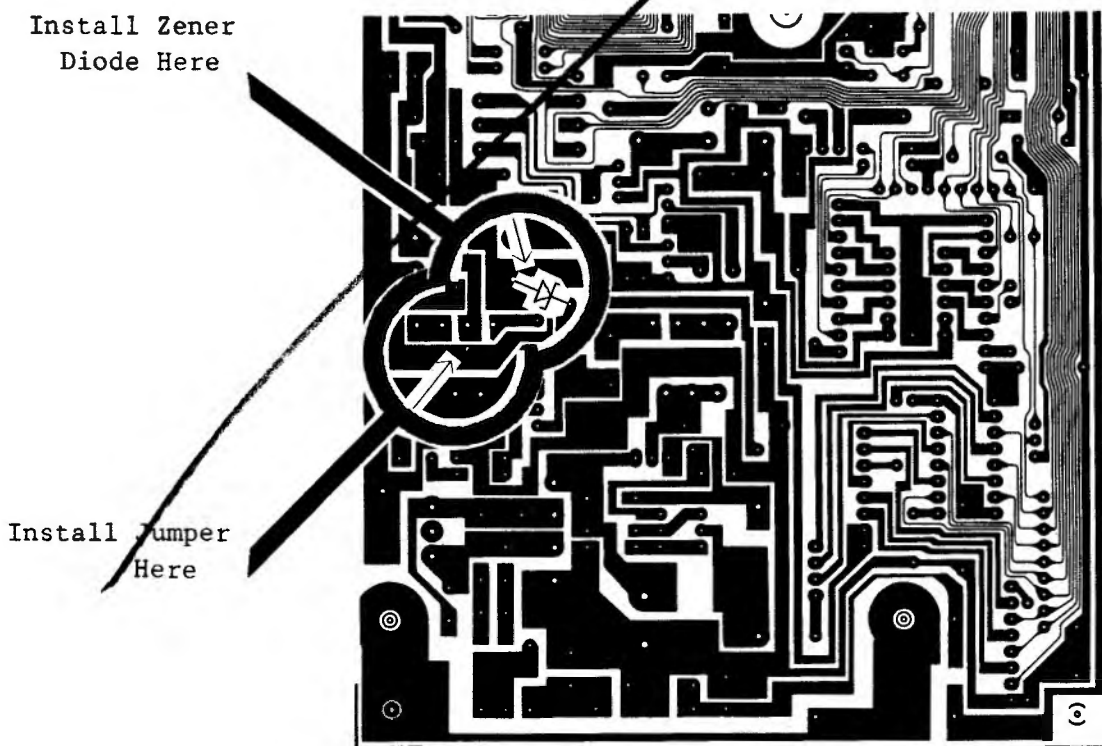
Figure 6

- 9.) On the solder side of the circuit board a jumper must be added. Locate the remaining hole on the solder pad for L1. Jumper from this point to the input side of coil L1 using insulated wire of 20-22 GA. See figure 6.

- 10.) On the solder side of the circuit board a 27 volt zener diode must be added between the emitter of Q9 and ground with the cathode on the emitter. See figure 6.

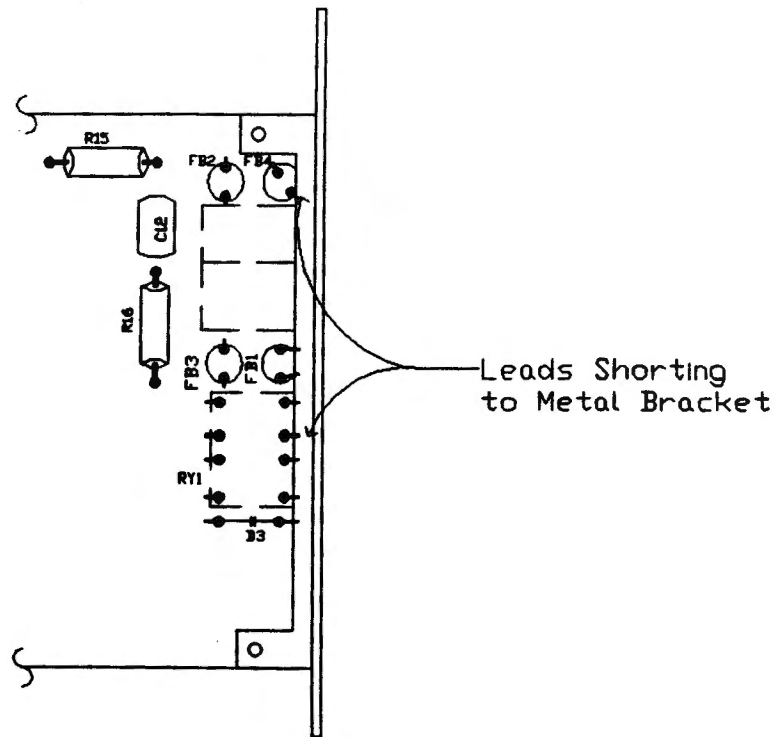
Figure 1
(PCB Top View, "leads touching mounting bracket")

The Tandy 1000EX/HX mounting bracket for the Tandy 25-1018 modem may come in contact with component leads on the solder side of the PC board (See Figure 1). Play between the metal mounting bracket screw holes and the modem's logic board may cause the bracket to come in contact with D3, RY1, FB1, and FB4 component leads. Also, D3 and RY1 leads are at +12 volts potential. If the mounting bracket accidentally comes in contact with these leads, it's possible for the Tandy 1000EX/HX power supply to become grounded causing no or intermittent operation.

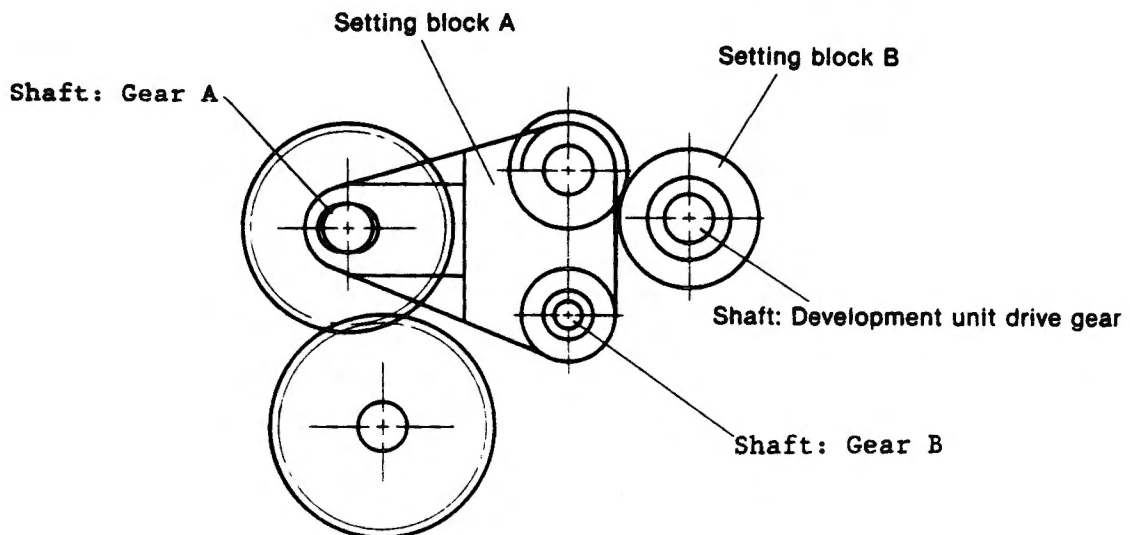
Figure 3

The main motor of the laser printer drives a gear cluster, part of which rotates the development unit roller. If this gear cluster is not aligned properly with the development unit, it could cause the development unit to not line up correctly with the OPC unit. This could cause printing to be darker or lighter from one side of the paper to the other, depending on the amount of misalignment.

7. Now attempt to slide setting block B on the development unit drive gear shaft as shown in figure 3. The development unit drive gear shaft is centered in gear (2) of figure 1. The round part of the two setting blocks should fit together snugly. If they do not, loosen the two screws (4) shown in figure 1 and adjust the bracket (5) for a snug fit between the two setting blocks.
8. Remove setting block B and recheck the fit several times. Adjust as necessary.
9. Reassemble and test for proper operation. To test the print density, place the laser printer into HP LaserJet mode and run the following basic program. This program will print a dense grey scale for a good visual representation of the print density.

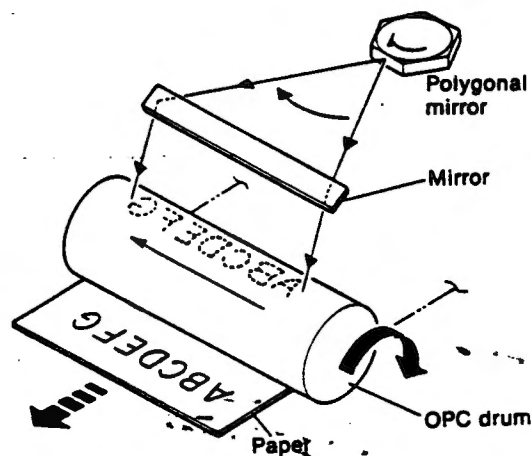
Figure 1

The scanning of the laser beam is accomplished by a scanning motor rotating a polygonal mirror. The polygonal mirror causes the laser beam to scan across the drum. Each side of the polygonal mirror equals one scan line. The scanning motor is built into the optical unit, along with the laser, laser control circuitry, and other lenses and mirrors.

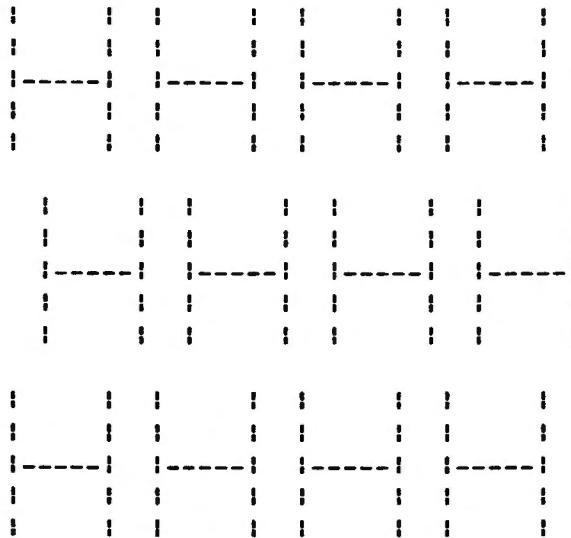
Example of incorrect vertical character alignment.
