TECHNICAL BULLETIN INDEX
Sorted by Bulletin Number
06/25/86

DATE: January 10, 1983
REVISION DATE: January 10, 1983
BULLETIN NO.: 12/16B:1
PRODUCT: 26-4004/5 (Model 12)
SUBASSEMBLY: Motorola Video Board

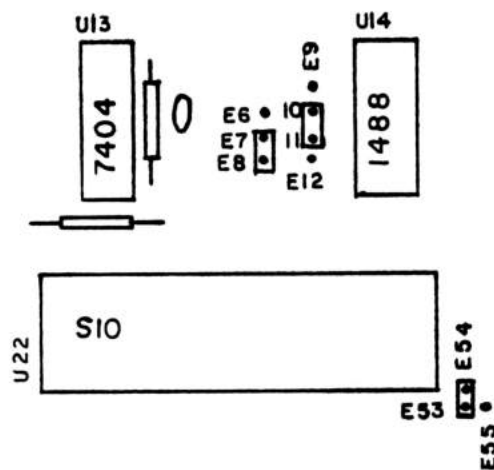
Figure 1

Jumpers for the Main logic board for use asynchronously (normal):

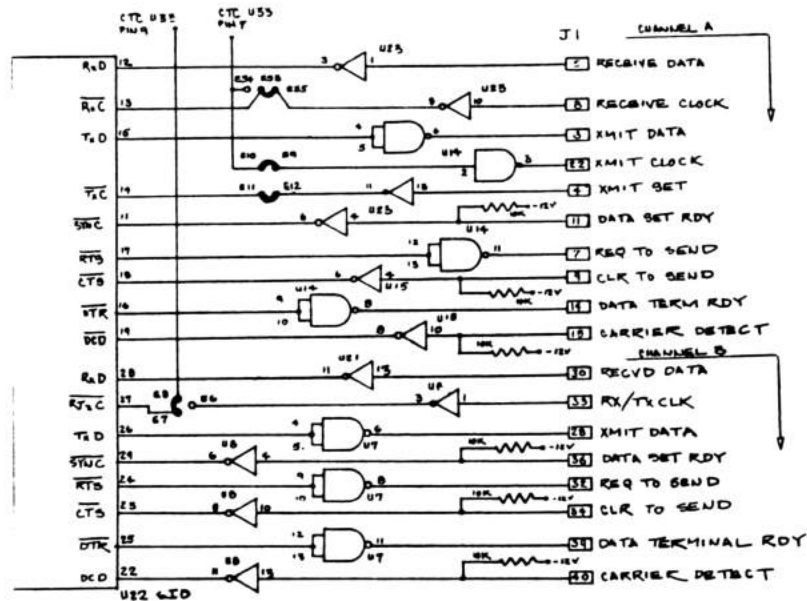
WITHOUT MODEM

Schematic changes

If it is going to be used with a modem the main logic board should be modified as shown in figure 3 by removing E10-E9. If it is going to be wired directly to another computer it should be left as in figure 2. Also, it is recommended that the customer use a 12 conductor cable on their serial channel instead of a 25 conductor cable.

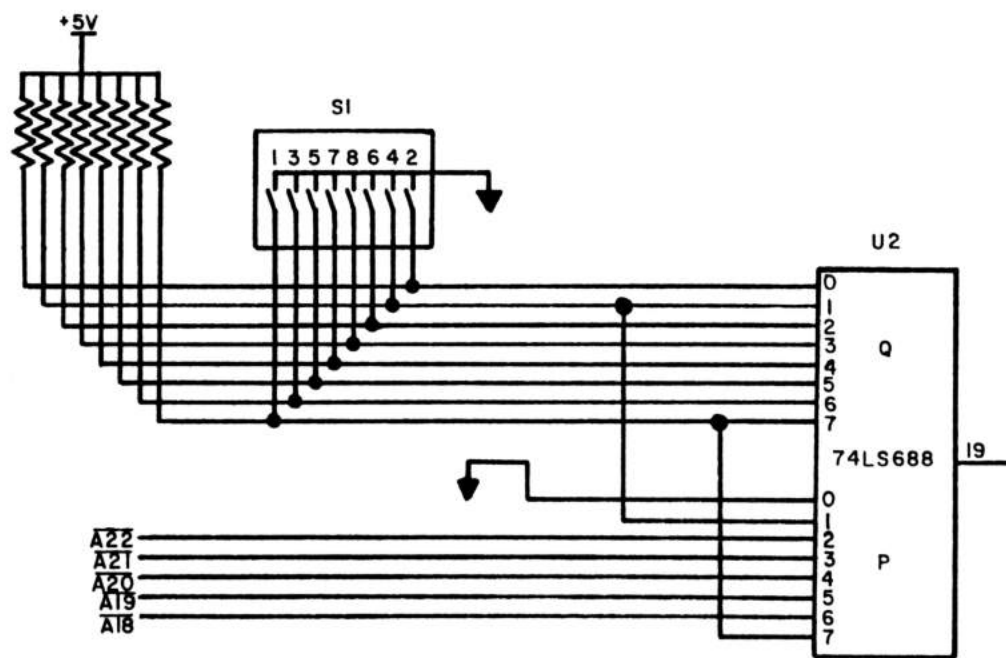
Figure 1

Below is a chart of the switch positions that should be closed corresponding to the number of the memory board you are installing:
