TECHNICAL BULLETIN INDEX  
Sorted by Bulletin Number  
06/25/86

DATE: May 12, 1982  
REVISION DATE: May 13, 1983  
BULLETIN NO: 16:1  
PRODUCT: 26-6001/2 Model 16  
SUBASSEMBLY: AX-9241 FDC Board (Redesign)

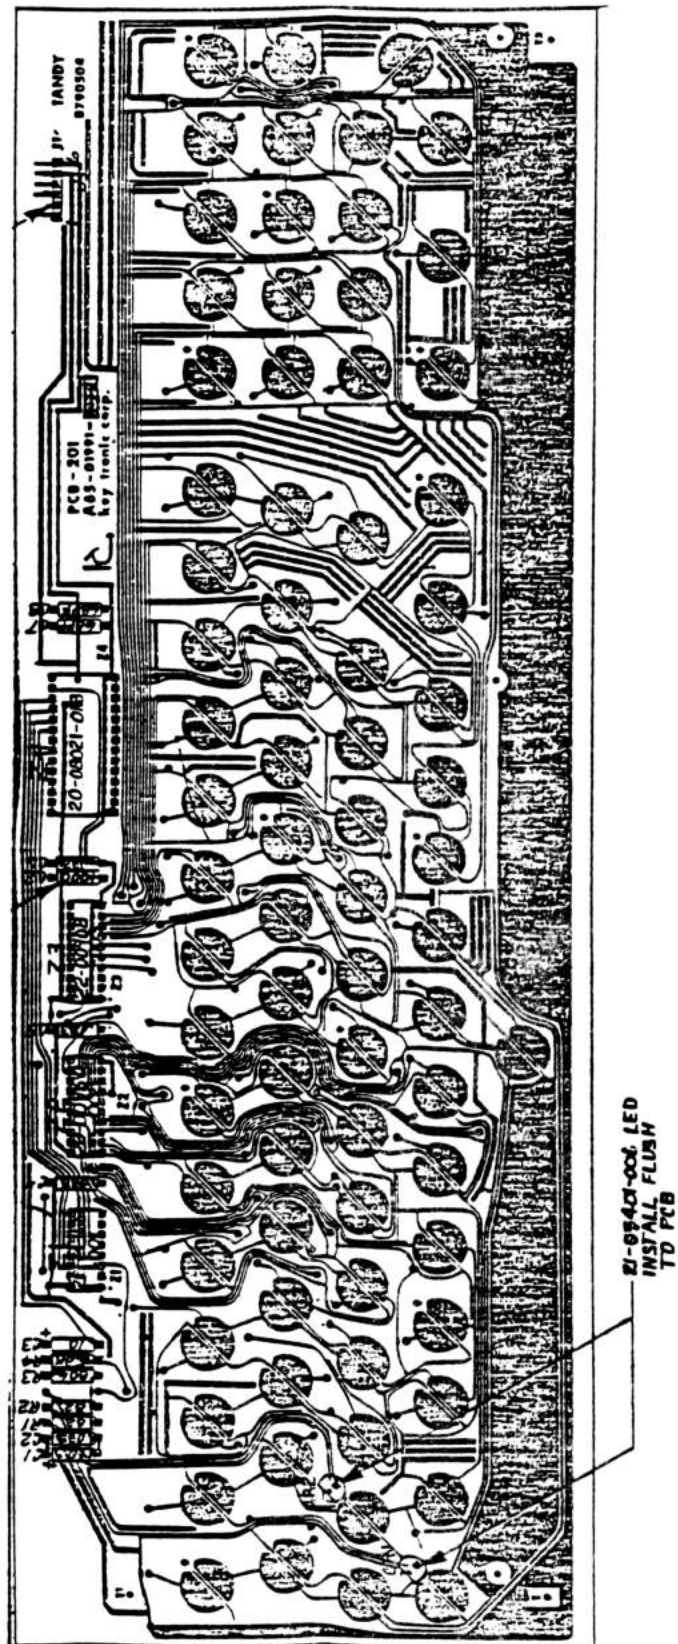
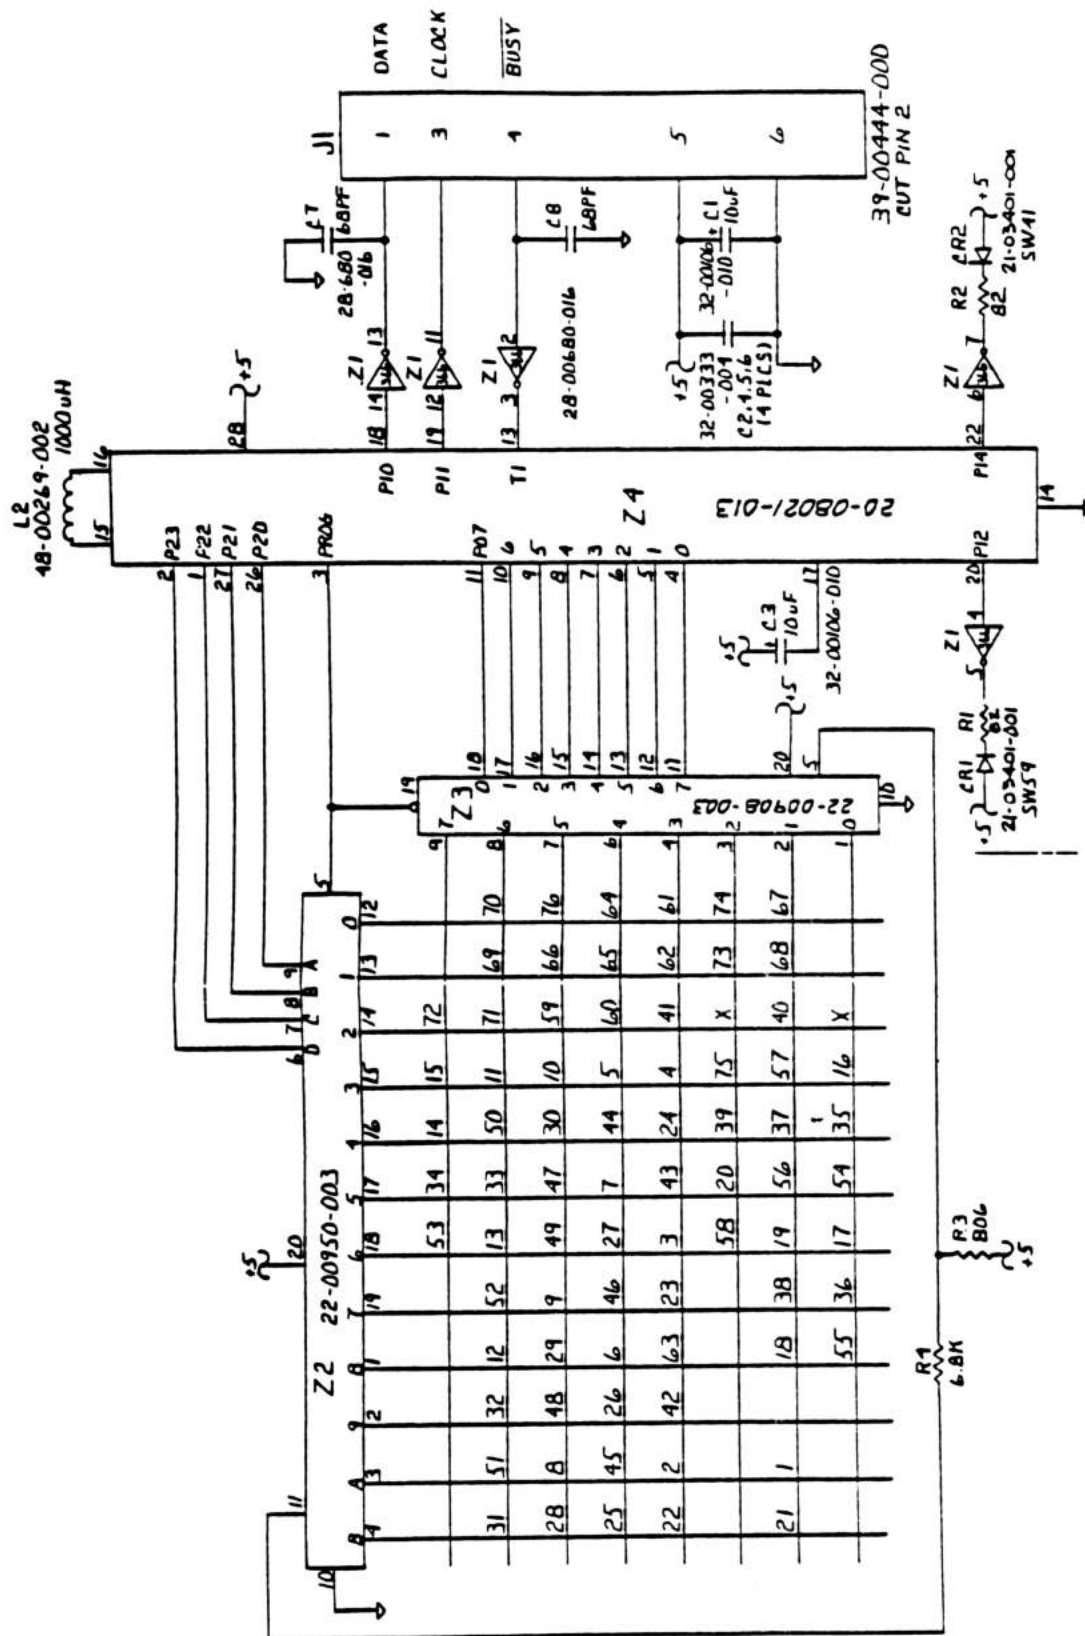
DISCUSSION: The Schematics for the Model II/16 keyboards in the Model II Technical Reference Manual are incorrect. Attached is the correct schematic and component location diagram.
