TECHNICAL BULLETIN INDEX
Sorted by Bulletin Number
04/03/86

PRODUCT: 26-4001/2 Model II

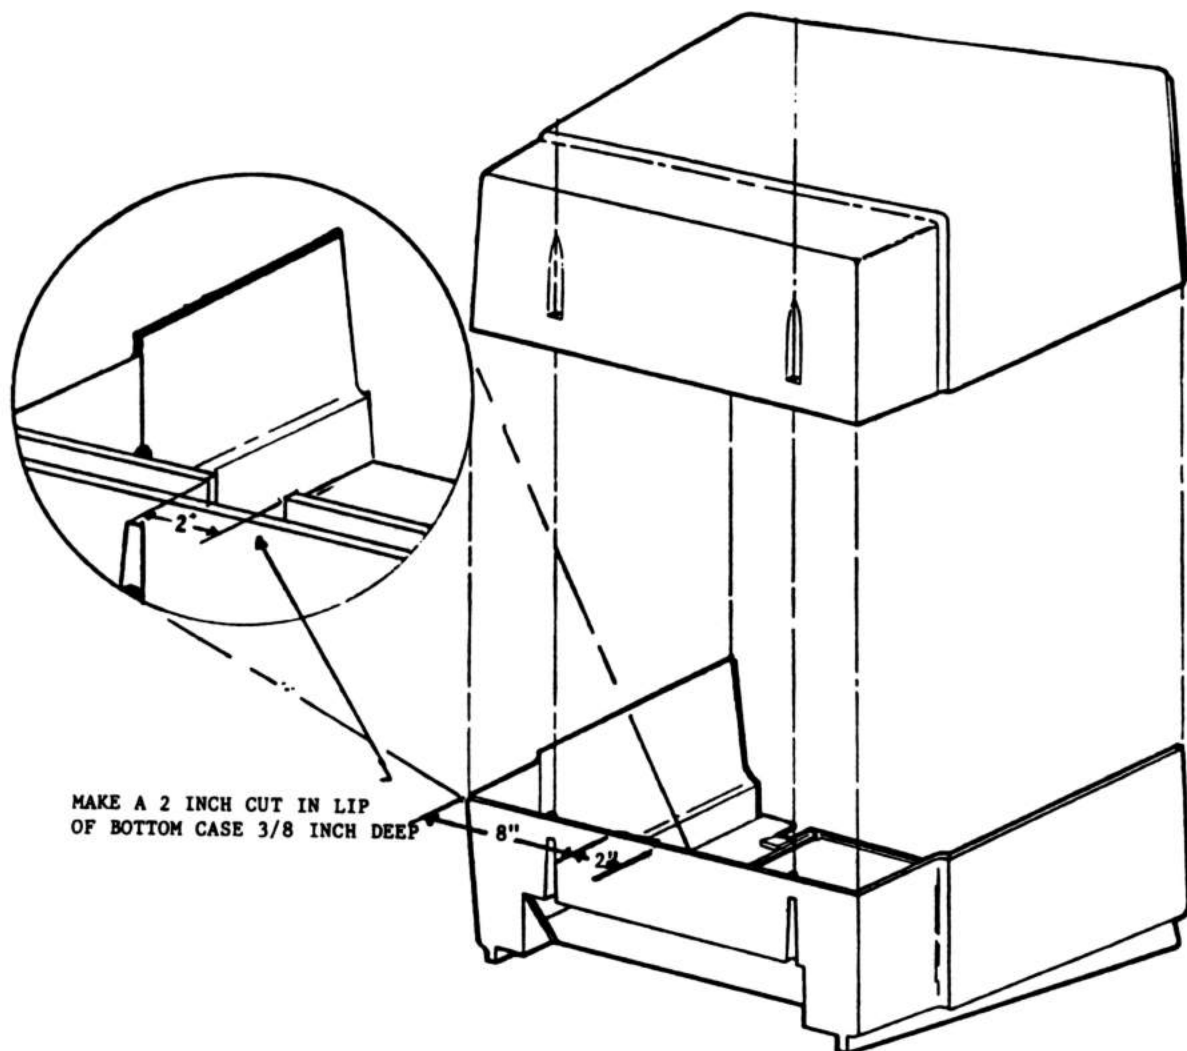
Figure 1.

PURPOSE: To correct keyboard power on reset problems.

CAUTION: Watch for plastic hold tabs on back of case top, make sure you do not puncture cables with these hold tabs.

5. Reinstall top case and check for proper operation.
