TECHNICAL BULLETIN INDEX
Sorted by Bulletin Number
04/03/86

BULLETIN NO: II:1

PRODUCT: 26-4001/2 Model II

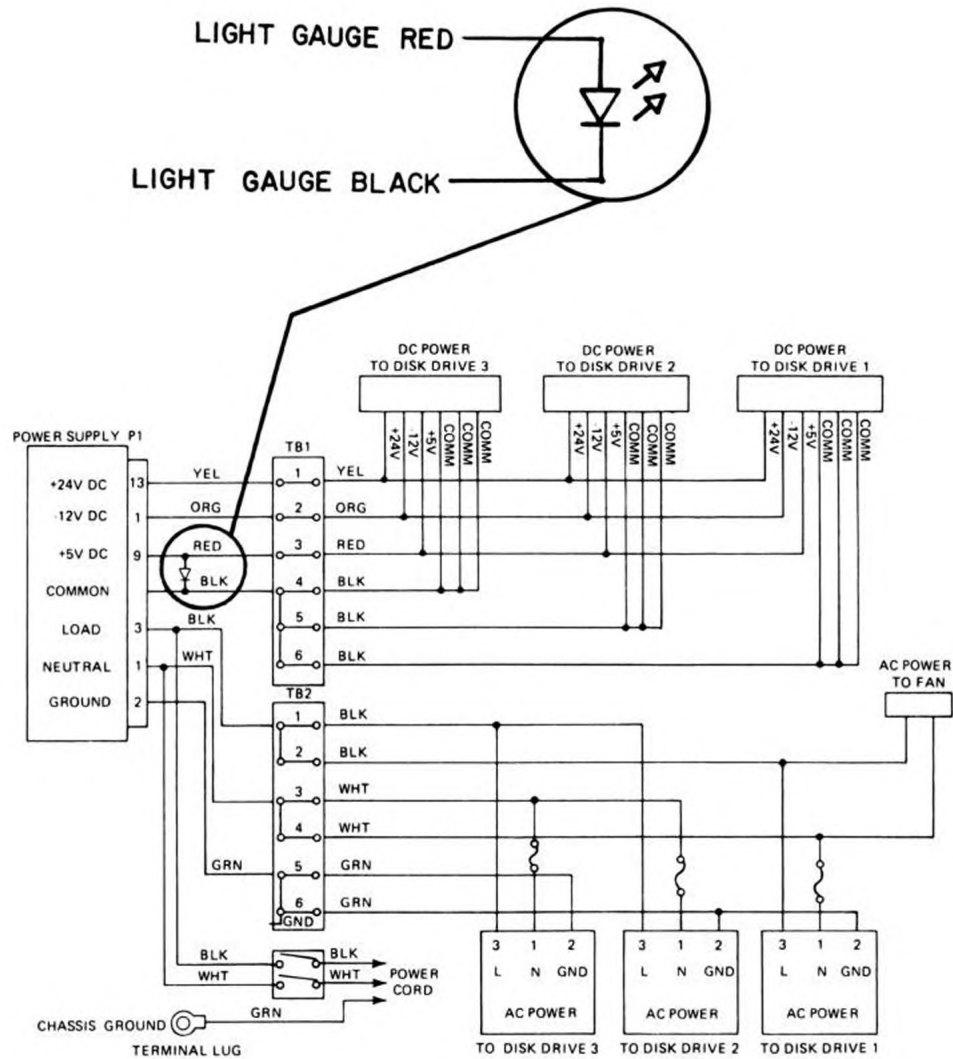
FIG 1 OLD PSU WIRING

PROCEDURE: Refer to Figure 1 for the early version power supply (closed case) wiring diagram. Refer to Figure 2 for the later version power supply (open case) wiring diagram.
