TECHNICAL BULLETIN INDEX  
Sorted by Bulletin Number  
04/03/86

BULLETIN NO: II:1

PRODUCT: 26-4001/2 Model II

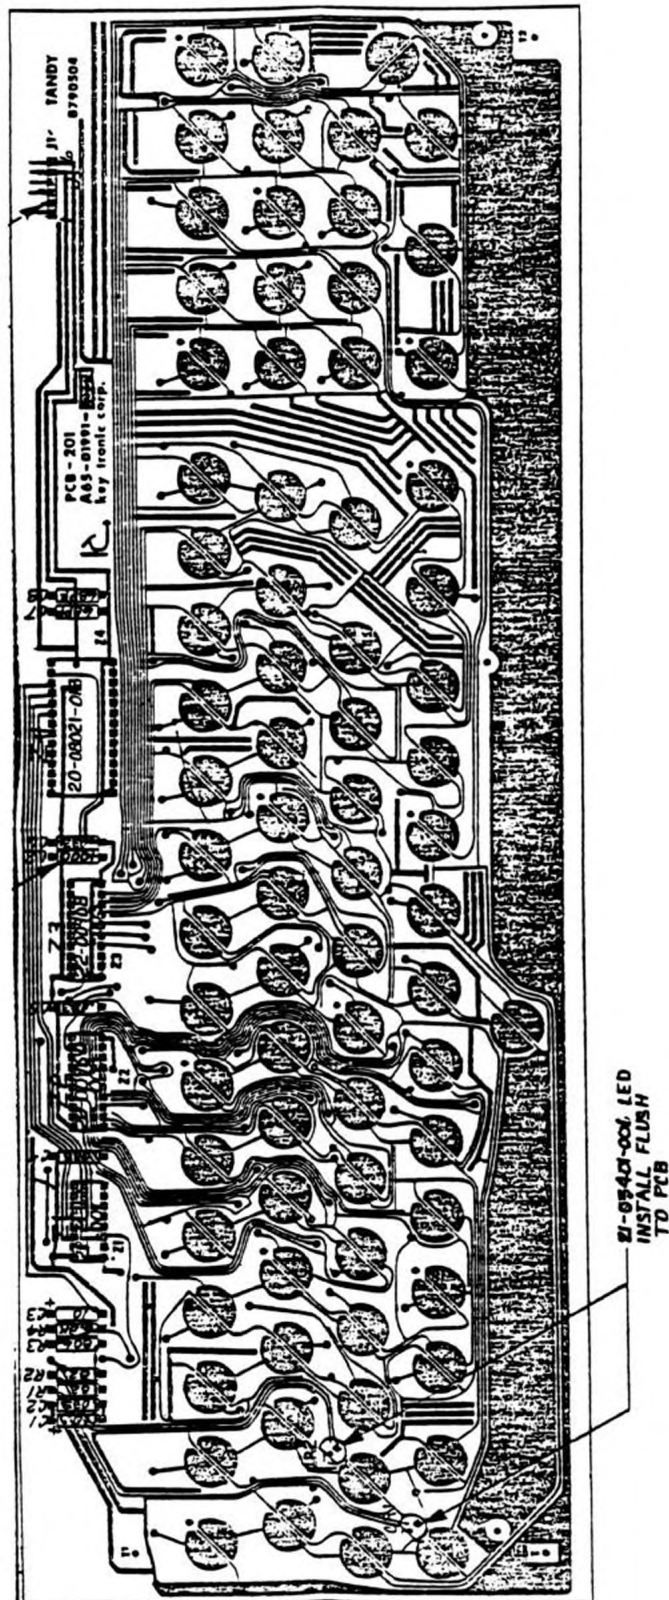
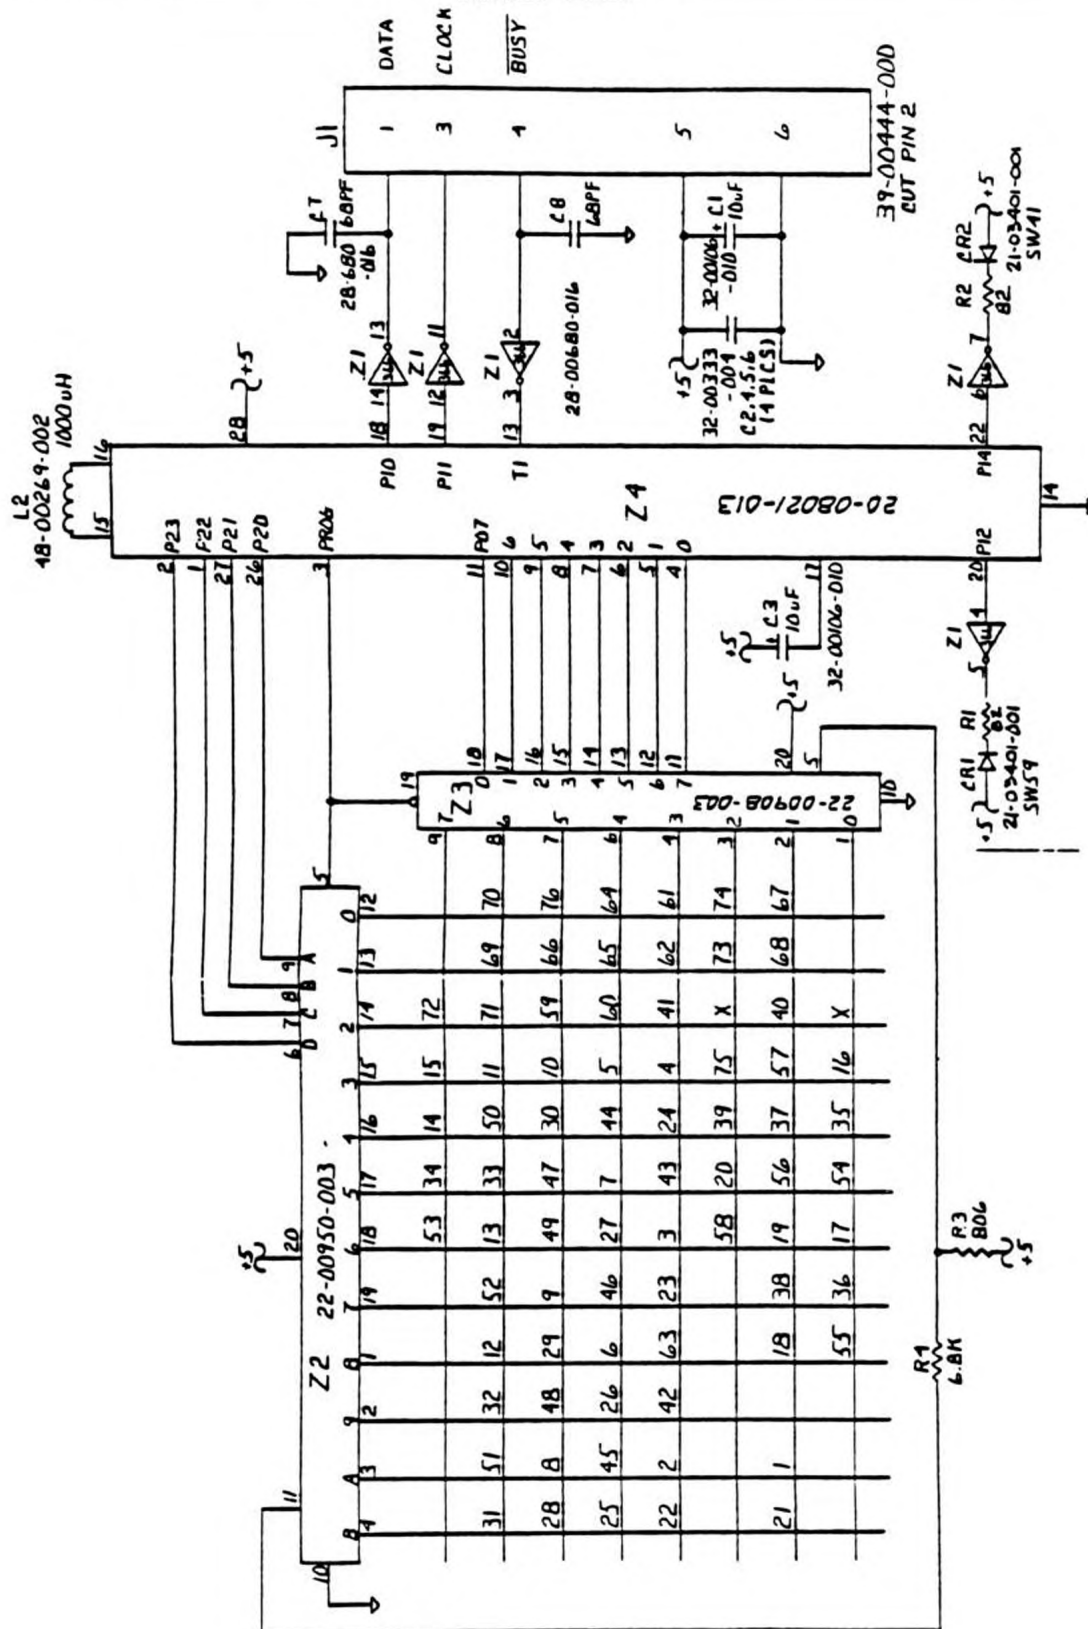
DISCUSSION: The Schematics for the Model II/16 keyboards in the Model II Technical Reference Manual are incorrect. Attached is the correct schematic and component location diagram.

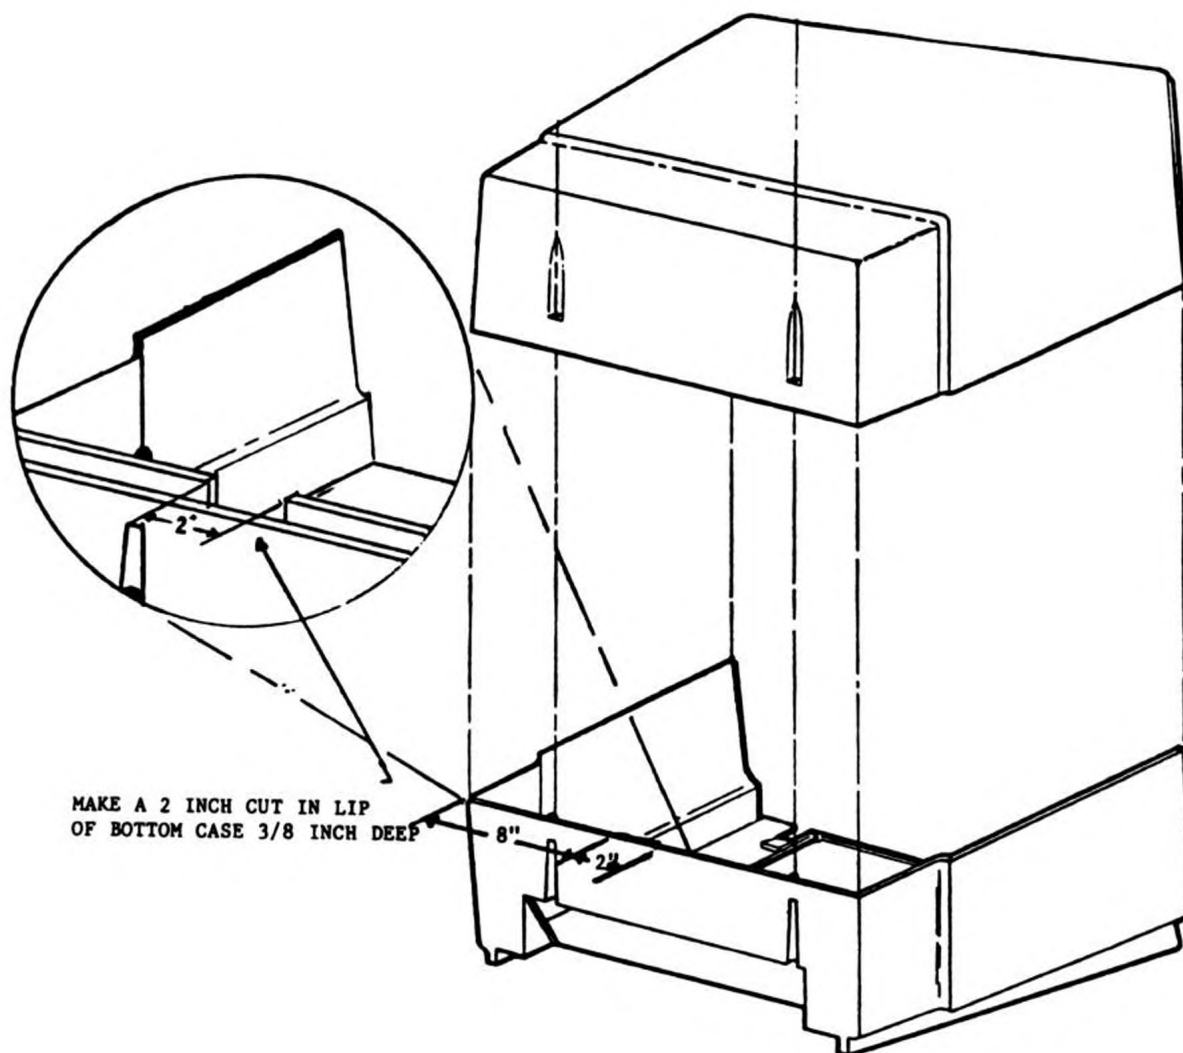
Figure 1.

**CAUTION:** Watch for plastic hold tabs on back of case top, make sure you do not puncture cables with these hold tabs.

5. Reinstall top case and check for proper operation.
