TECHNICAL BULLETIN
Sorted by Bulletin Number
September 28, 1988

TANDY COMPUTER PRODUCTS

DATE: December 8, 1983

BULLETIN NO: 20000:1

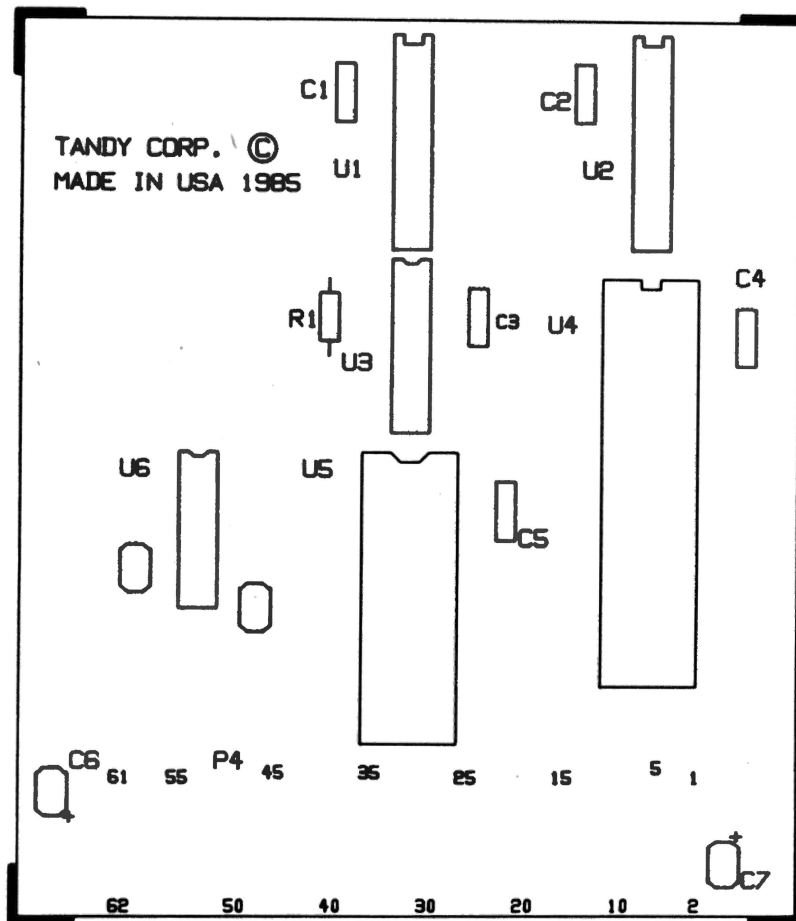
Tandy 2000 8087 Numeric Coprocessor Component Layout

The iAPX 8087 identifies numeric instructions by monitoring the bus activity of the 80186 CPU. Two sets of status lines (S0* - S2* identify the type of bus cycle, and QS0 - QS1 identify queue operations) inform the 8087 of the bus cycle being run as well as the status of the CPU's internal queue (the 80186 maintains a queue up to six bytes long from which opcodes are fetched). A certain class of instruction codes (ESCAPE opcodes) have been reserved for the numeric coprocessor extension. In response to an ESC opcode, the 80186 computes the EA (Effective Address) identified by the opcode, and does a single memory read from that address. The 8087 decodes the ESC instruction tandem with the 80186 and (if necessary) grabs both the data and the address generated by the CPU. If further bytes need to be fetched to complete the instruction, the 8087 informs the 80186 of its status by outputting BUSY (active high while doing a numeric operation). The CPU has an instruction (WAIT, no operands) that waits for its TEST* (active low) to go active before it continues. All 86 family assemblers insert a WAIT instruction before floating point instructions unless explicitly directed not to do so. That way, the CPU does not embark on a new numeric instruction before the last one has completed its execution. Interface between the 8087 and the 80186 is performed by the 82188. This device provides system READY synchronization, converts the RQ/GTn* bus master control convention of the 8087 to the HOLD/HDLA convention of the 80186, synchronizes the QSn* lines of the 80186 to the 8087, and provides RD*, WR*, and ALE strobes by decoding the S0* - S2* status lines that are common to both the 80186 and the 8087.

Additional logic on the circuit board regenerates the MCS0* and MCS1* (Memory Chip Select 0 and 1, active low in 00000H - 1FFFFH for MCS0* and in 20000H - 3FFFFH for MCS1*) that is generated by the 80186 so that the 8087 may access these areas also. In order for the 8087 to properly track accesses to the UCS* (Upper Chip Select, active low in F8000H - FFFFFH), SRDY (Synchronous Ready, active high) must be held inactive to maintain the appearance of a three wait state access (the 80186 is programmed by the boot ROM to run a three wait state access to this area).
